## REVISED LIST OF NORTH BOUND CRASH BARRIER

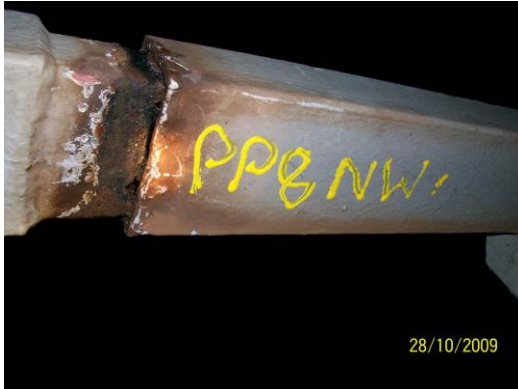
**ITEM 1**

| | | COMPLETED | |
|---|---|---|---|
| 1. P.P.08 N.W. – MALE END HOLED. | | | |

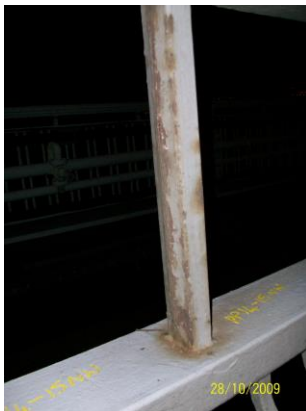
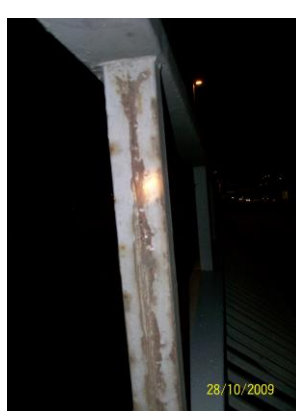
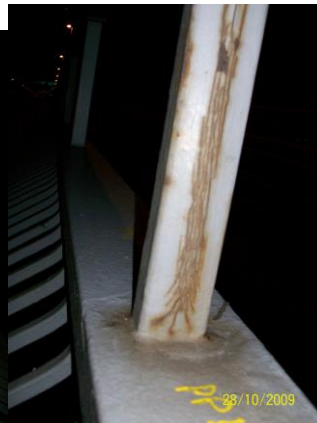
**ITEM 2**

| | | COMPLETED | |
|---|---|---|---|
| 2. P.P.14-15 N.W. – REPLACE POST, SEE PHOTOGRAPH FOR DEFECT. | | | |

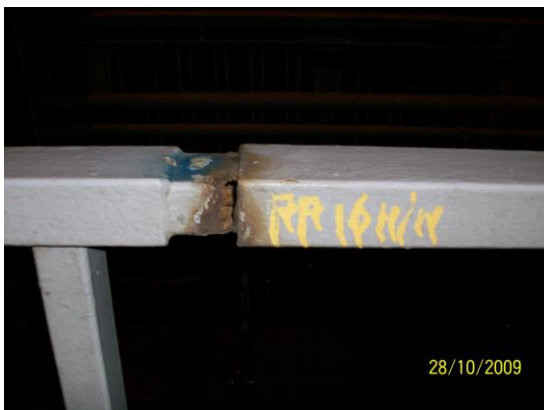
**ITEM 3**

| | | COMPLETED | |
|---|---|---|---|
| 3. P.P.16 N.W. – MALE END (STILL OUTSTANDING). | | | |

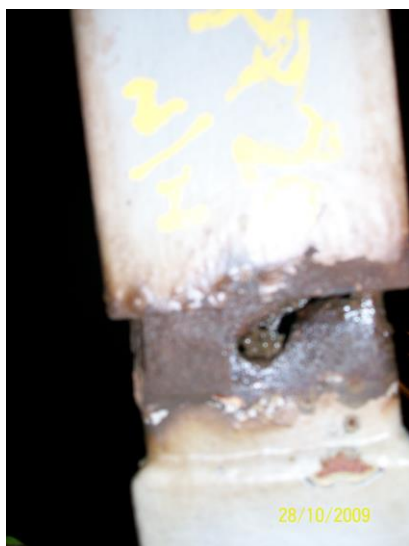
**ITEM 4**

| | | COMPLETED | |
|---|---|---|---|
| 4. P.P.20 N.W. - MALE END (STILL OUTSTANDING). | | | |

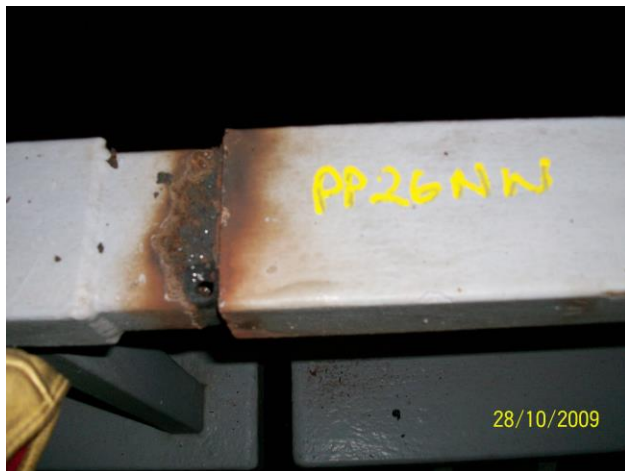
**ITEM 5**

| | | COMPLETED | |
|---|---|---|---|
| 5. P.P.26 N.W. – MALE END HOLED. | | | |

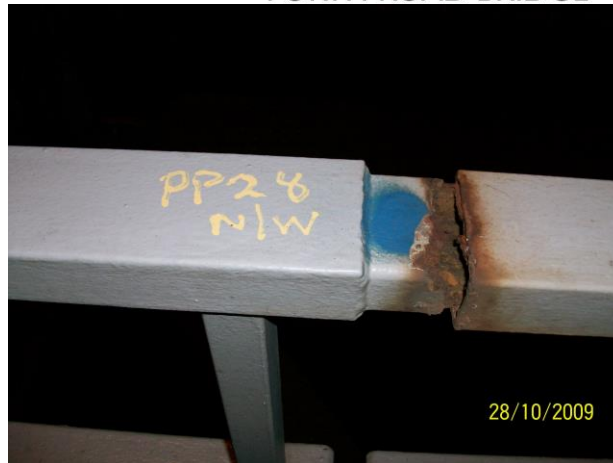
**ITEM 6**

| | | COMPLETED | |
|---|---|---|---|
| 6. P.P.28 N.W. – MALE END (STILL OUTSTANDING). | | | |

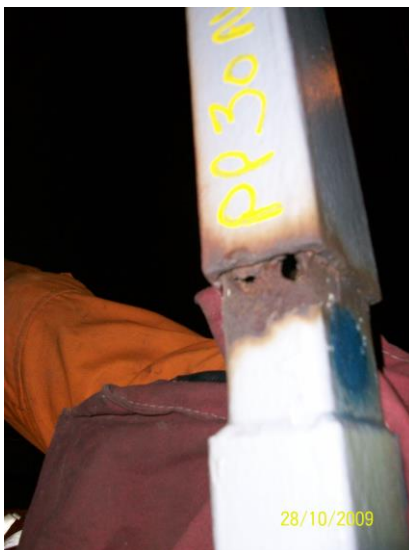
**ITEM 7**

| | | COMPLETED | |
|---|---|---|---|
| 7. P.P.30 N.W. – MALE END (STILL OUTSTANDING). | | | |

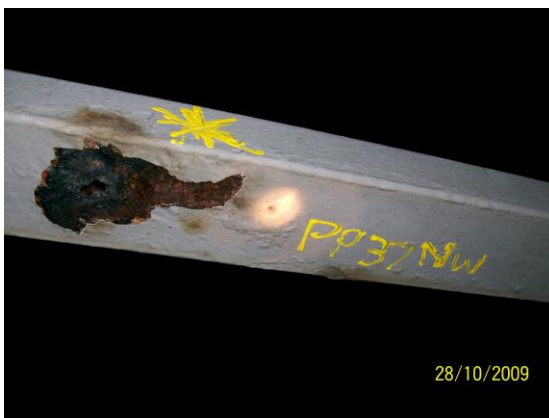
**ITEM 8**

| | | COMPLETED | |
|---|---|---|---|
| 8. P.P.37 N.W. – TOPRAIL HOLED UNDERSIDE (POST SOUTH OF PANEL POINT). | | | |

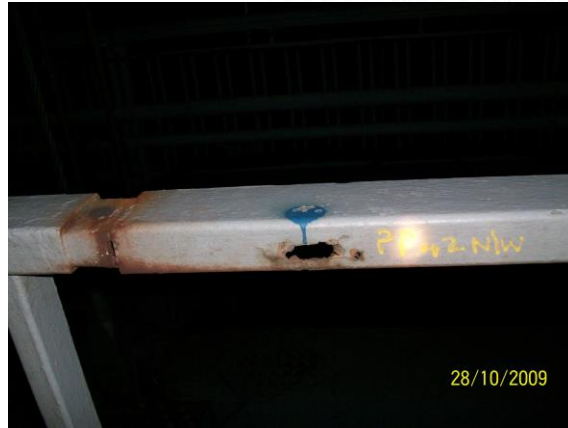
**ITEM 9 & ITEM 10**

| | | COMPLETED | |
|---|---|---|---|
| 9. NUMEROUS CORROSION SPOTS BETWEEN P.P.36 – 38. | | | |
| 10. P.P.42 N.W. – TOPRAIL HOLED, 180mm FROM END (STILL OUTSTANDING). | | | |

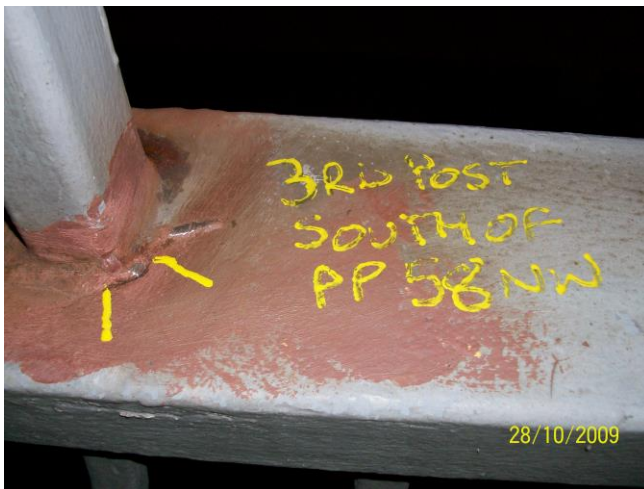
**ITEM 12**

| | | COMPLETED | |
|---|---|---|---|
| 12. P.P. 58 N.W. – 25mm TOE CRACK ON PREVIOUSLY REPAIRED WELD. | | | |

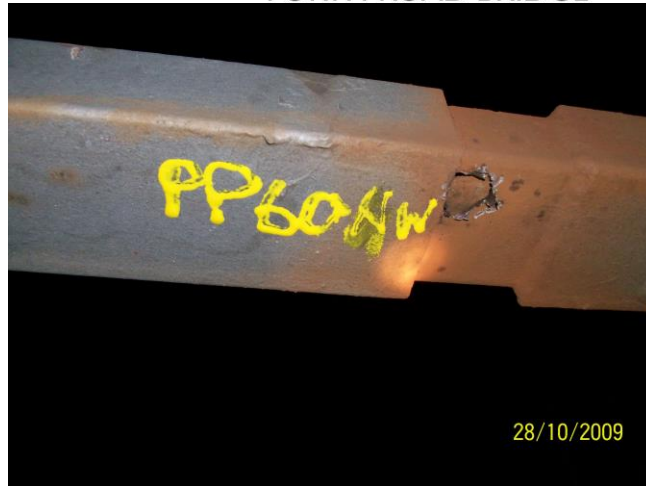
**ITEM 13**

| | | COMPLETED | |
|---|---|---|---|
| 13. P.P. 60 N.W. – MALE END HOLED. | | | |

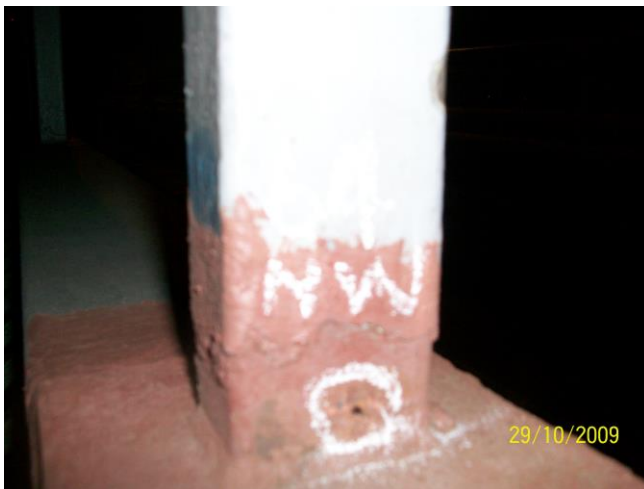
**ITEM 14**

| | | COMPLETED | |
|---|---|---|---|
| 14. P.P. 64 N.W. – 2 <sup>ND</sup> POST SOUTH (RECENT REPAIR) HAS SMALL HOLE. | | | |

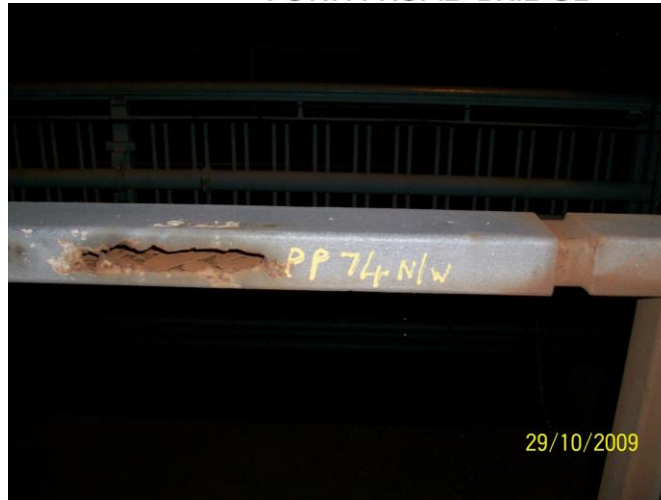
**ITEM 15**

| | | COMPLETED | |
|---|---|---|---|
| 15. P.P. 74 N.W. – TOP RAIL HOLED (STILL OUTSTANDING). | | | |

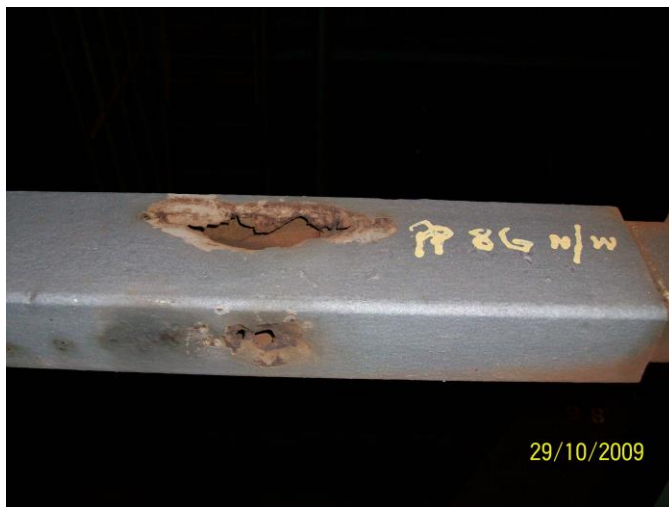
**ITEM 16**

| | | COMPLETED | |
|---|---|---|---|
| 16. P.P. 86 N.W. – FEMALE END (STILL OUTSTANDING). | | | |

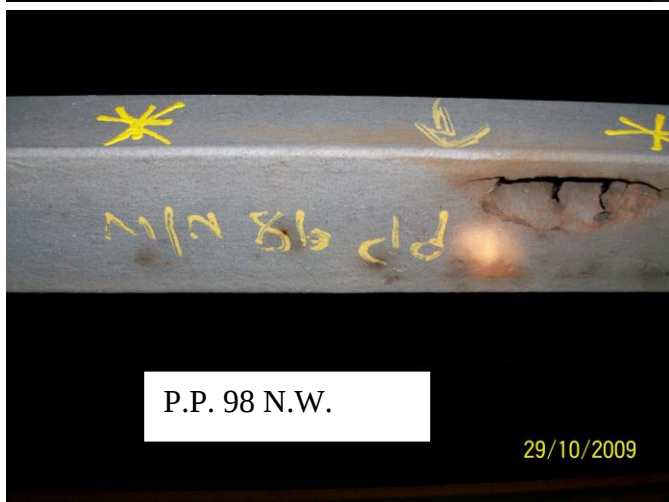
**ITEM 17**

| | | COMPLETED | |
|---|---|---|---|
| 17. P.P. 98 N.W. – TOPRAIL HOLED UNDERSIDE 400mm FROM END (STILL OUTSTANDING). | | | |

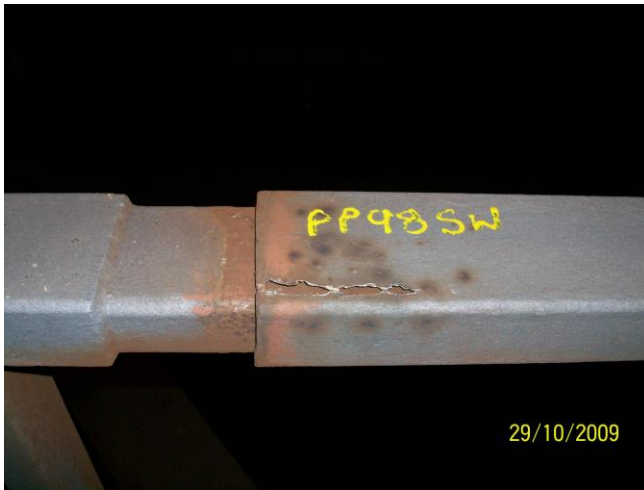
**ITEM 18**

| | | COMPLETED | |
|---|---|---|---|
| 18. P.P. 98 S.W. – FEMALE END HOLED/CORRODED. | | | |

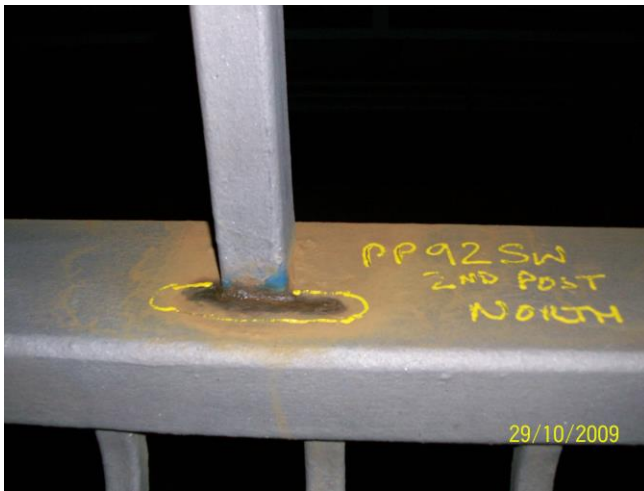
**ITEM 19**

| | | COMPLETED | |
|---|---|---|---|
| 19. P.P. 92 S.W. – 2 <sup>ND</sup> POST NORTH, BASE WELD CRACKED. | | | |

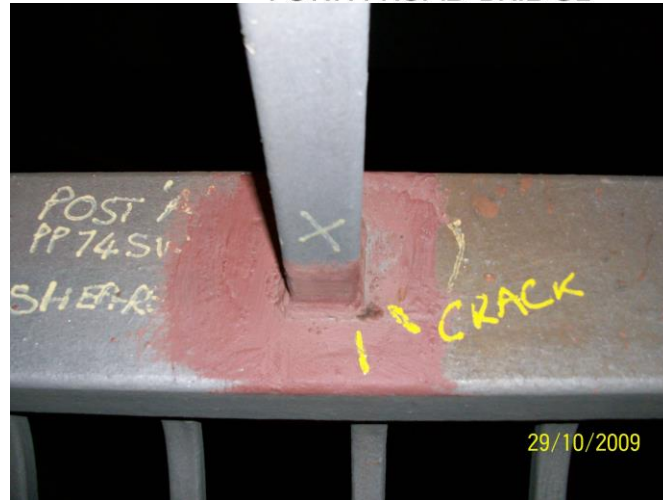
**ITEM 20**

| | | COMPLETED | |
|---|---|---|---|
| 20. P.P. 74 S.W. – POST “A” SMALL BASE WELD CRACK, RE-REPAIR. | S.WEST | 04.11.09 | |

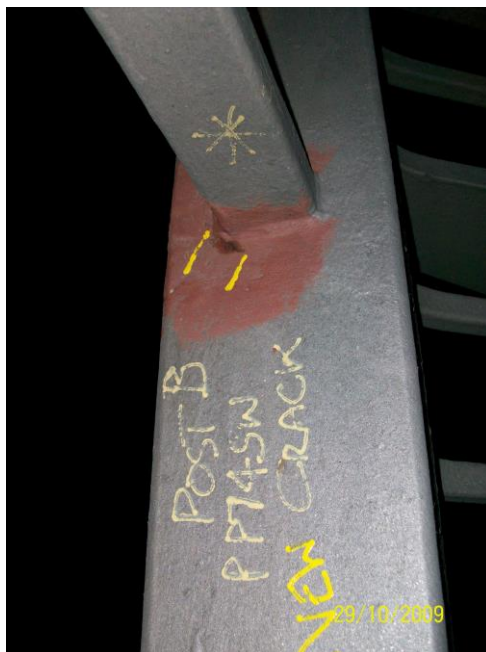
**ITEM 21**

| | | COMPLETED | |
|---|---|---|---|
| 21. P.P. 74 S.W. – POST “B” SMALL BASE WELD CRACK, RE-REPAIR. | S.WEST | 04.11.09 | |

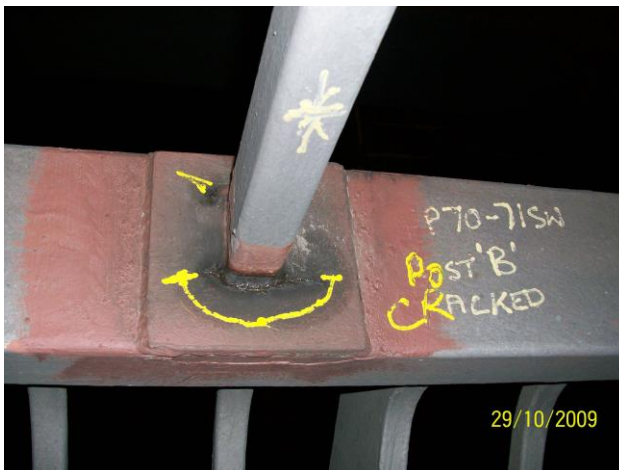
**ITEM 24**

| | | COMPLETED | |
|---|---|---|---|
| 24. P.P. 70-71 S.W. – POST “B” BASE WELD CRACK, RE-REPAIR. | S.WEST | 04.11.09 | |

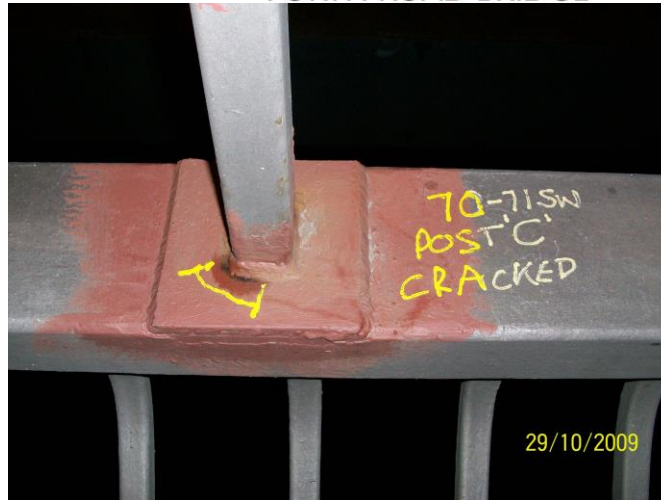
**ITEM 25**

| | | COMPLETED | |
|---|---|---|---|
| 25. P.P. 70-71 S.W. – POST “C” BASE WELD CRACK, RE-REPAIR. | S.WEST | 04.11.09 | |

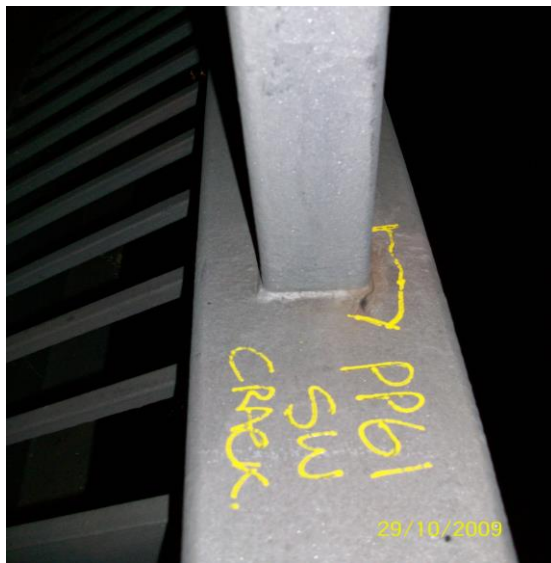
**ITEM 26**

| | | COMPLETED | |
|---|---|---|---|
| 26. P.P. 61 S.W. – POST BASE WELD CRACK. | S.WEST | 04.11.09 | |

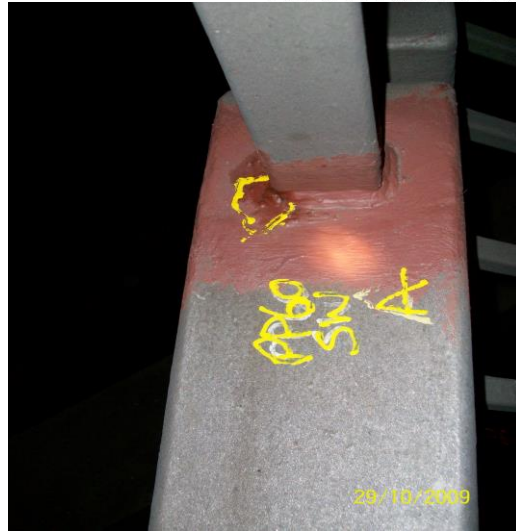
**ITEM 27**

| | | COMPLETED | |
|---|---|---|---|
| 27. P.P. 60 S.W. – POST “A” BASE WELD CRACK, RE-REPAIR. | K.HORN | 04.11.09 | |

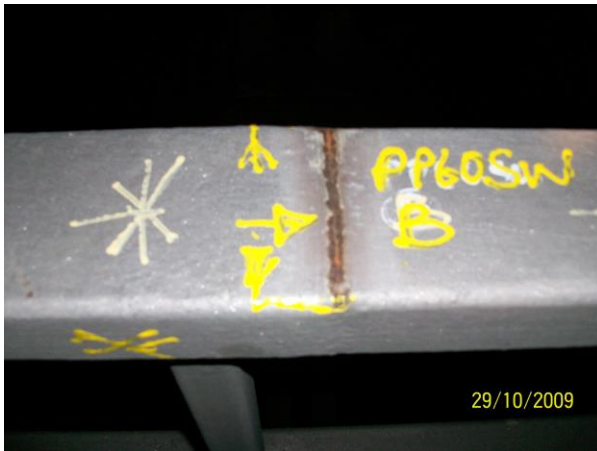
**ITEM 28**

| | | COMPLETED | |
|---|---|---|---|
| 28. P.P. 60 S.W. - ITEM “B” TOPRAIL WELD CRACK (STILL OUTSTANDING). | K.HORN | 04.11.09 | |

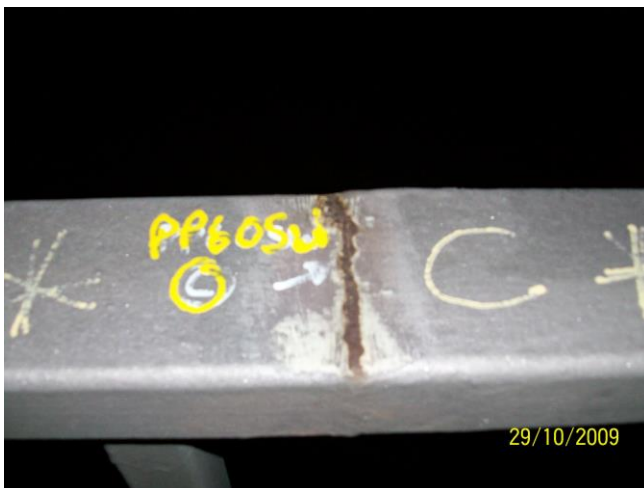
**ITEM 29**

| | | COMPLETED | |
|---|---|---|---|
| 29. P.P. 60 S.W. - ITEM “C” TOPRAIL WELD CRACK (STILL OUTSTANDING). | K.HORN | 04.11.09 | |

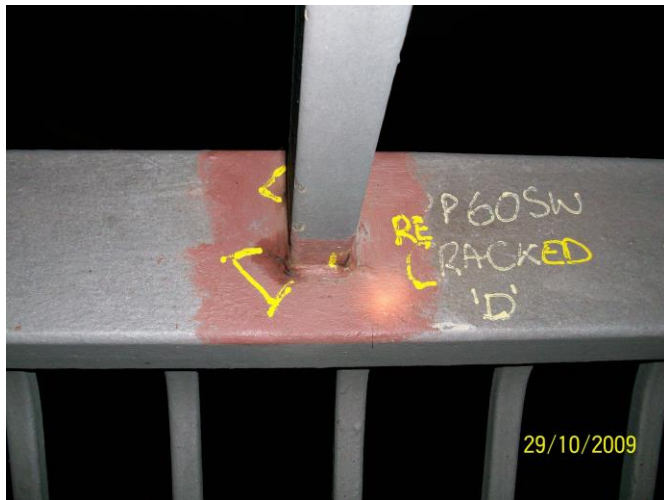
**ITEM 30**

| | | COMPLETED | |
|---|---|---|---|
| 30. P.P. 60 S.W. – POST “D” BASE WELD CRACK, 3 POSITIONS, RE-REPAIR. | K.HORN | 04.11.09 | |

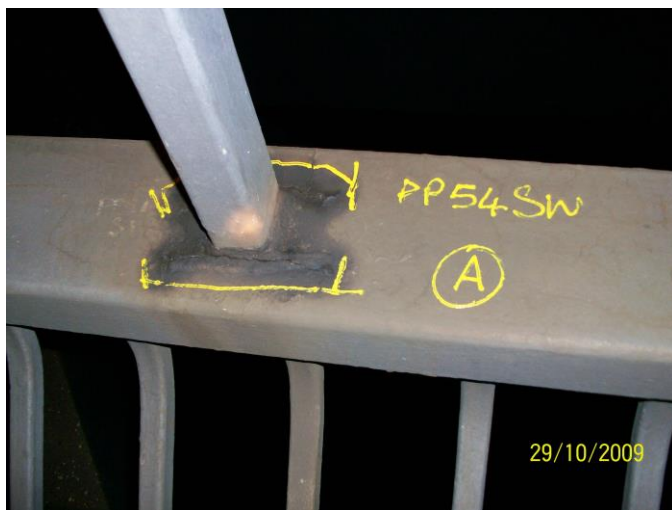
**ITEM 31**

| | | COMPLETED | |
|---|---|---|---|
| 31. P.P. 54 S.W. - POST “A” BASE WELD CRACK, RE-REPAIR. | S.WEST | 04.11.09 | |

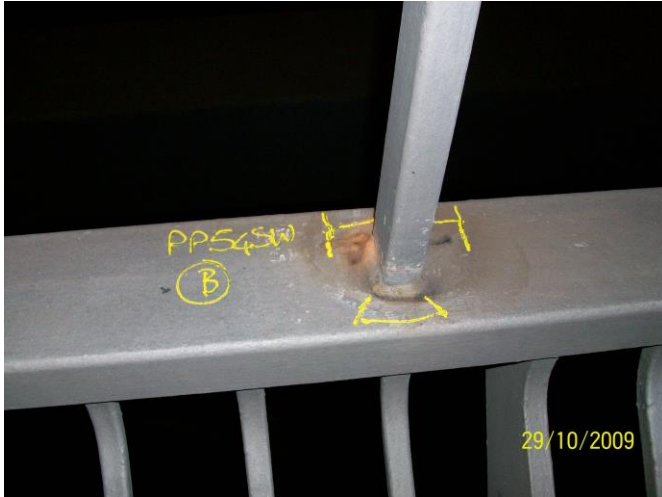
**ITEM 32**

| | | COMPLETED | |
|---|---|---|---|
| 32. P.P. 54 S.W. - POST “B” BASE WELD CRACK, RE-REPAIR. | S.WEST | 04.11.09 | |

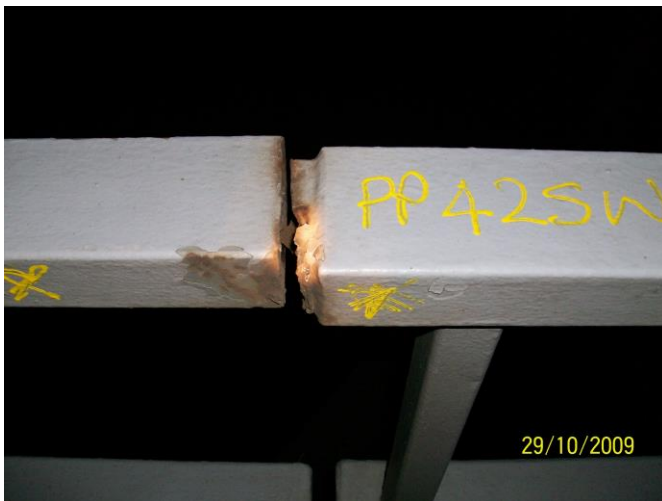
**ITEM 33**

| | | COMPLETED | |
|---|---|---|---|
| 33. P.P. 42 S.W. – MALE END SHEARED. (STILL OUTSTANDING). | | | |

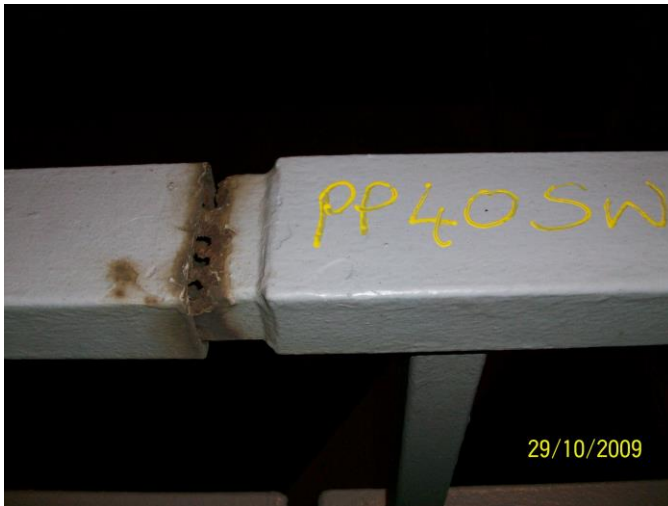
**ITEM 34**

| | | COMPLETED | |
|---|---|---|---|
| 34. P.P. 40 S.W. – MALE END CORRODED. (STILL OUTSTANDING). | | | |

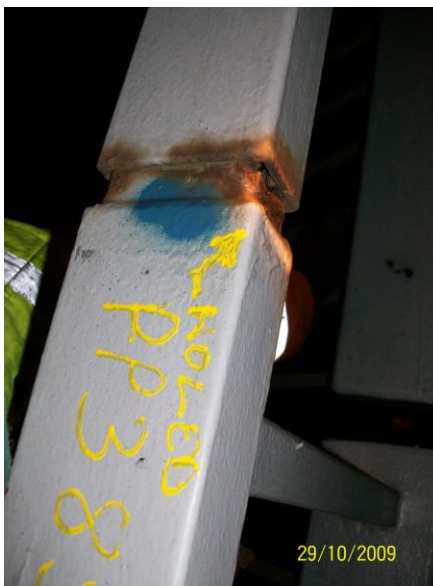
**ITEM 35**

| | | COMPLETED | |
|---|---|---|---|
| 35. P.P. 38 S.W. – MALE END HOLED. | | | |

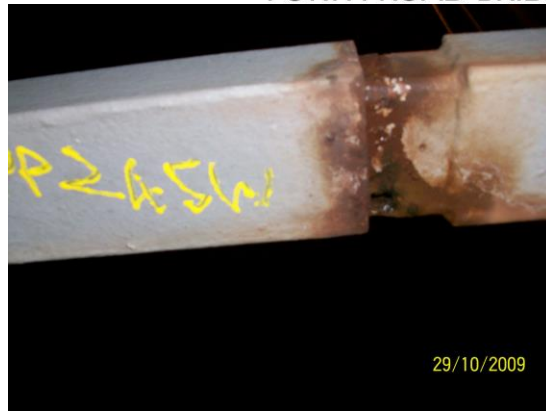
**ITEM 36**

| 36. P.P. 24 S.W. - MALE END HOLED ON UNDERSIDE. (STILL OUTSTANDING). | | |

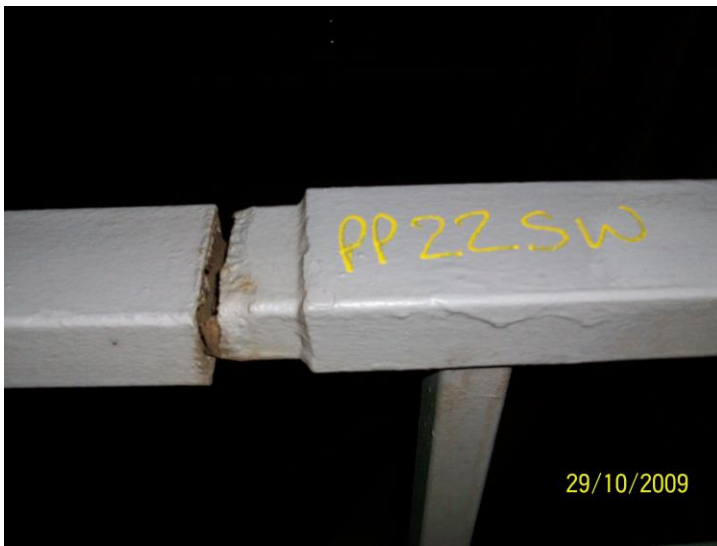
**ITEM 37**

| 37. P.P. 22 S.W. - MALE END SHEARED. (STILL OUTSTANDING). | | |

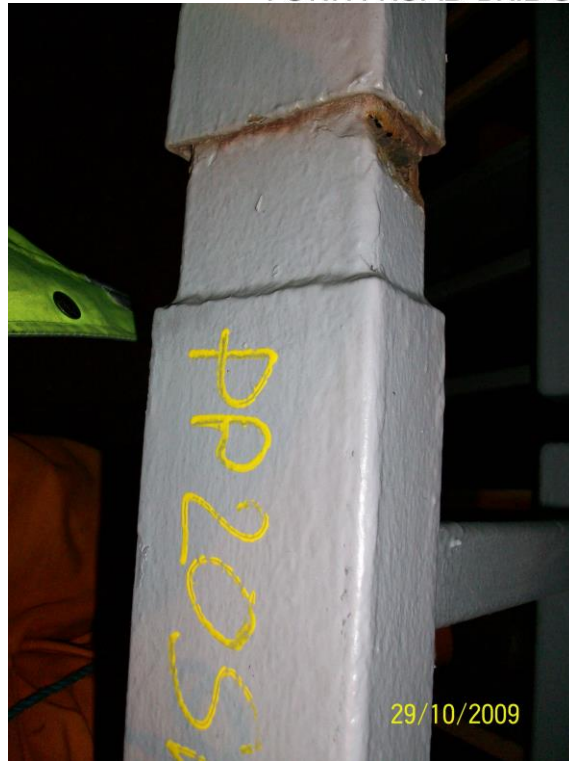
**ITEM 38**

| 38. P.P. 20 S.W. - MALE END HOLED. (STILL OUTSTANDING). | | |
