Forth Estuary Transport Authority

**Forth Road Bridge
Options Report for Bridge Deck Joints**

Revision No. A

September 2007

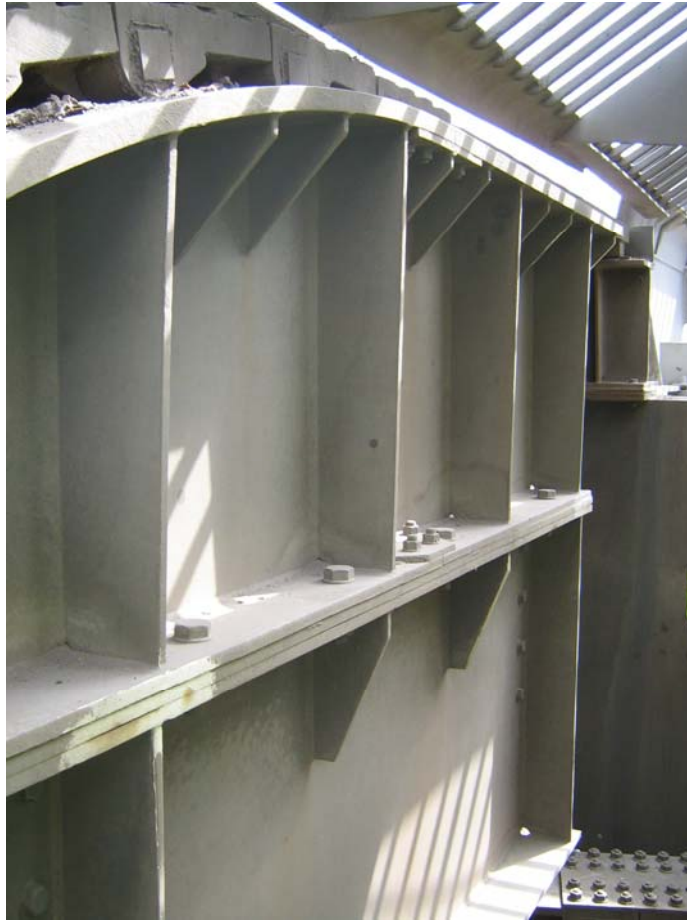
Photograph 1 – Roller Shutter Joint, View of Curved Link Plate Support Beam

The recent sample inspections by FETA have shown excessive wear in the curved link plate support beams and in the hinges and feet of the link plates. The effect of this wear is that the joint becomes increasingly noisy and play in the mechanisms and wear surfaces causes rapidly increasing damage to the joint. Ultimately the joint will break up with safety implications for the travelling public and / or parts of the joint will seize causing excessive loading on the bridge structure.

- c) Repair / refurbishment of each component. For the curved support beams this will likely include refacing or replacing the top curved flange to remove damage. The link plate hinges probably require replacement pins and bushes. The feet under the link plates will require refacing to make good wear. Holding down bolts, springs and washers should be replaced. Finally all components can receive corrosion protection.

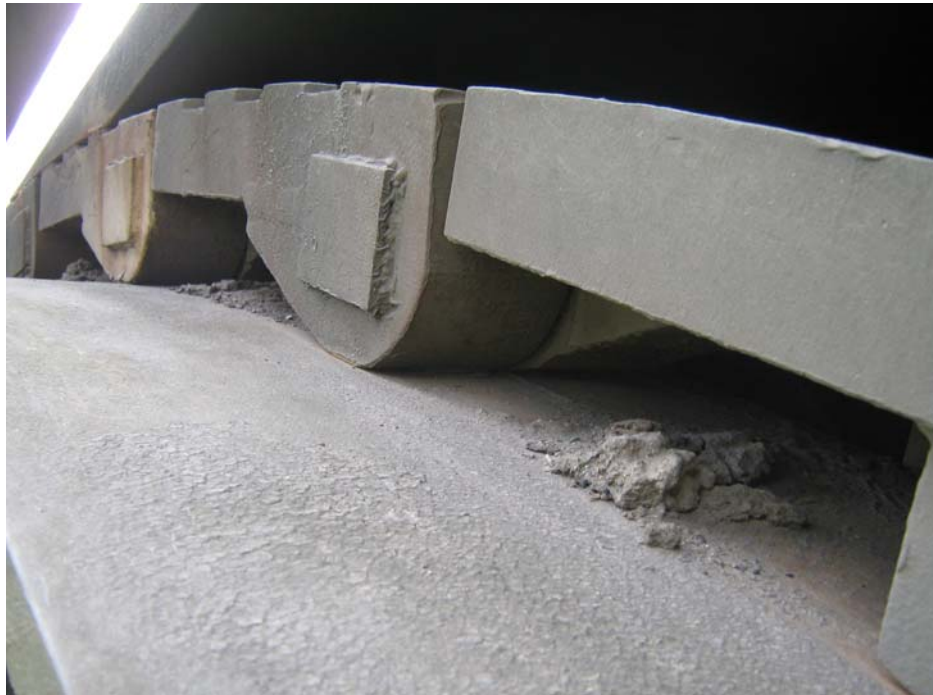
Photograph 2 – Roller Shutter Joint, Link Plate Train

- Two of the tongue plates were cracked;
- Some of the link and anchor plates were loose;
- Play was detected in the hinge joint pins;
- The springs to the holding down bolts for the plates were corroded;
- General wear in the interface between the link plates and the support beam;

In addition to the wear in the joint itself, the traffic surfaces of the steel plates have also become very worn. This has resulted in the wear of the leading edge of the first link plate. In addition, originally the traffic face of the main link plates had grooves cut into them in a diamond pattern to form an anti-skid surface and these have worn away. The steel plates now form a very smooth surface which has a low vehicle skidding resistance, particularly when wet.

For the roller shutter joints the recommended option is to completely replace the joint with a new similar type. This takes advantage of improved designs and materials and gains maximum benefit in terms of future performance. A new joint can be pre-fabricated to the tight tolerances this type of joint requires. This option has the least potential for traffic disruption.

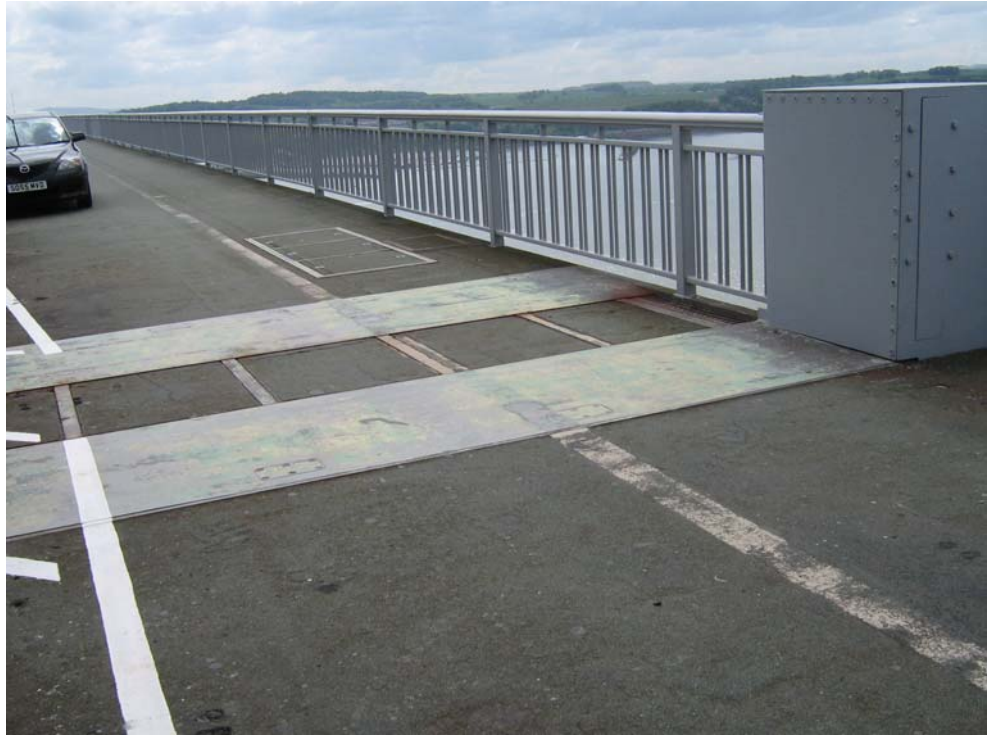
Photograph 3 – Sliding Plate Joint in Foot / Cycle Way

The joints appear to be working well. However the step between the upper and lower plates does provide a potential tripping hazard to pedestrians and the smooth surface can be slippery particularly when wet. Since the original construction the sliding plates have become worn, by rubbing against each other resulting in a loss of thickness. This ultimately weakens the plates particularly against the weight imposed by maintenance vehicle loads.

The upper surfaces of the sliding plates could be modified to incorporate a recessed anti-slip surface to reduce a potential hazard. The underside of the upper sliding plate could incorporate phosphor bronze wear pads to reduce friction between the plates and general wear. Finally the leading edge of the upper sliding plate could be tapered to reduce the height of the tripping hazard, although care would be needed to ensure the plate is not weakened in the process.

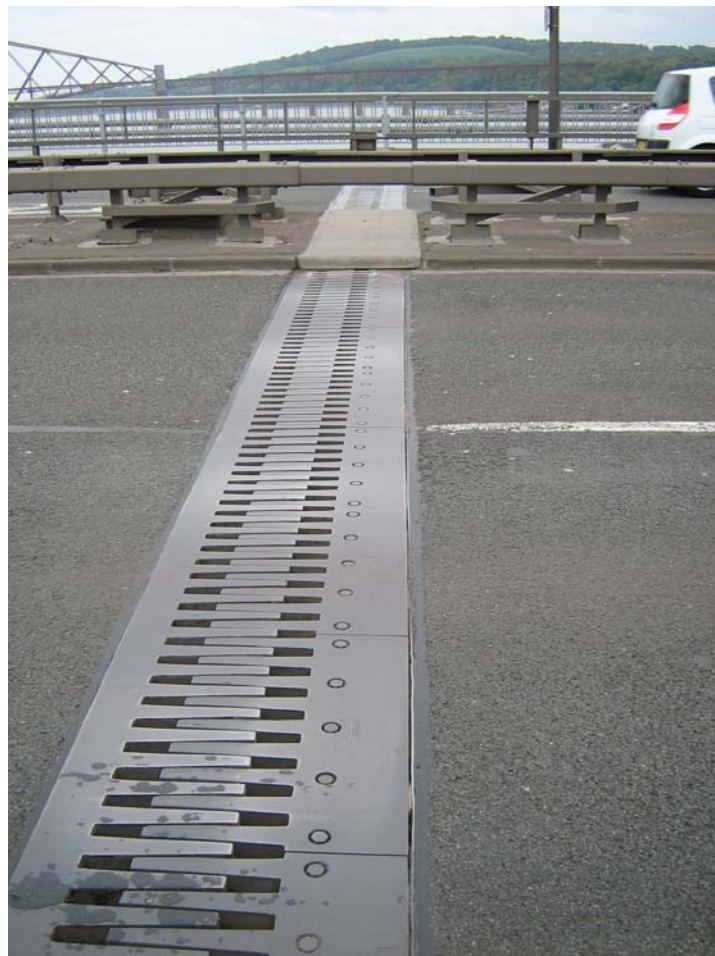
Photograph 4 – Typical View of Comb Joint

All the joints are still functioning as designed, but since the original construction have now become worn from general traffic usage and movement of the joints themselves.

Finally the comb joints should also be replaced with a new similar joint as repair or refurbishment would practically involve replacement.
