**Forth Estuary Transport Authority**

**Forth Road Bridge  
Extending the Life of the Main Expansion Joints**

## Reducing the Risk of Failure and Extending the Life of the Main Expansion Joints

**February 2009**

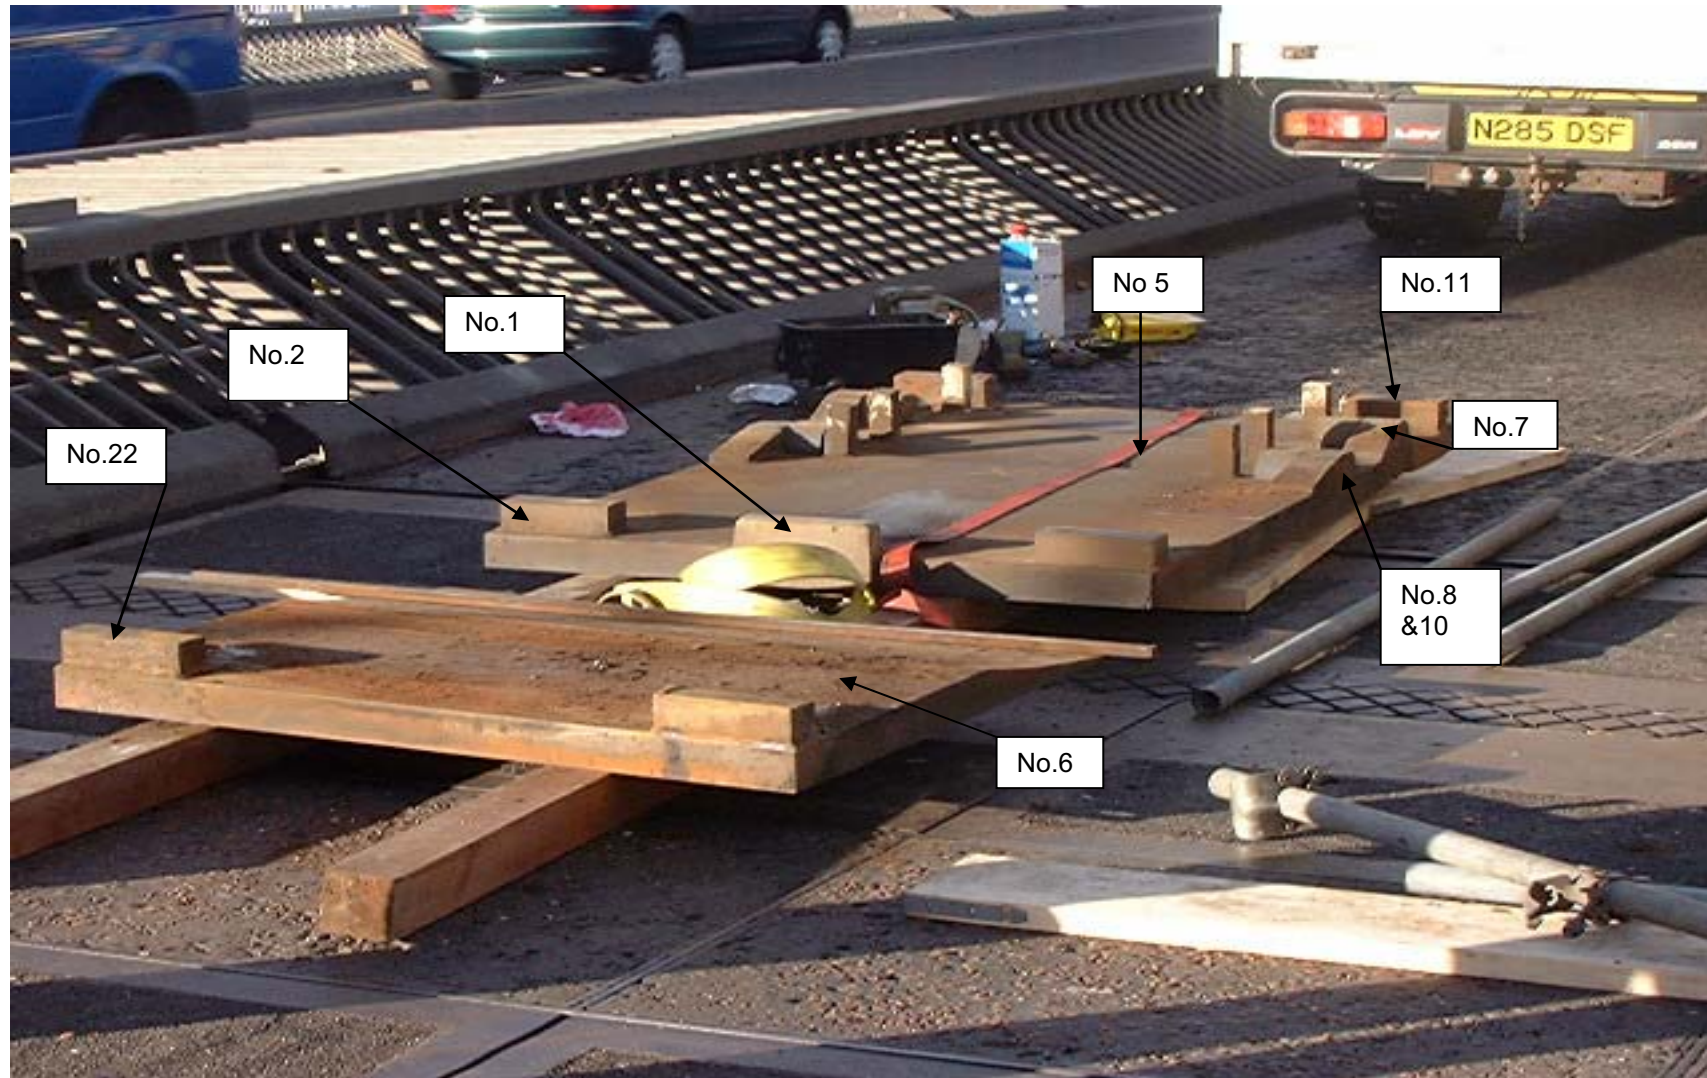
Photograph 1 - View of Underside of Lifted out Plate Train and Tongue Plate

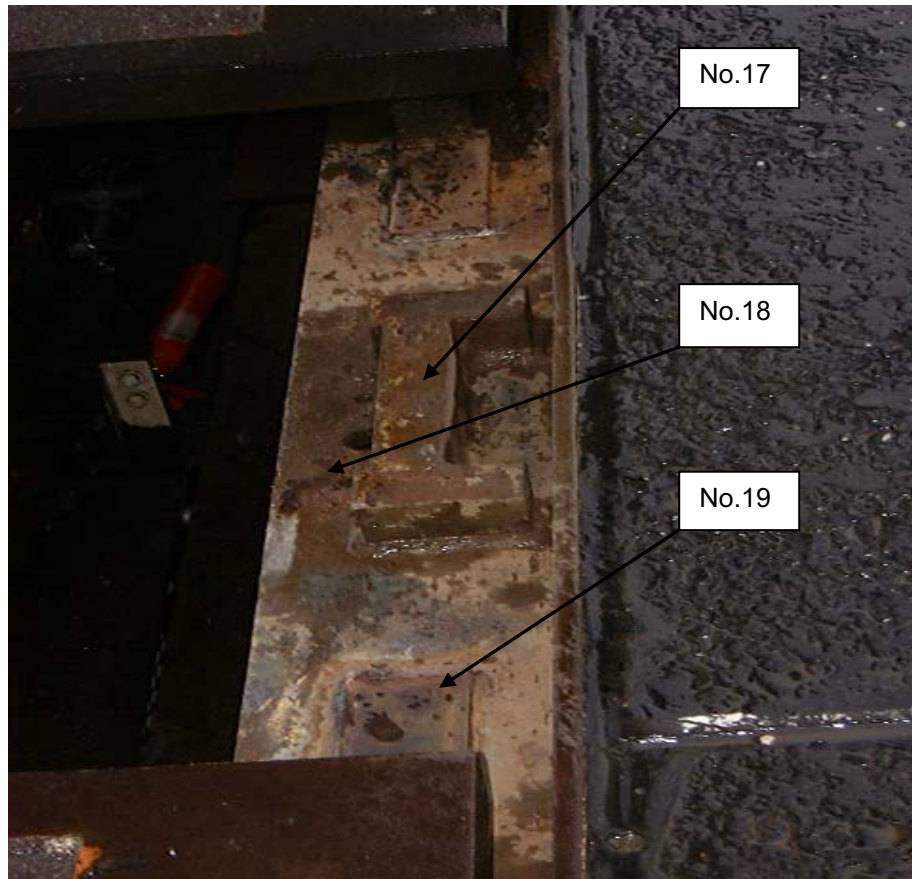
**Photograph 2 – View of Top of Shuttle Plate Support Beam**

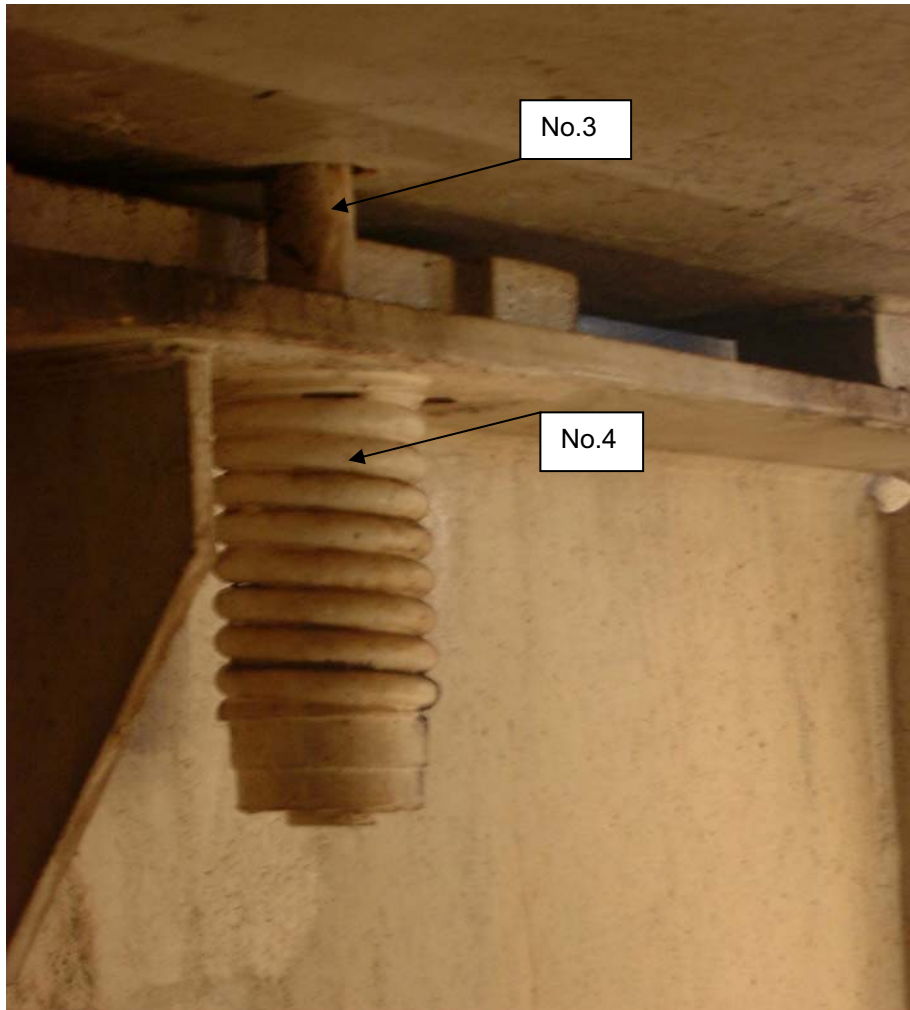
**Photograph 3 – View of a Shuttle Plate Holding Down Pin and Spring**

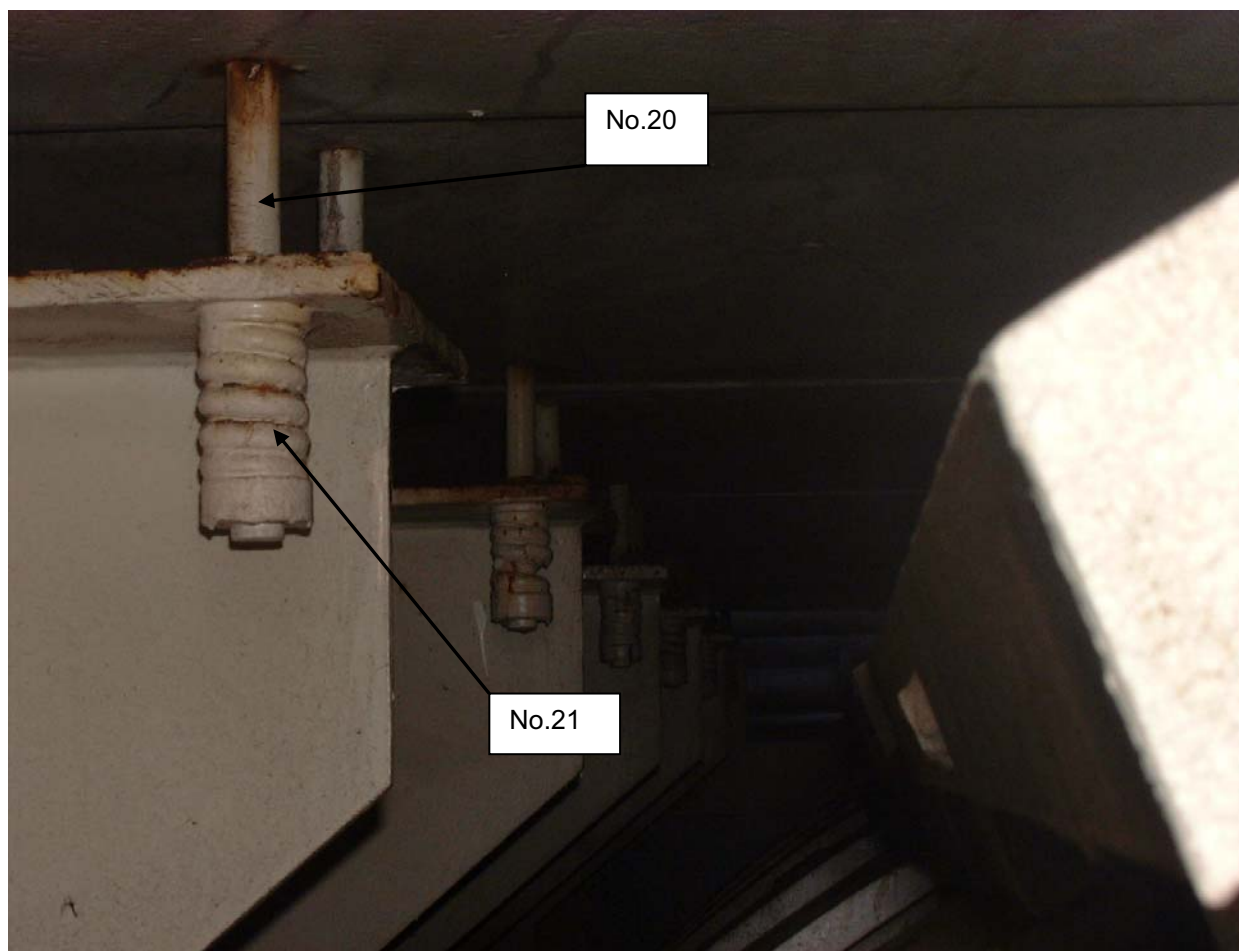
**Photograph 4 – View of a Tongue Plate Holding Down Pin and Spring.**

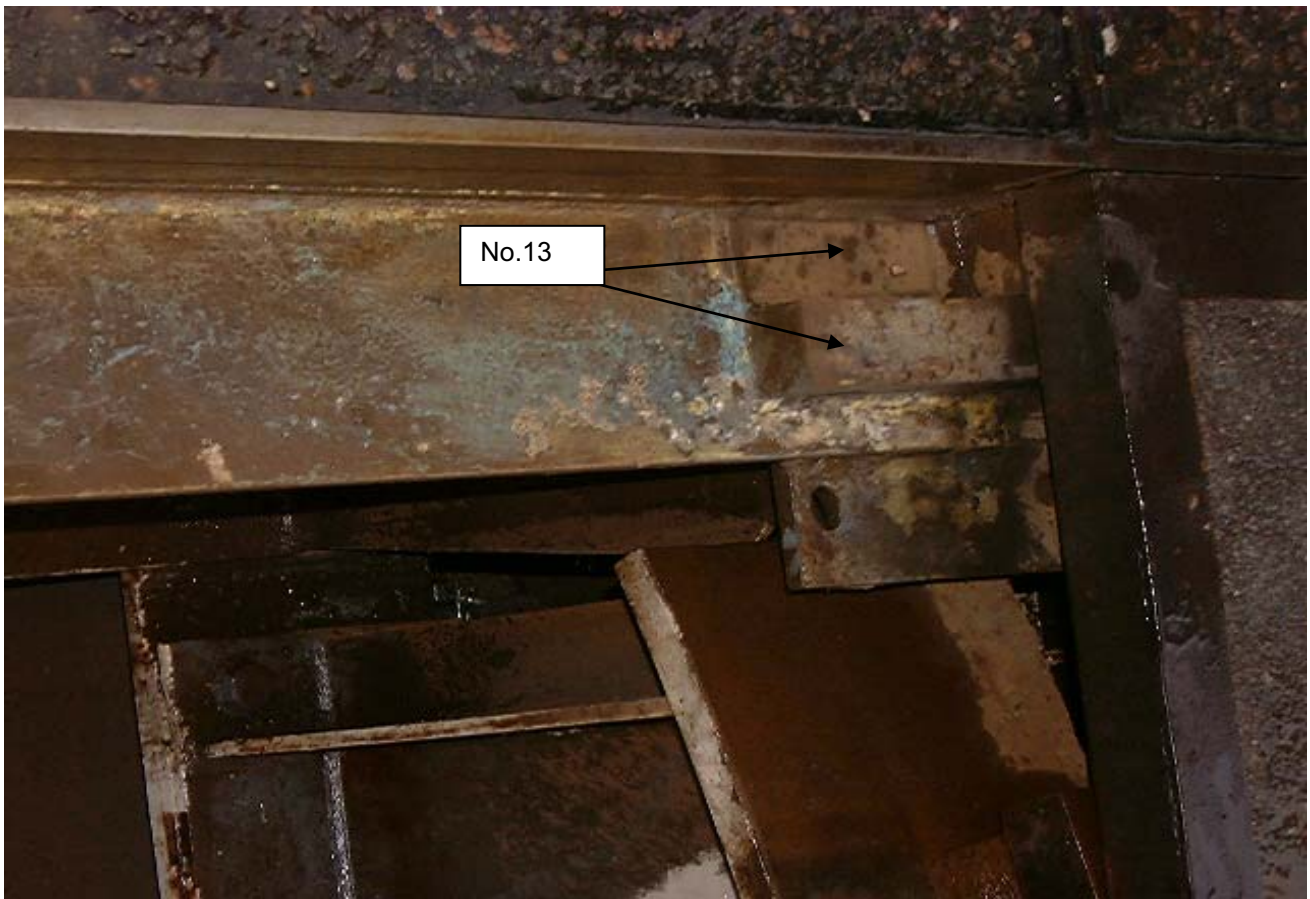
**Photograph 5 – View of Tongue Plate Restraint Block**

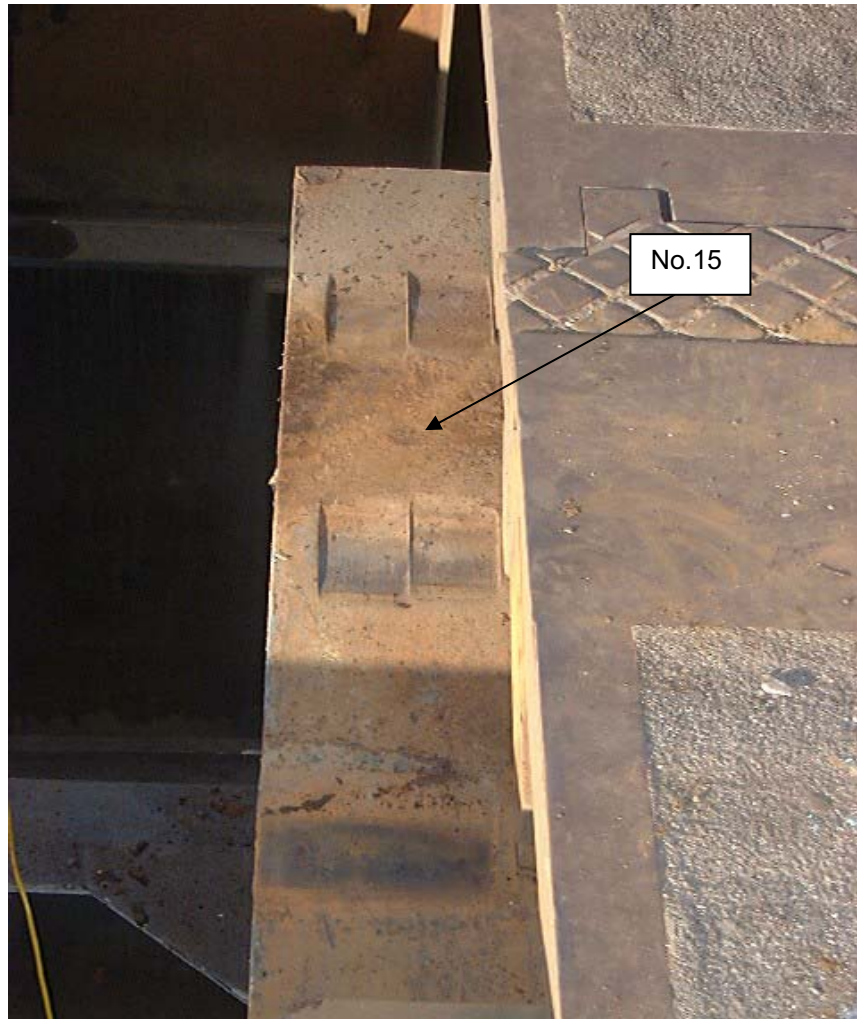
**Photograph 6 – View of Top of a Track Beam**

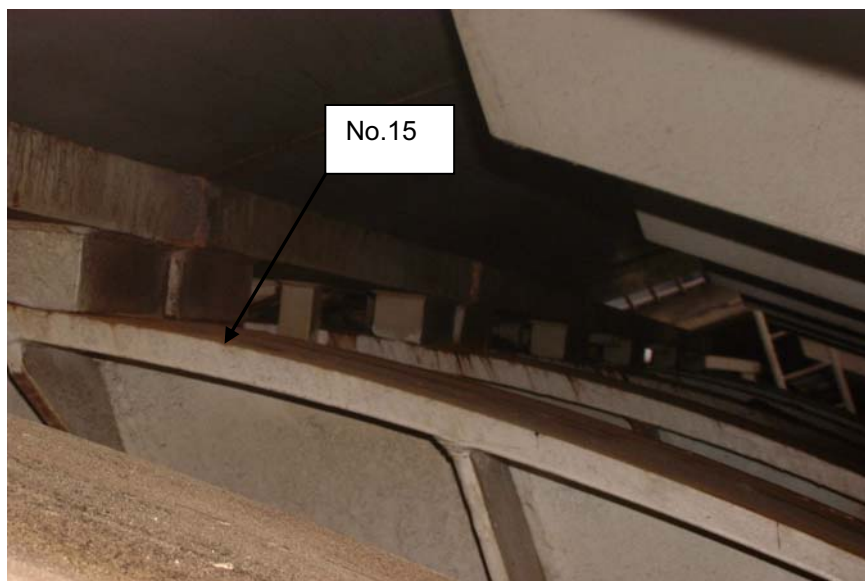
**Photograph 7 – Side View of a Track Beam**
