# **Forth Road Bridge**

## **Main Expansion Joints- Condition**

### **Inspection Report**

Forth Estuary Transport Authority

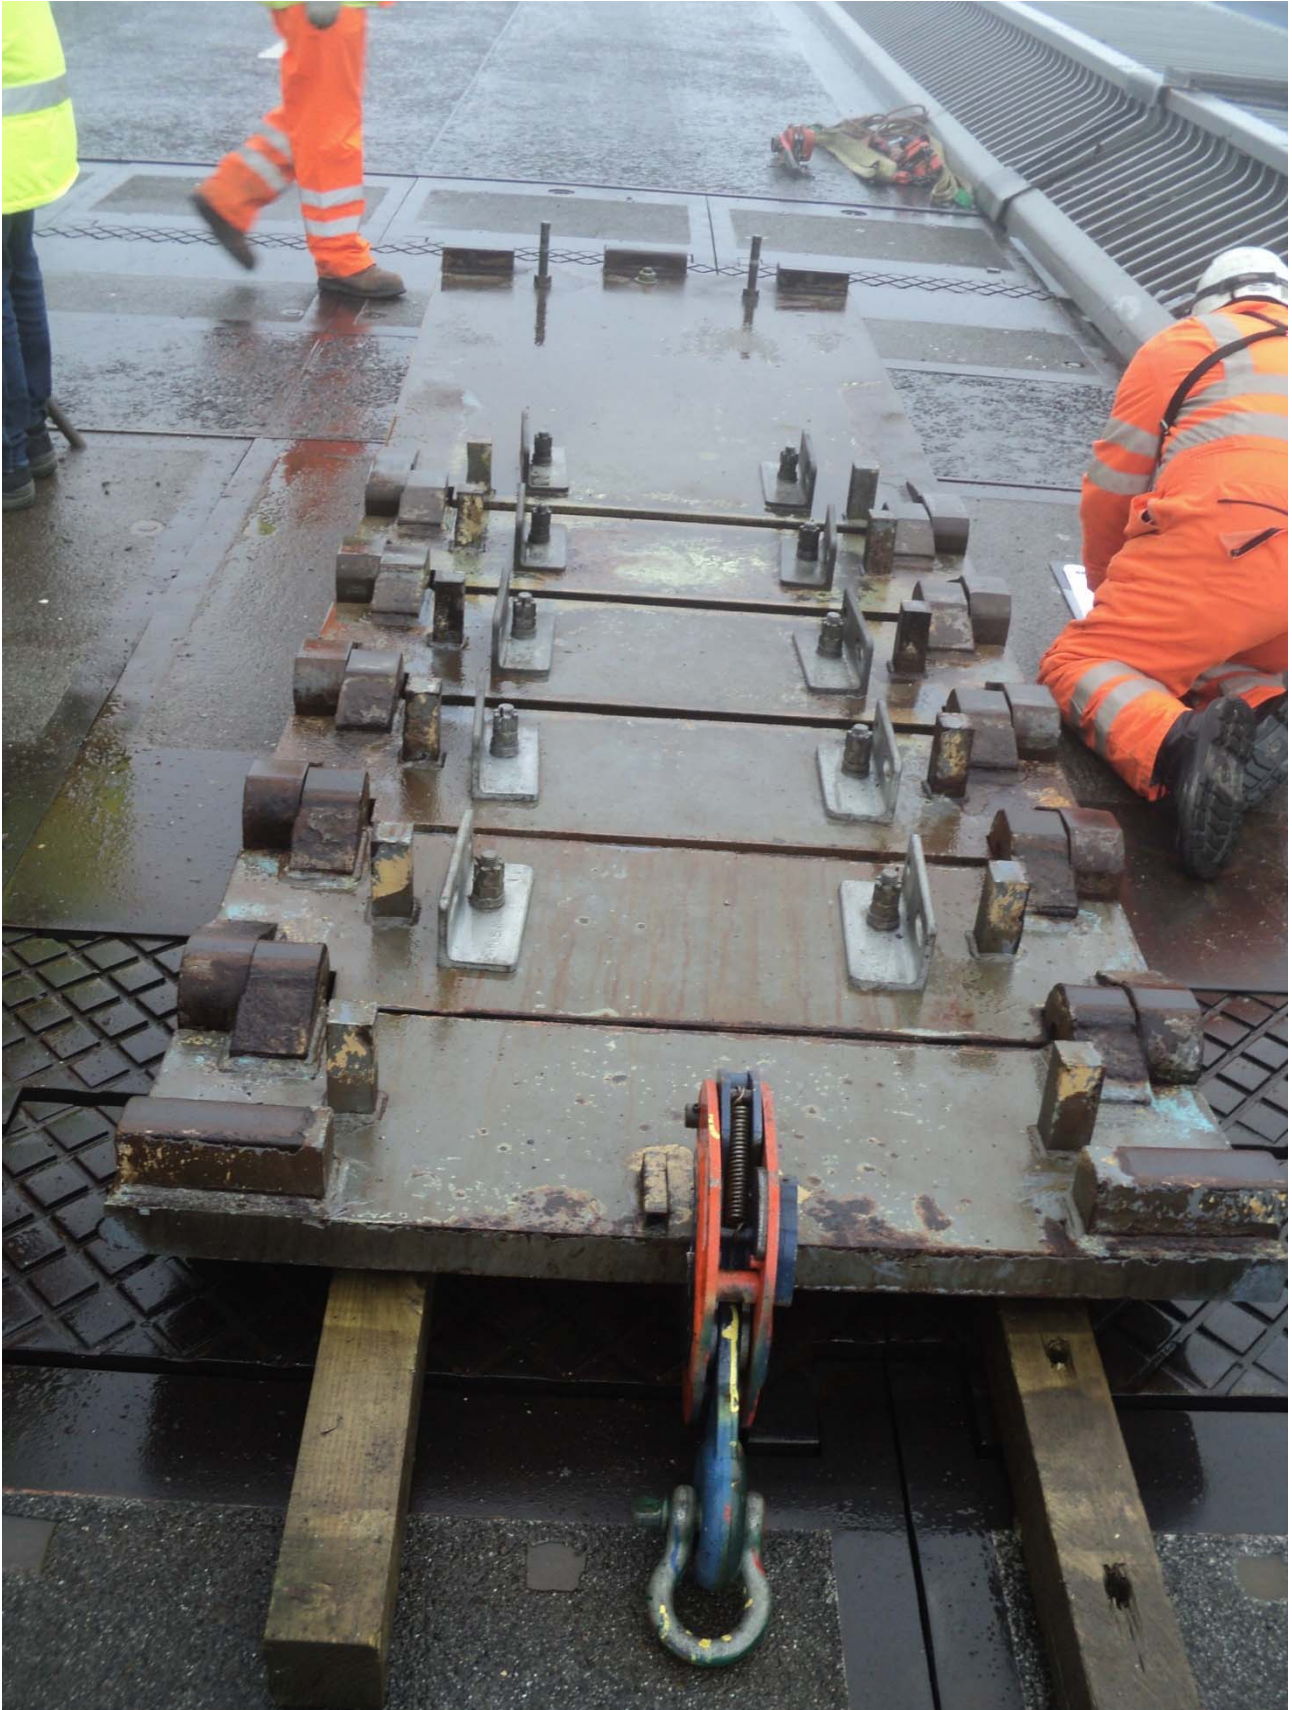
Photograph 1 – Overview of plate train, after removal and up-turned. Note failsafe linkages have been removed prior to lifting.

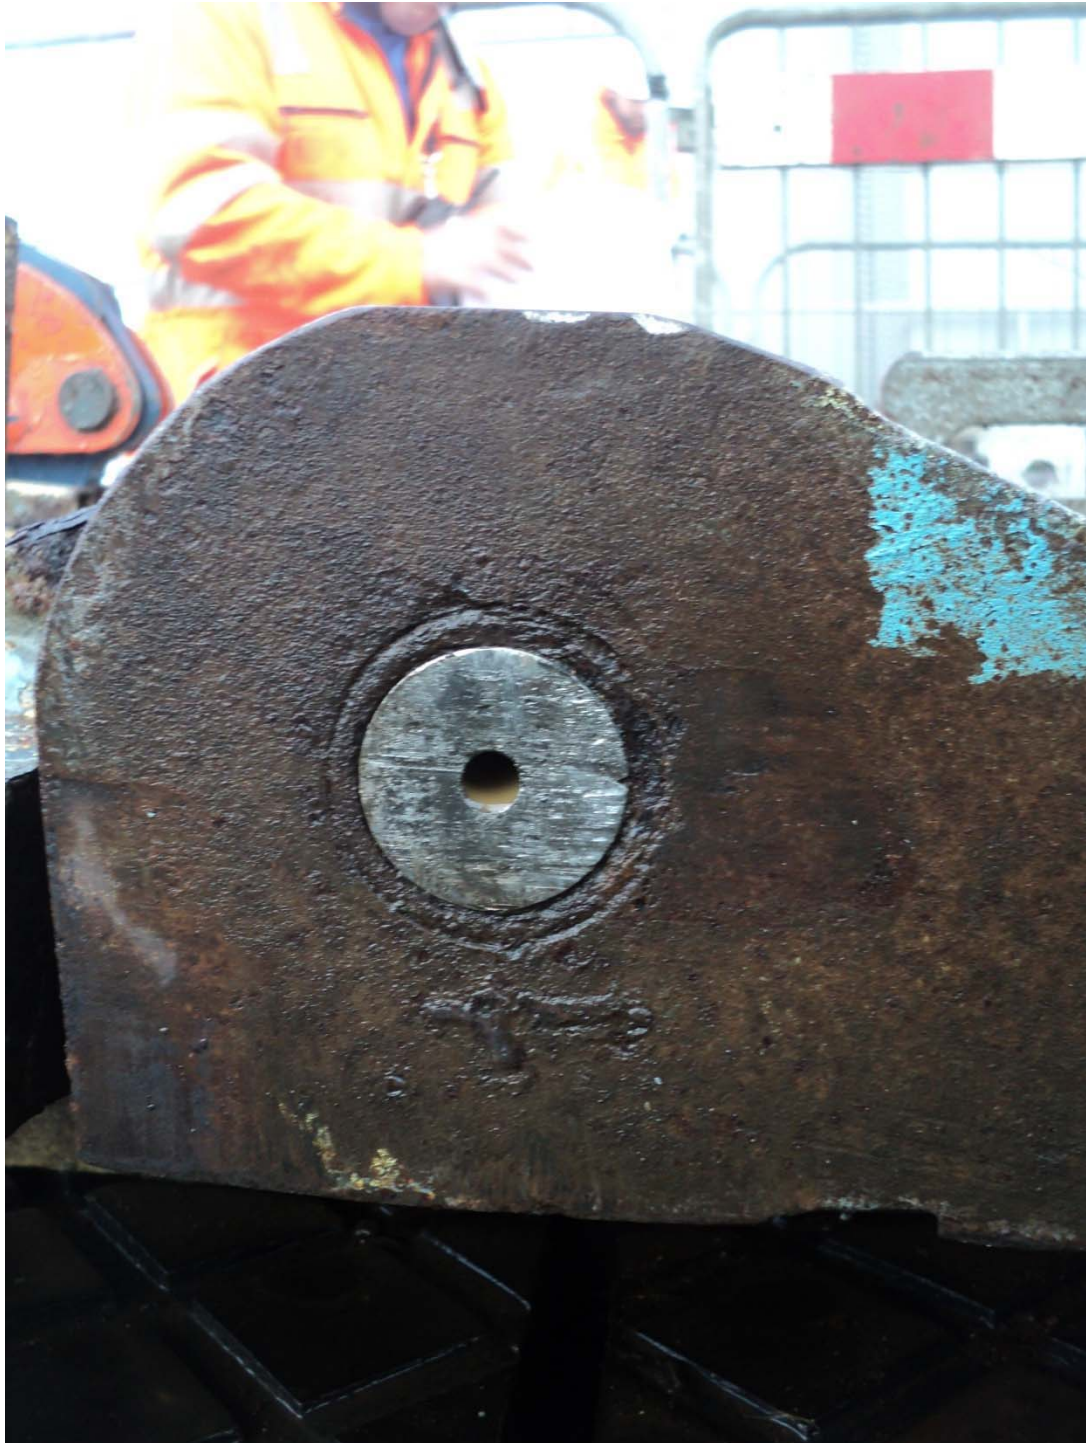
- Slide track wear to top surface increased in depth(maximum measured wear 9.0 mm (Photograph 10 - Photograph 11),
- Joint train feet excessively worn (Photograph 2 - Photograph 5, Photograph 12 - Photograph 14),
- Hinge pin holes and bushing excessively worn (Photograph 3 - Photograph 5, Photograph 12 - Photograph 14),
- Tongue plate and Anchor plate bearing blocks worn causing a step in the carriageway (Photograph 7 - Photograph 9, Photograph 16).
- Accumulated wear in components affecting carriageway running profile, leading to increased noise and dynamic effects.

**Photograph 2 – Hinge at extreme end of Joint showing original condition of hinge pin and foot profile (note foot profile is slightly flattened).**

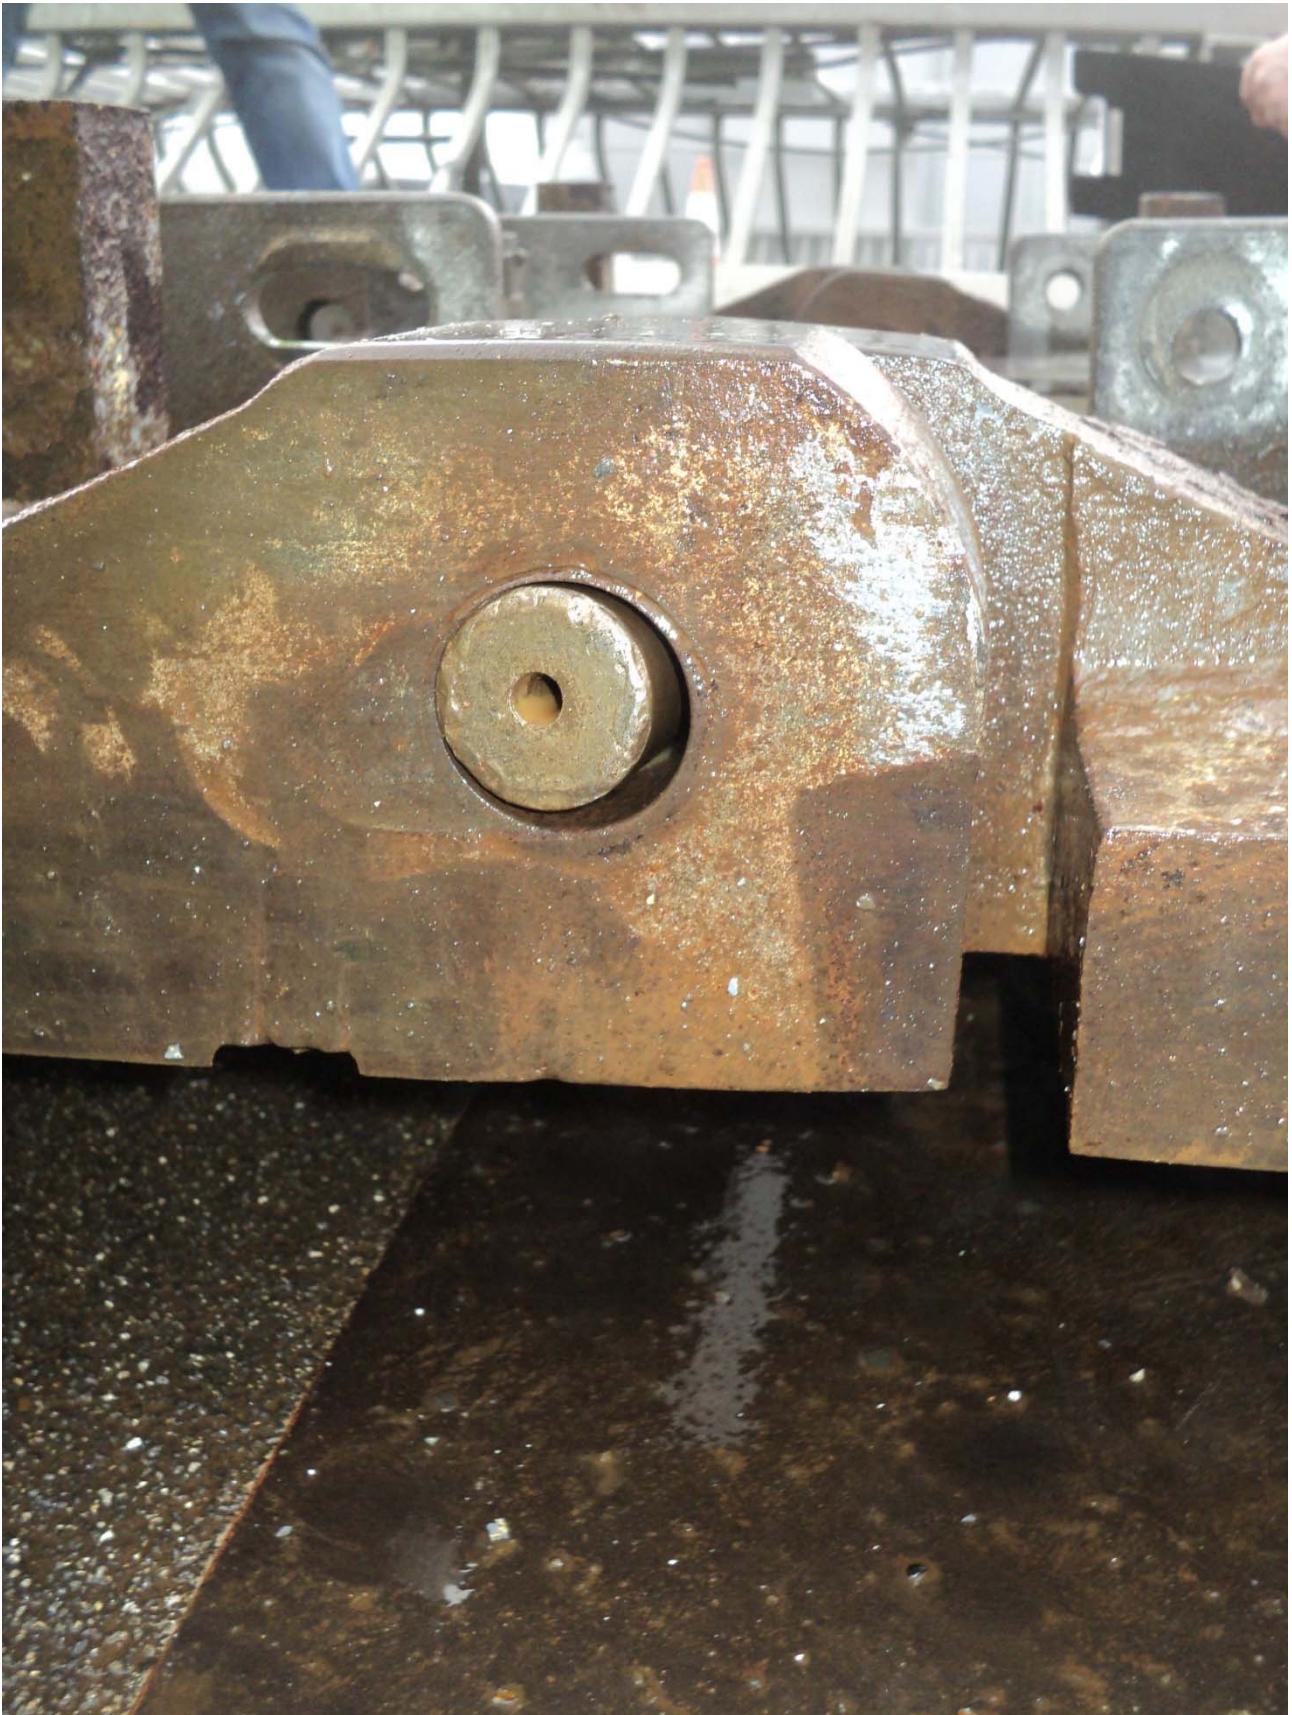
**Photograph 3 – Typical wear to hinge and foot**

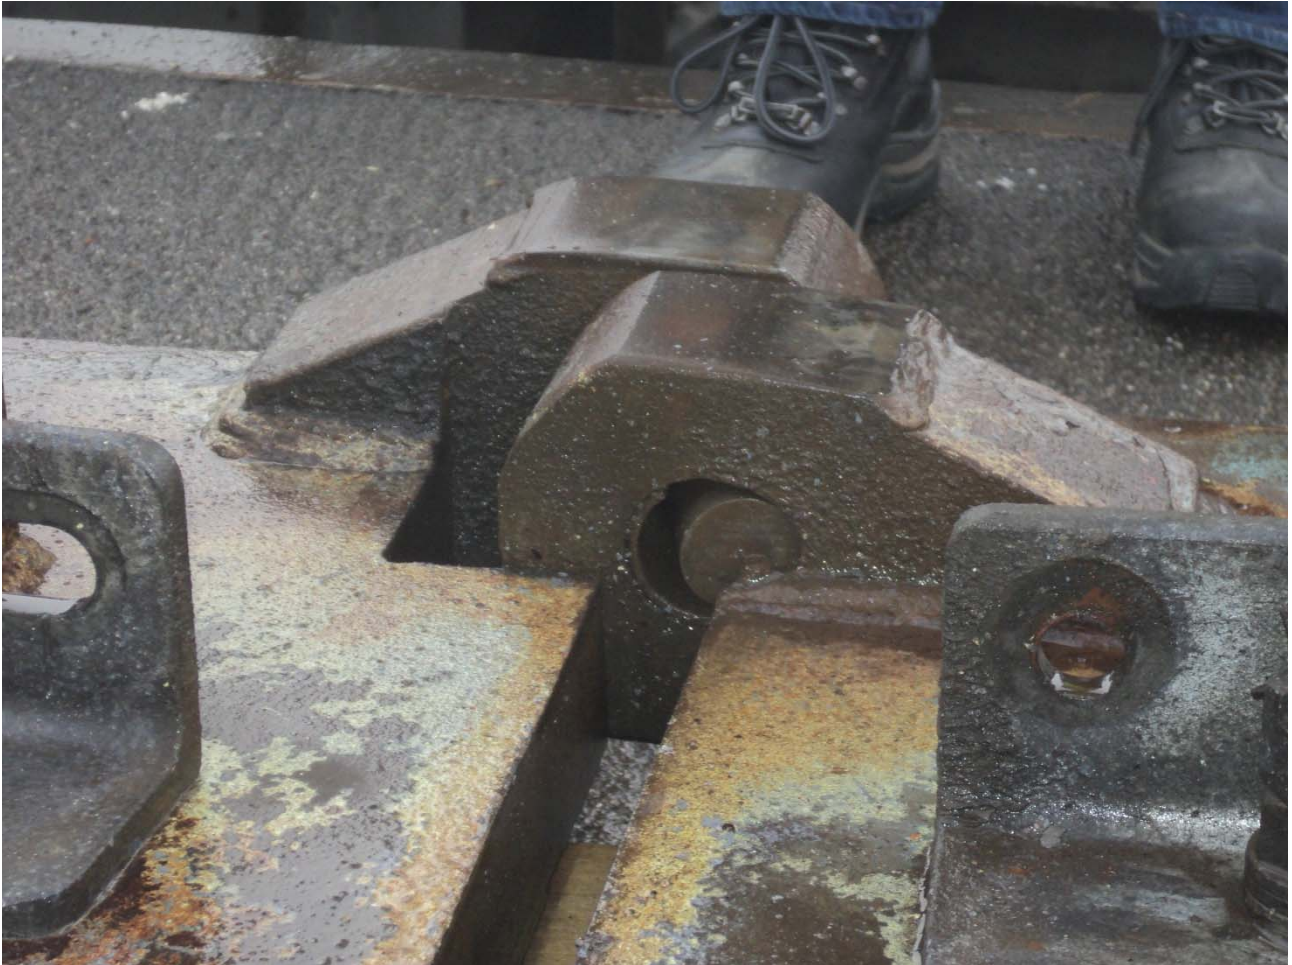
**Photograph 4 – Note previous weld repairs to foot, now worn, and wear to hinge**

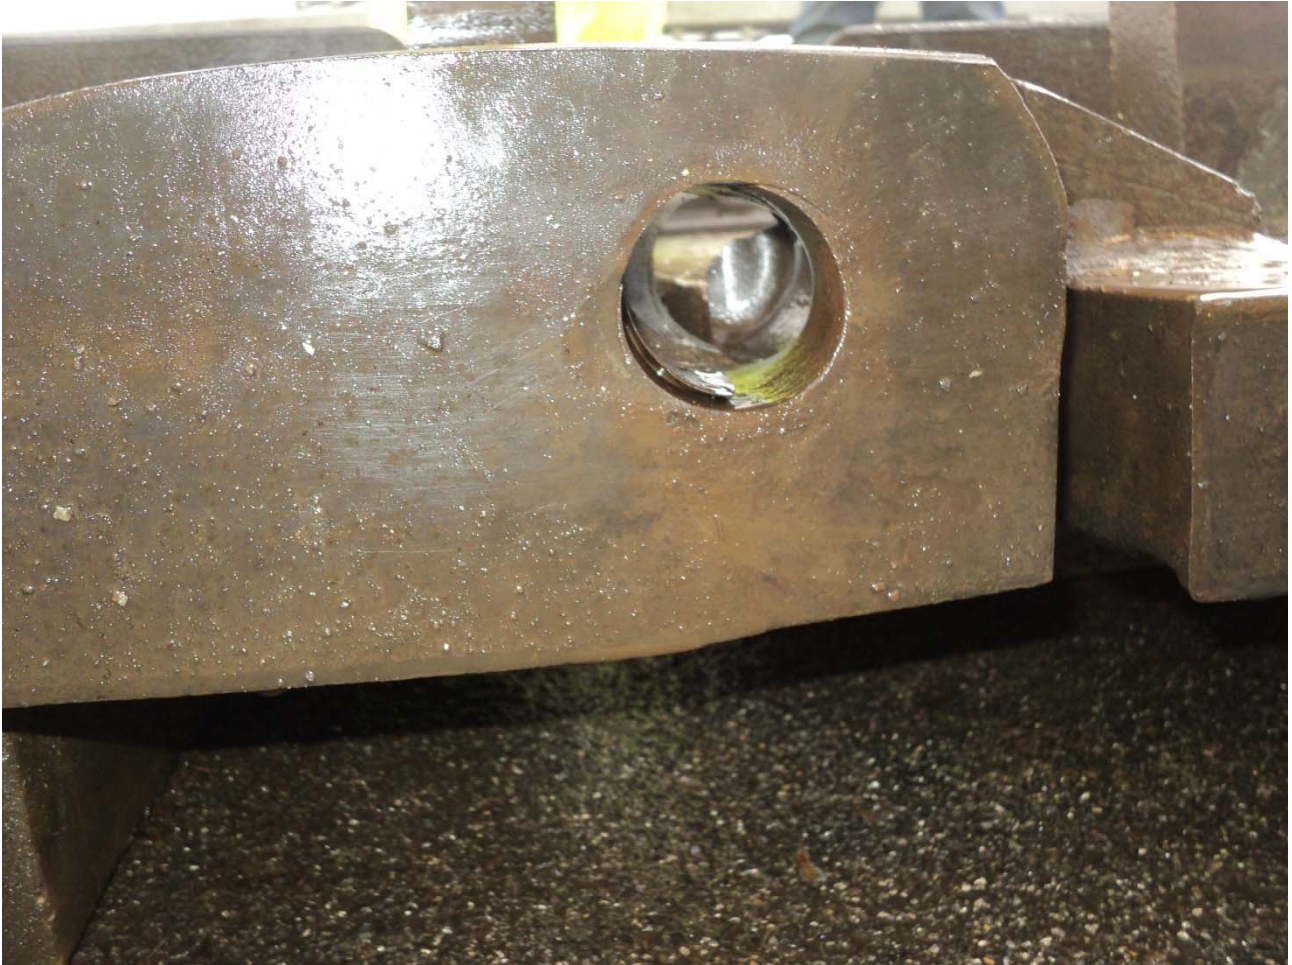
**Photograph 5 – Worn and deformed pin hole. Bushing worn and loose. Worn foot profile.**

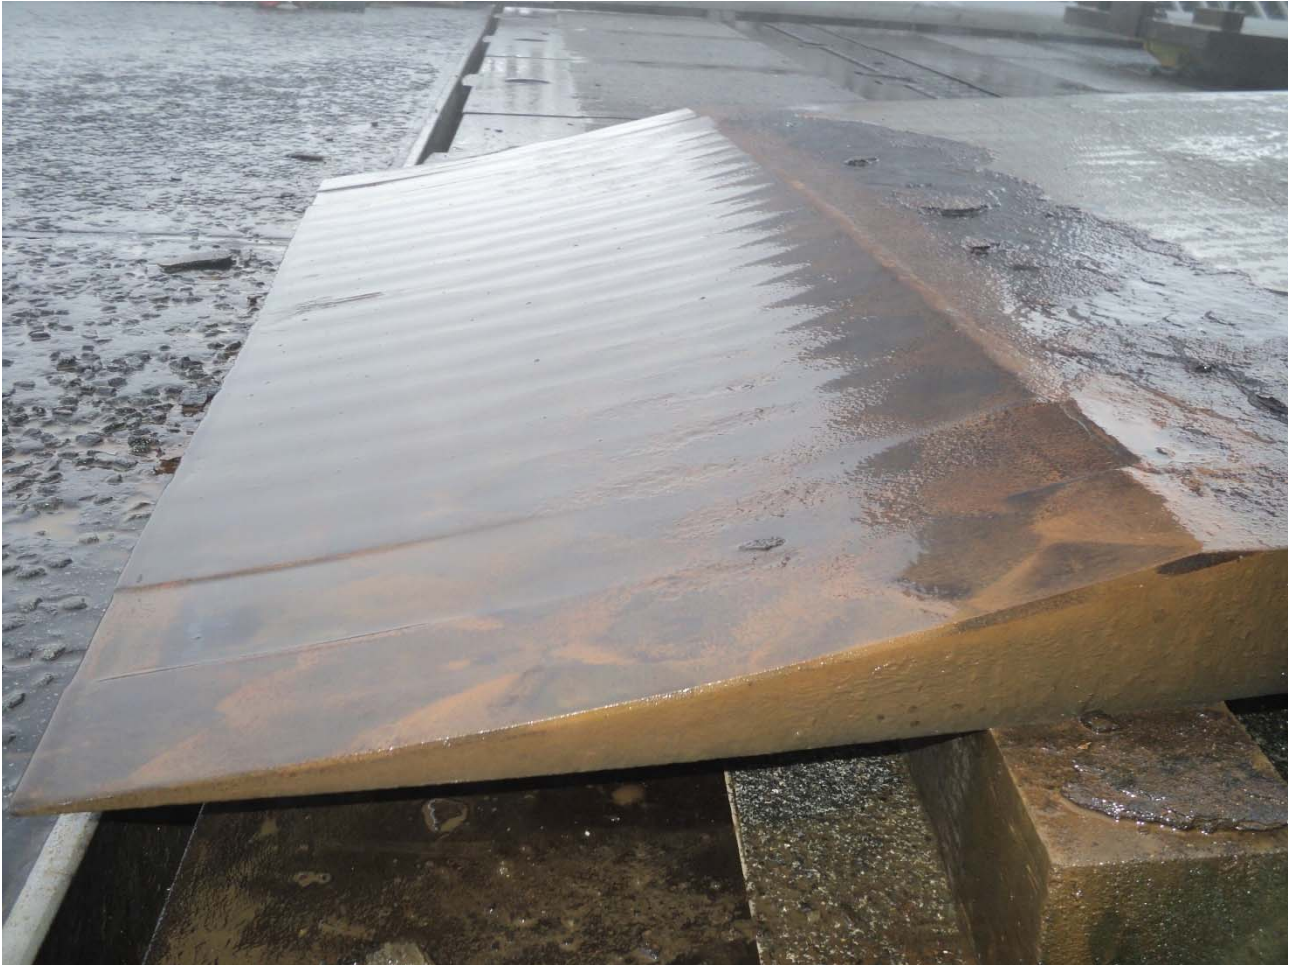
**Photograph 6 – Worn tongue plate. Note thinning where grooves are worn where tongue plate rides over raised plate hinges. Tongue plates ends are trimmed to remove sharp edges created by wear.**

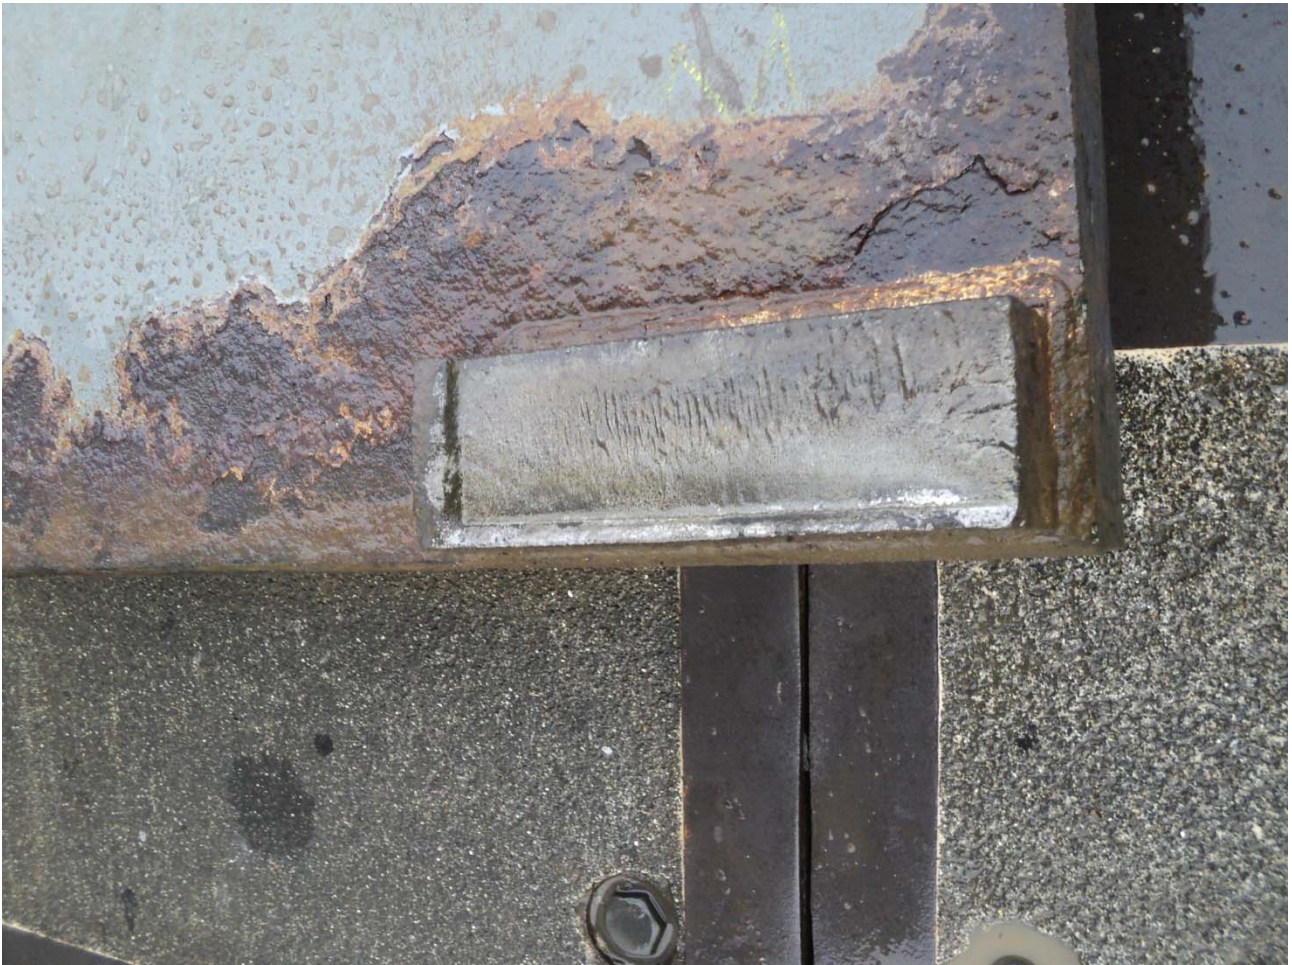
**Photograph 7 – Worn anchor plate bearing.**

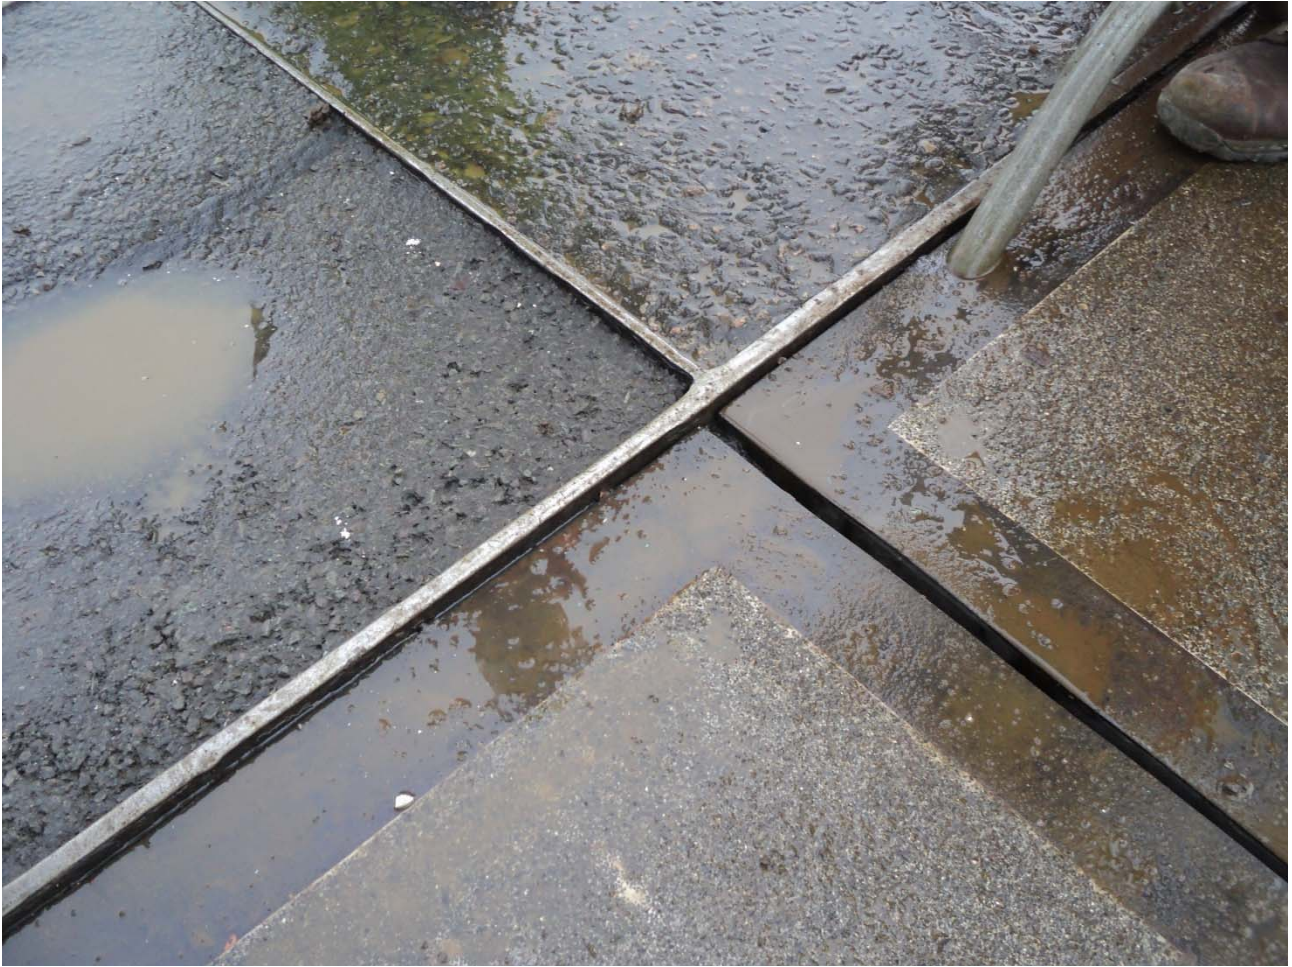
**Photograph 8 – Worn edges and uneven ride surface. Note drop in joint level due to wear on bearings.**

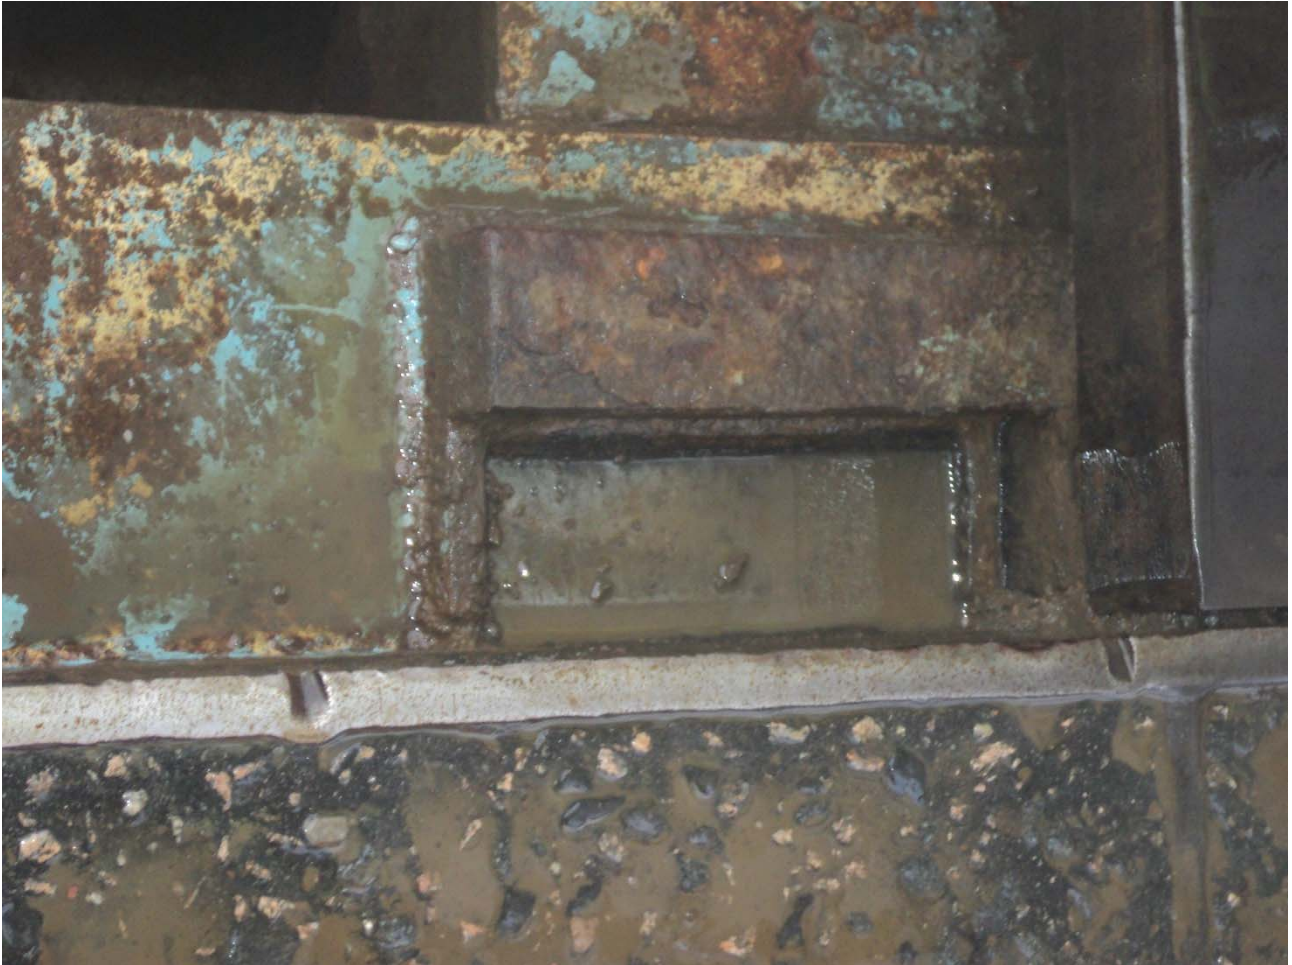
**Photograph 9 – Worn lateral restraint at tongue plate and bearing blocks.**

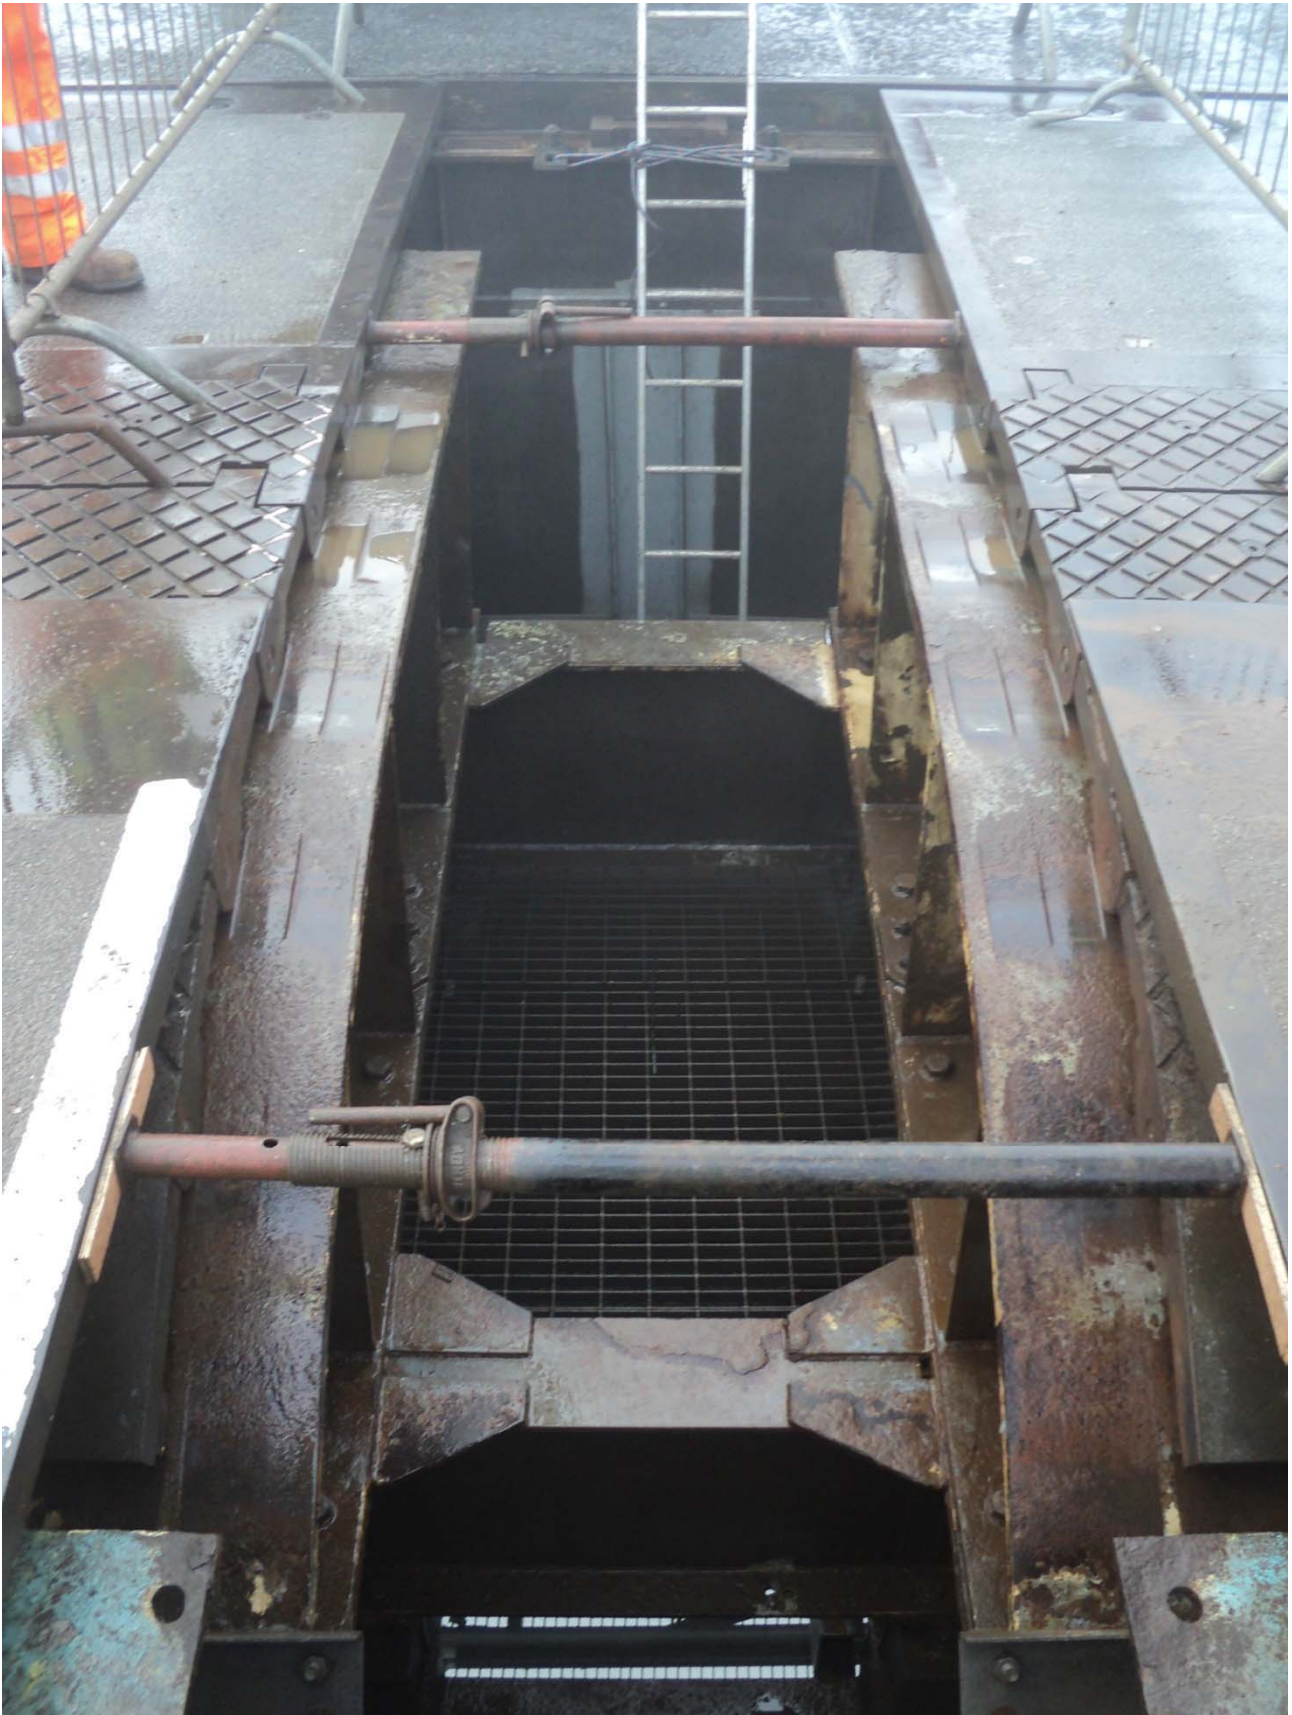
Photograph 10 – General view of slide tracks showing wear at foot locations.

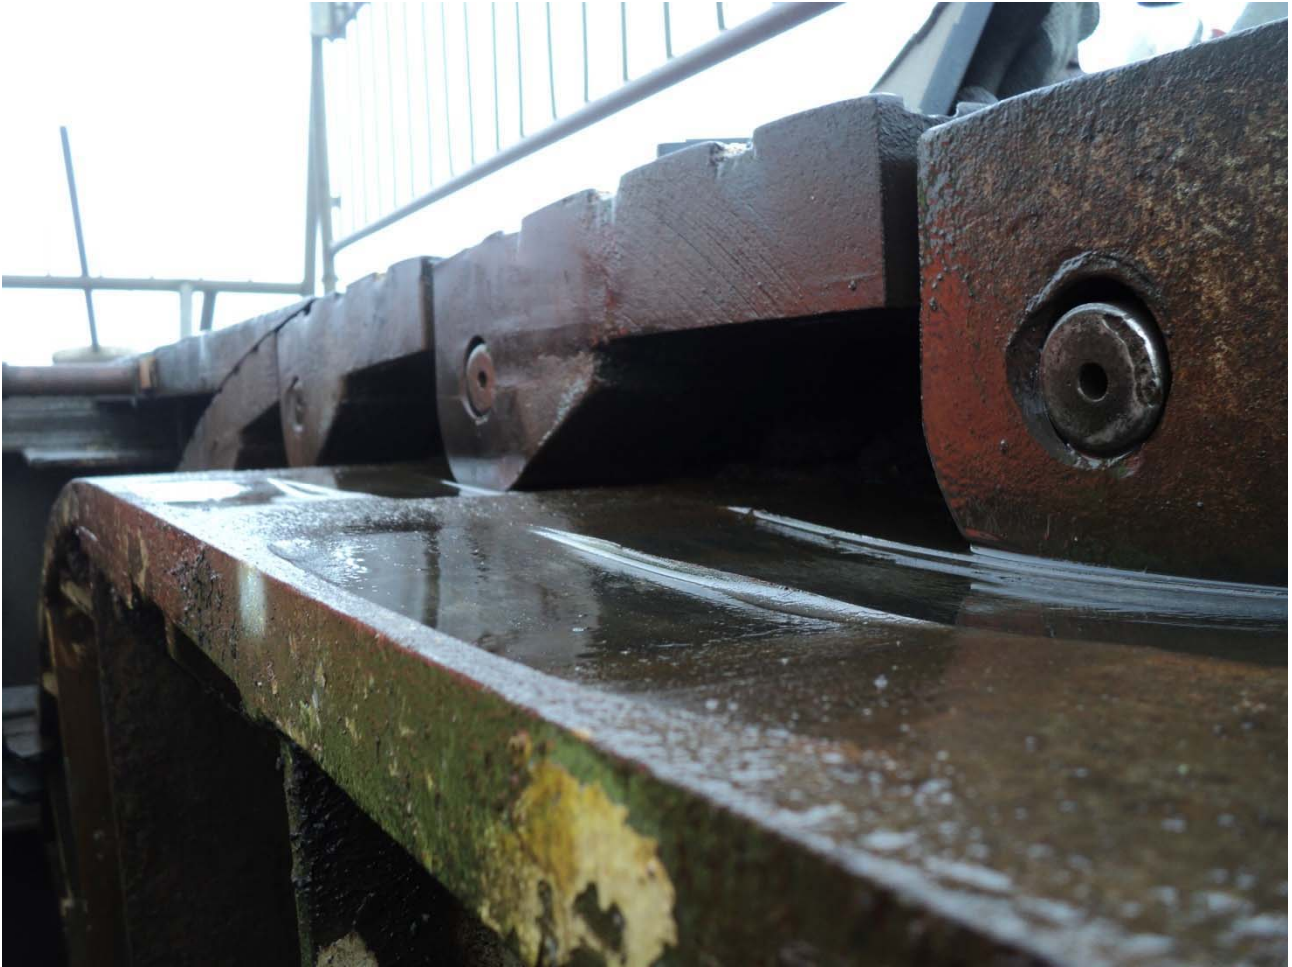
**Photograph 11 – Wear in slide track at typical hinge positions. Note uneven carriageway level.**

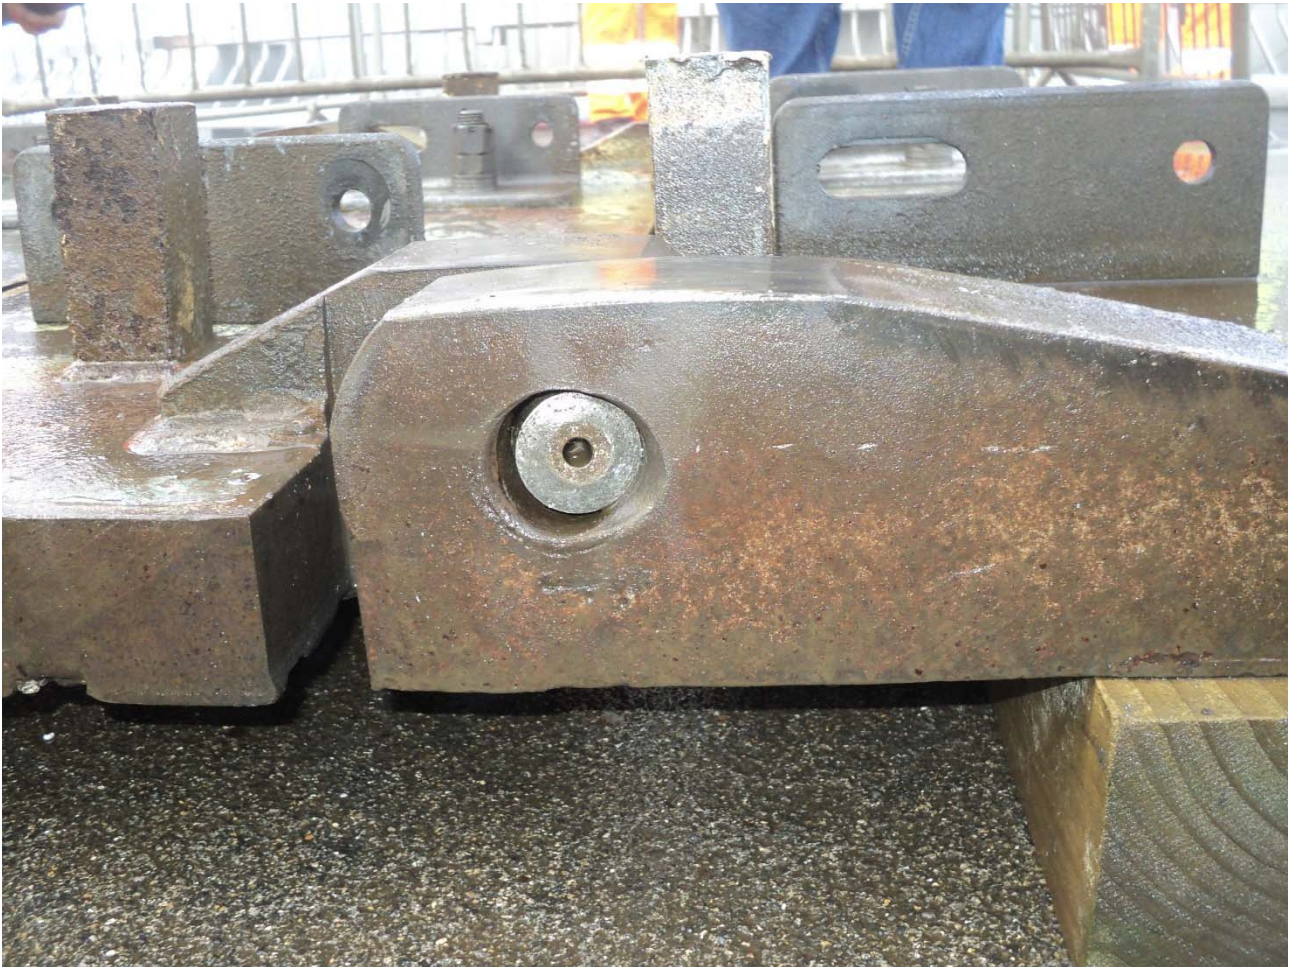
**Photograph 12 – Excessive wear on foot and hinge**

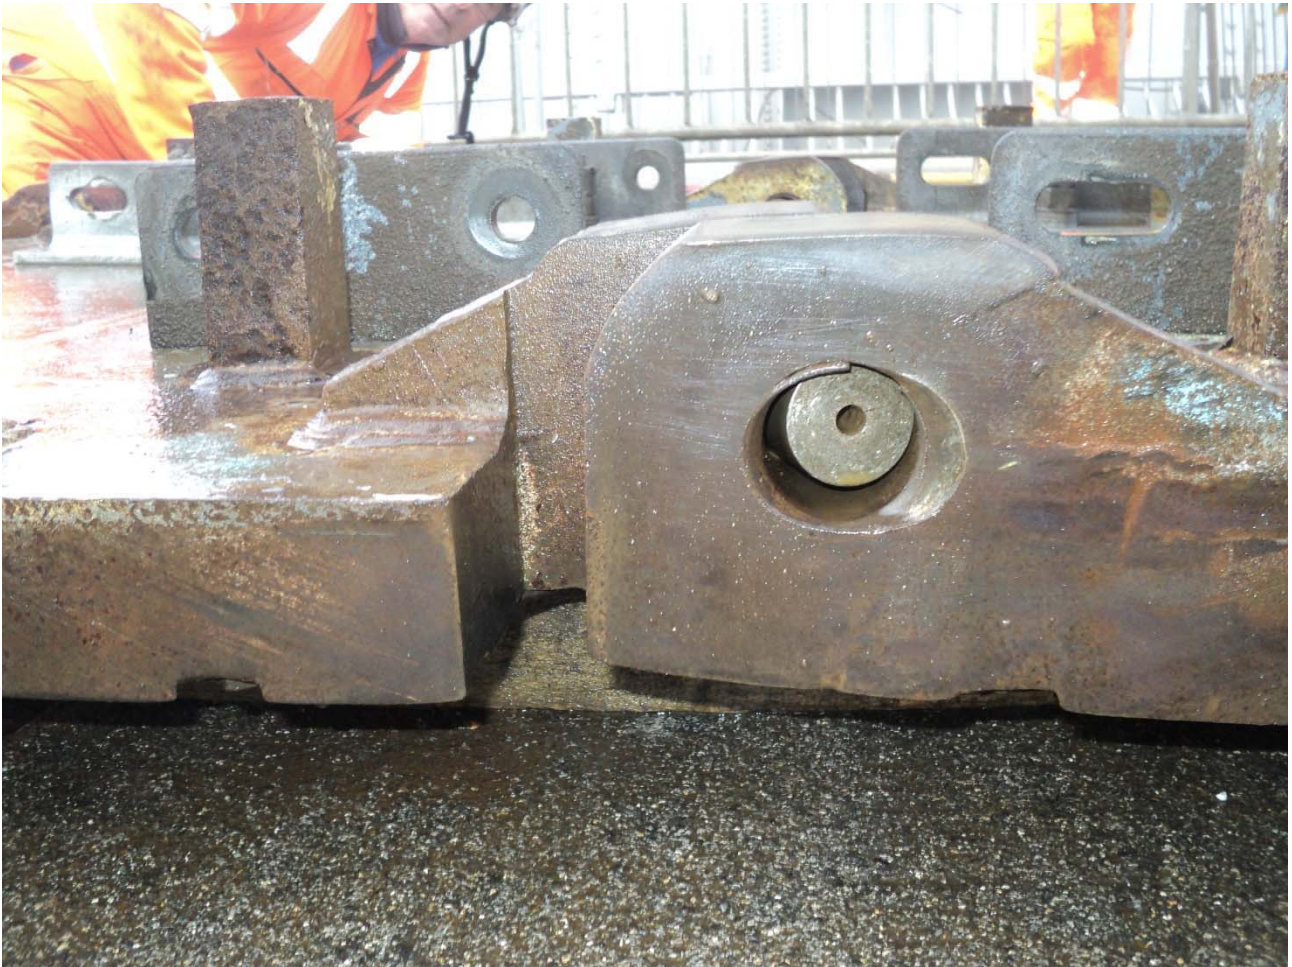
**Photograph 13 – Excessive wear on foot and hinge, gap opening between joints.**

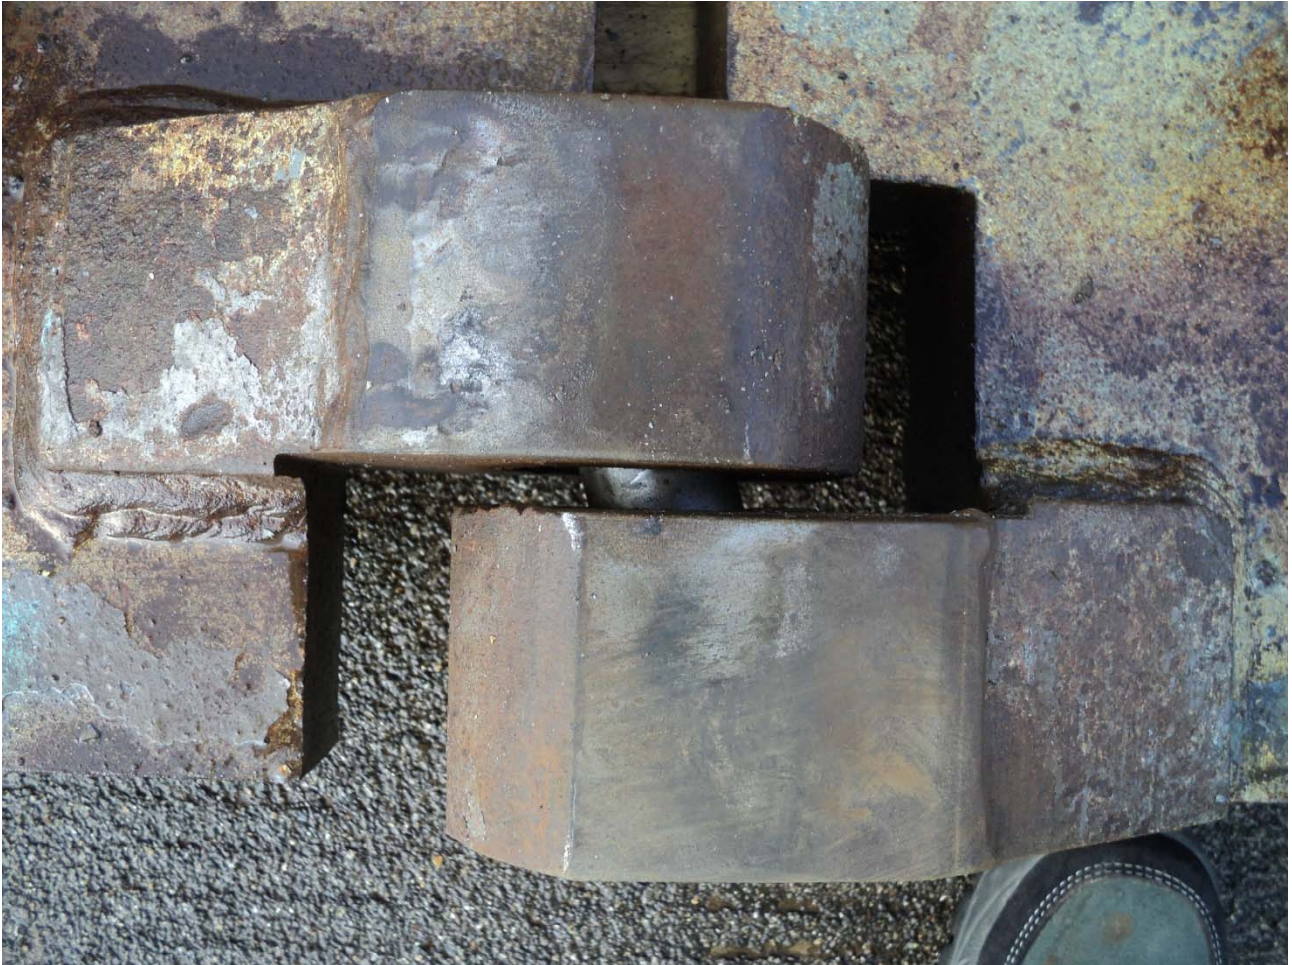
**Photograph 14 – Excessive wear on hinge, gap opening between joints and hinge pin lateral rotation.**

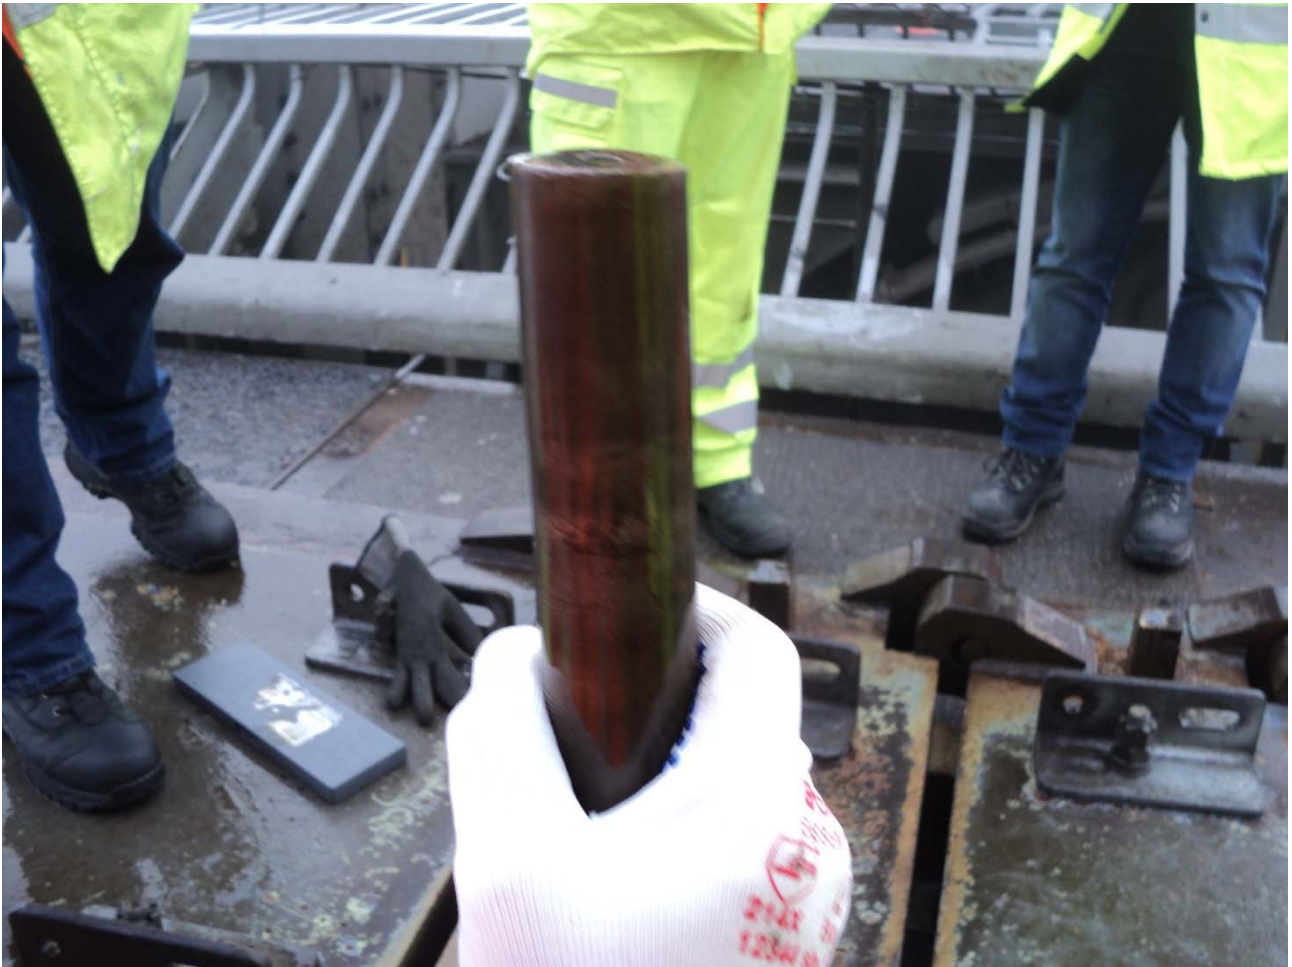
**Photograph 15 – Hinge pins appear in good condition with little wear evident.**
