# **Forth Road Bridge**

## **Main Expansion Joints- Condition**

### **Inspection Report**

Forth Estuary Transport Authority

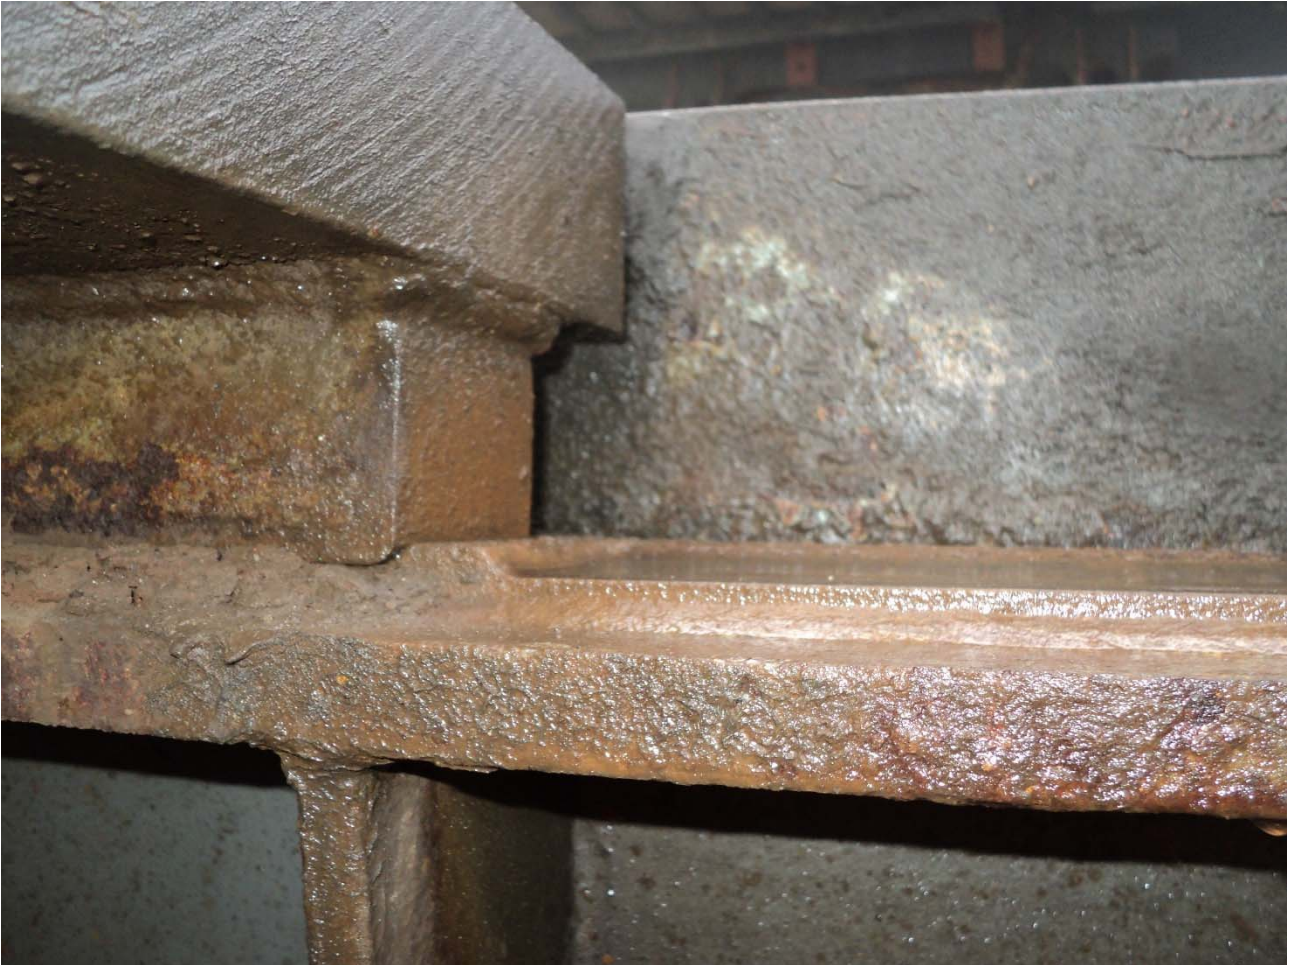
**Photograph 16 – Wear in anchor plate support bearings, causing drop in height.**

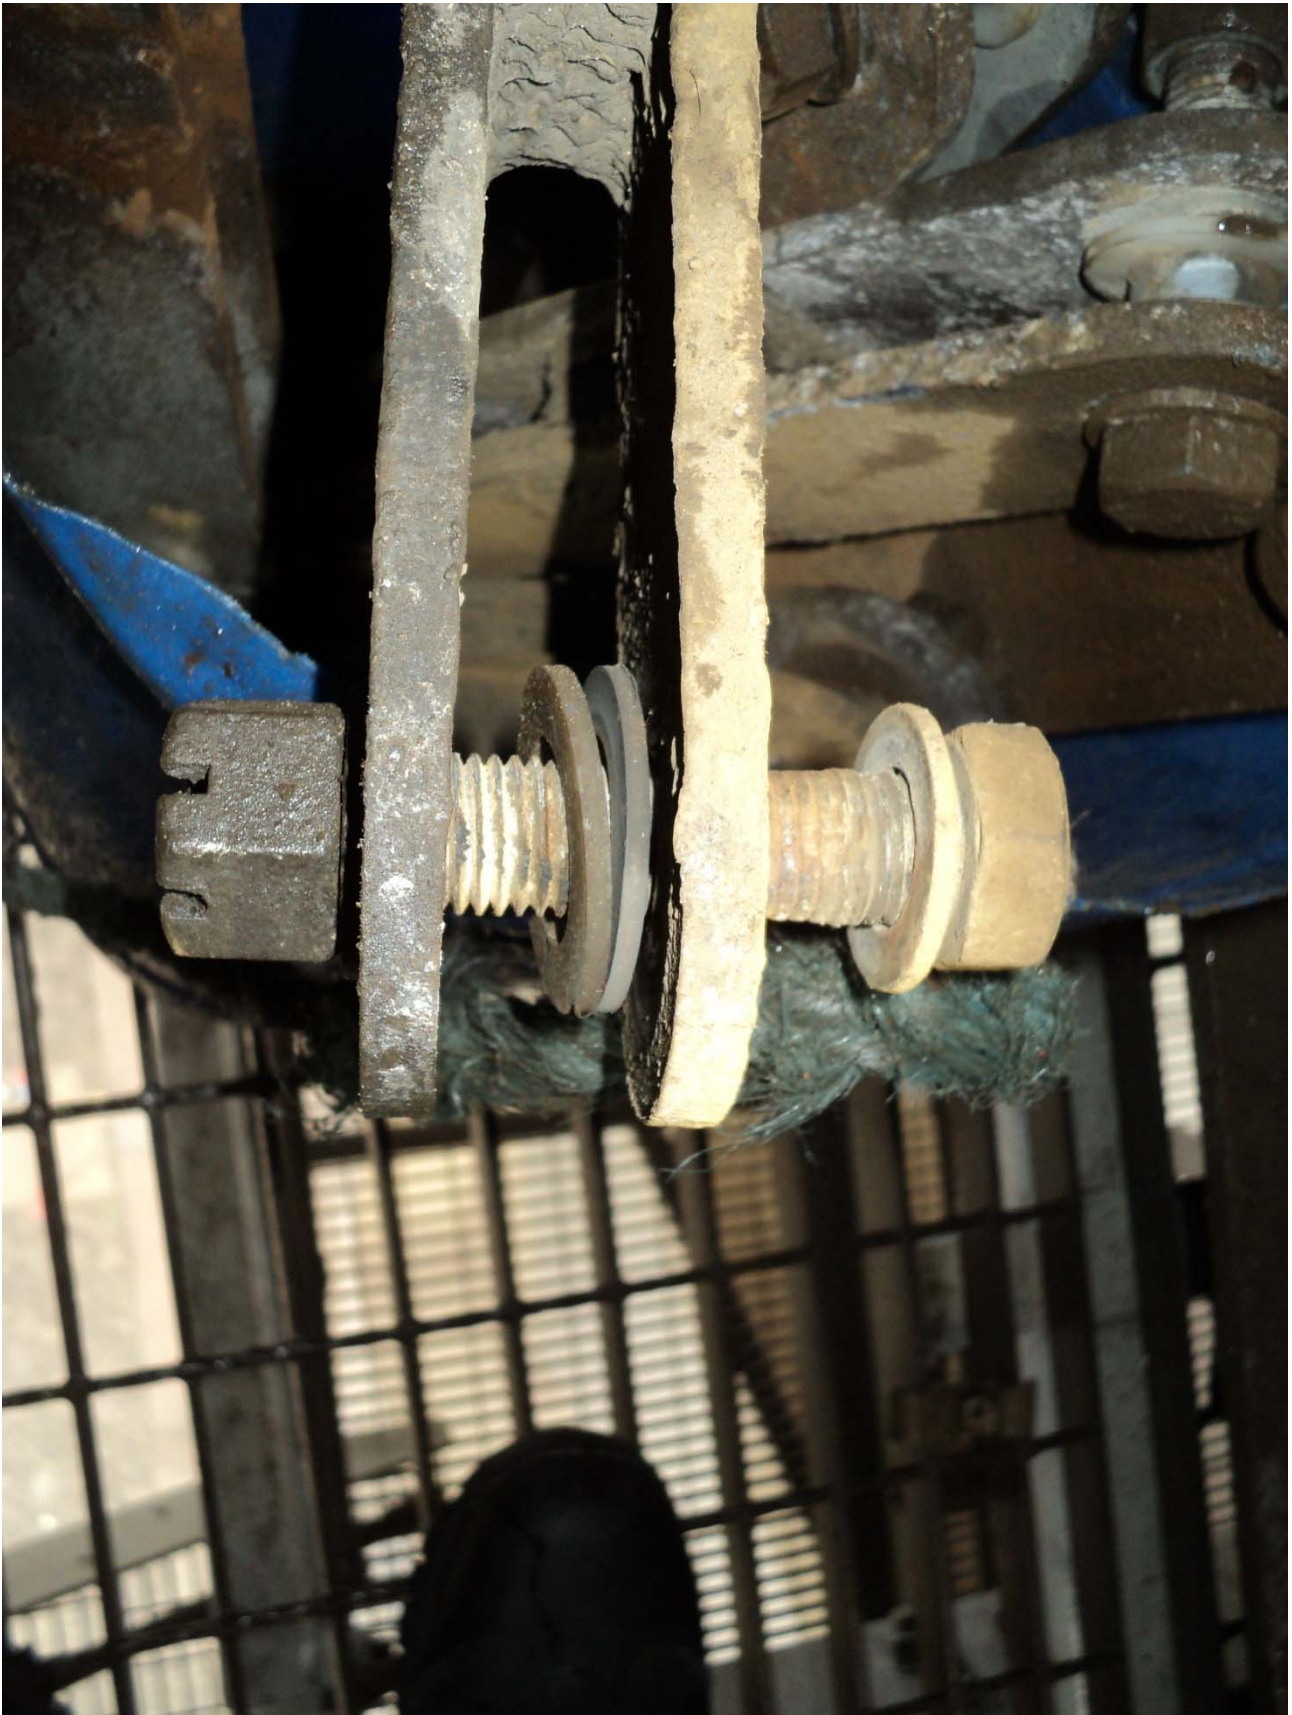
From the inspection undertaken wear on the hinges, slide rails, feet and bearings continues to accrue as the movement of the bridge continues. Wear on the failsafe components, particularly the bolted hinge plates, will occur as load is passed from the hinges to the failsafes. It is anticipated that wear on the bolts, and wear and plastic deformation of the bolt holes will occur as load is shared from the hinges. The failsafe hinge linkages are not robust enough to replace the main hinges under full service loading should the original hinges fail.

Photograph 17 – Wear on bolt thread of failsafe hinge linkage. Note bolt thread originally had nylon sleeve.

The failsafe hinge linkages currently show signs of taking up load. Excess loading on the linkages will cause wear and plastic deformation. It is recommended that linkages are inspected and checked to ensure bolts remain undamaged and bolt holes not unduly enlarged. This will require some disassembly and reassembly of suspect components.

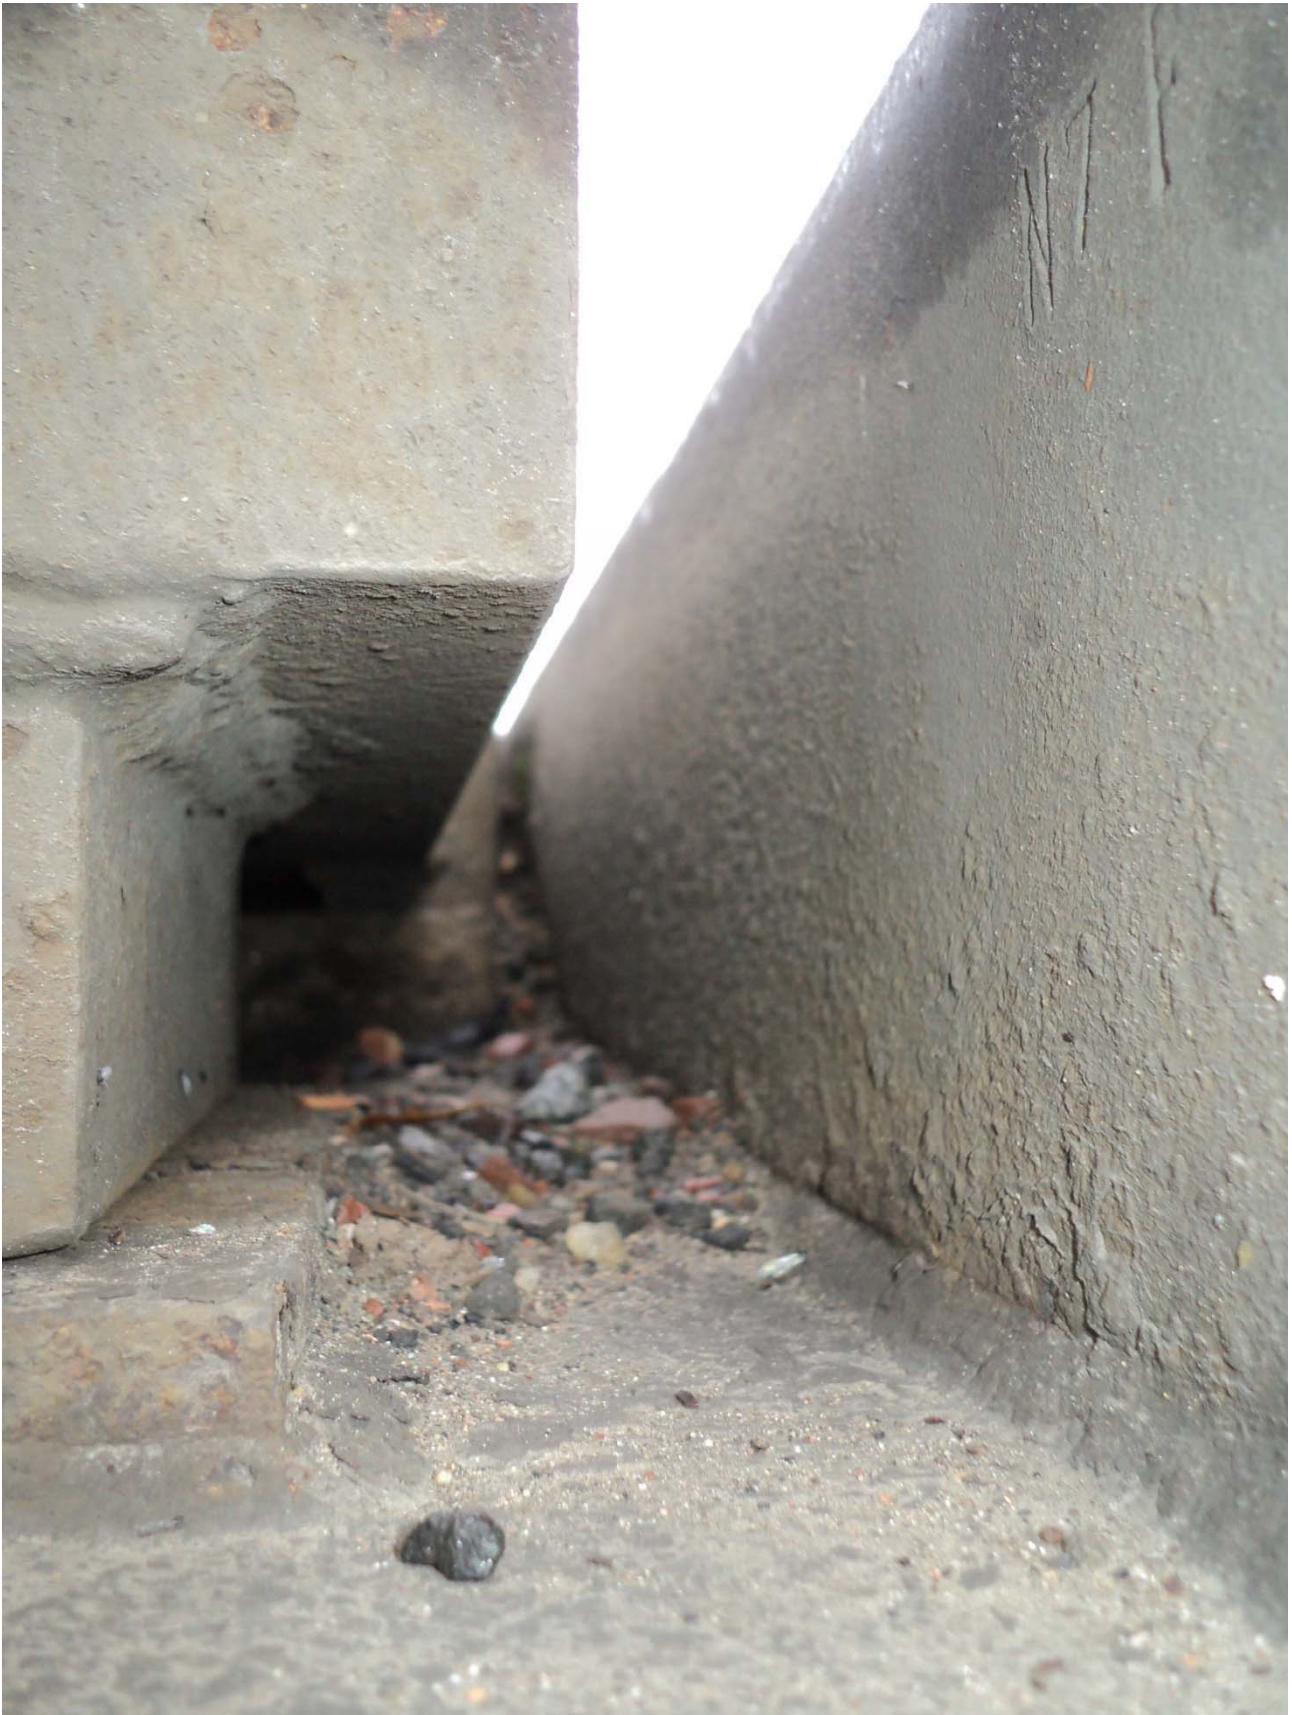
As the joint wears the carriageway level becomes more uneven and the gaps in the carriageway increase in size, more debris can accumulate on the slide track. This has the possibility of causing the joint to lock. Locking of the joint can increase the load exerted onto the hinges and anchor plate bearings. The current regime of regular cleaning and inspection of the slide track and joint components should continue. This will reduce the risk of debris locking up the joint, but not remove the risk altogether.

**Photograph 18 – Typical debris accumulating at joint.**

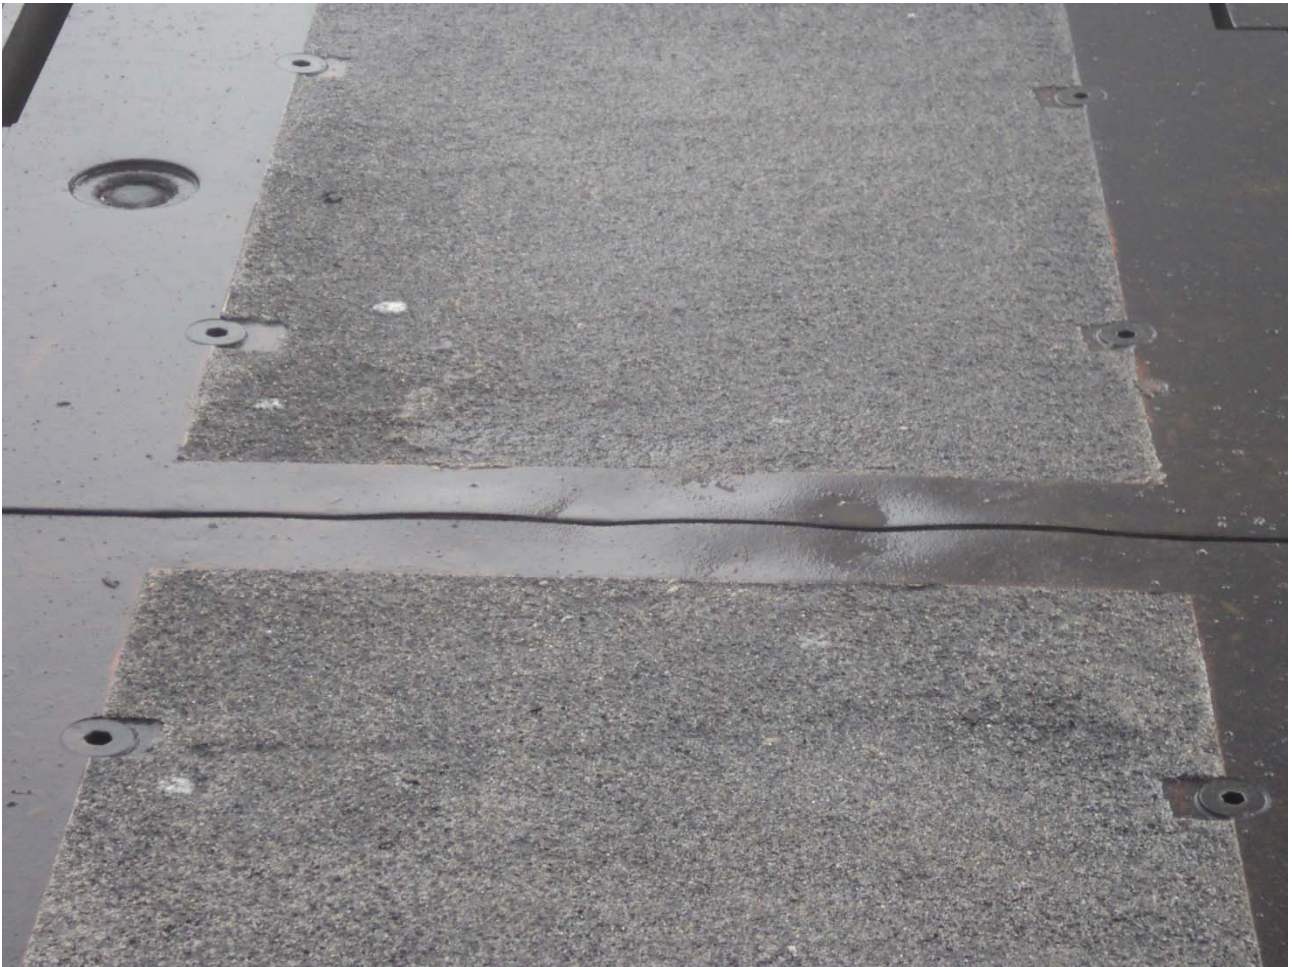
**Photograph 19 – Rippling in edging steelwork to carriageway surfacing.**
