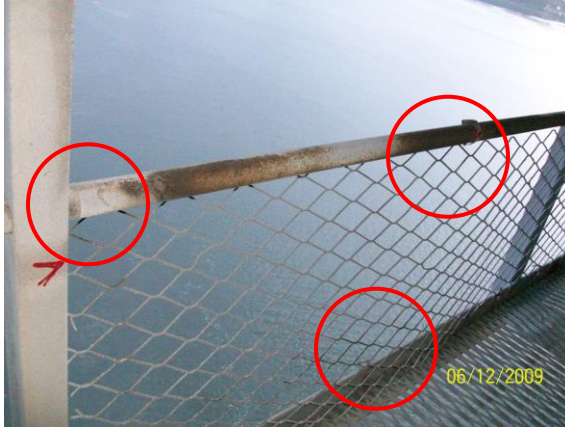
P.P.47-48 N.E.

MESH FIXINGS BORKEN, AT
THREE LOCATIONS
INDICATED.

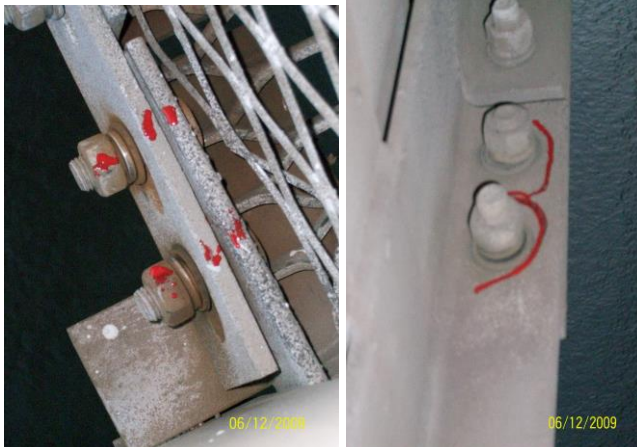
P.P.56 N.E.

2 SPLICE BOLTS LOOSE (EAST),
2 SPLICE BOLTS LOOSE (WEST).

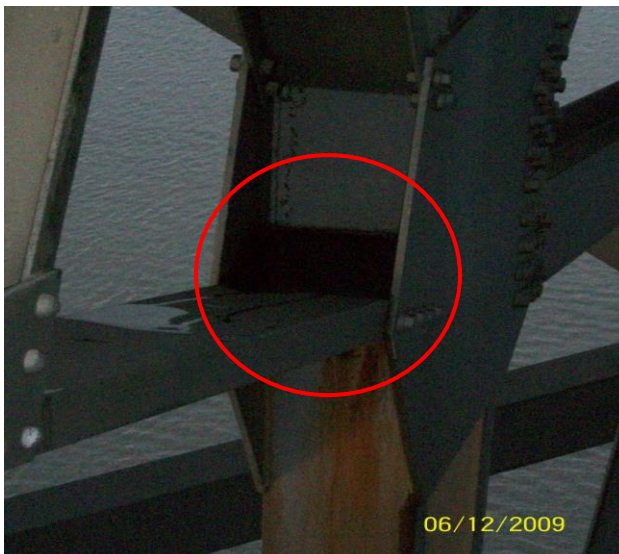
P.P.60 N.E.

BEAM 12 CONNECTION TO
VERTICAL TRUSS IS HOLDING
WATER.

**(THIS CAN BE ACCESSED
FROM GANTRY ACCESS
SCAFFOLD)**

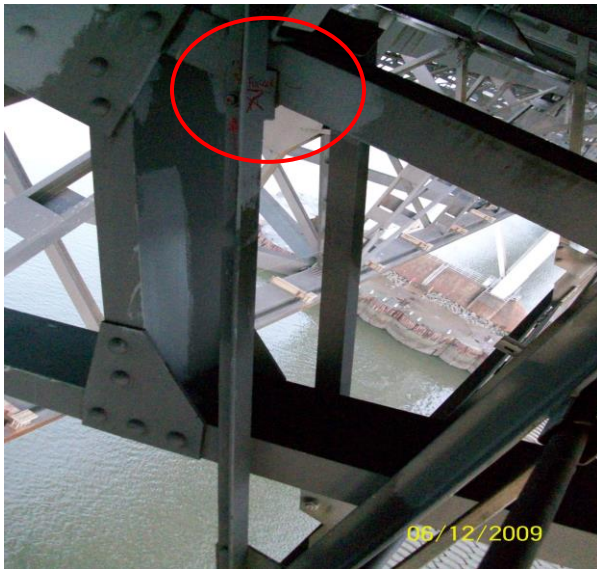
P.P.61 N.E.

WALKWAY DIAGONAL
BRACER TO BEAM 16 HAS
LOOSE LINDAPTOR.

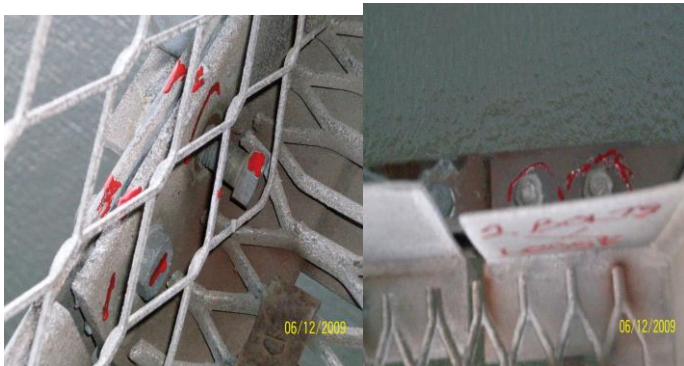
P.P.62 N.E.

2 SPLICE BOLTS LOOSE (EAST),
2 SPLICE BOLTS LOOSE (WEST).

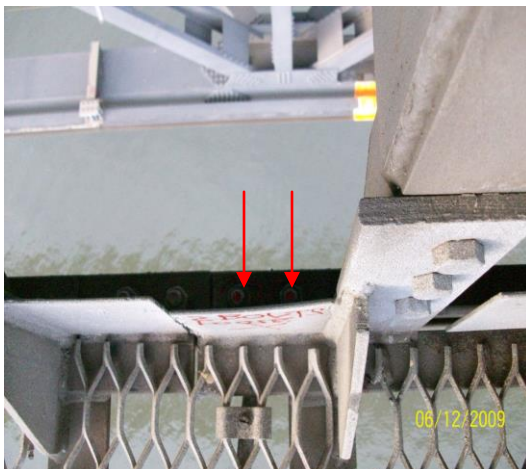
P.P.73 N.E.

2 SPLICE BOLTS LOOSE
(WEST).

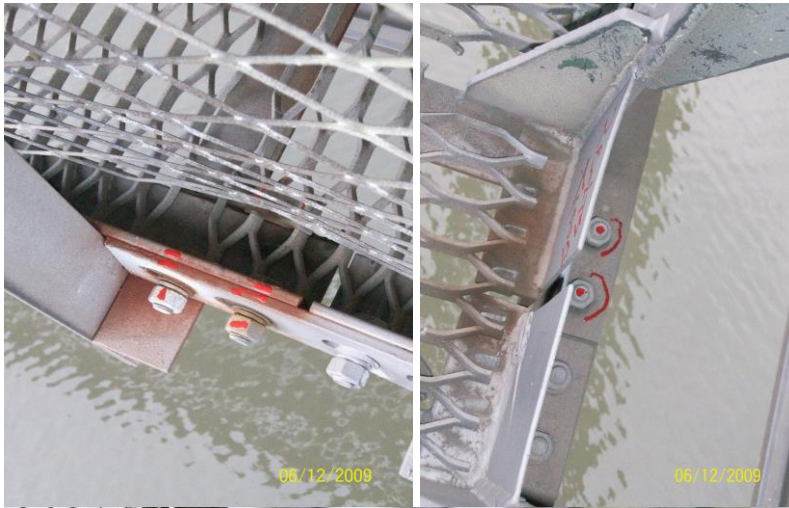
P.P.82 N.E.

2 SPLICE BOLTS LOOSE
(EAST),

2 SPLICE BOLTS LOOSE
(WEST).

SMALL GRATING PANEL –
BOTH FLOOR CLIP ARE
LOOSE, **PANEL NOT
SECURED.**

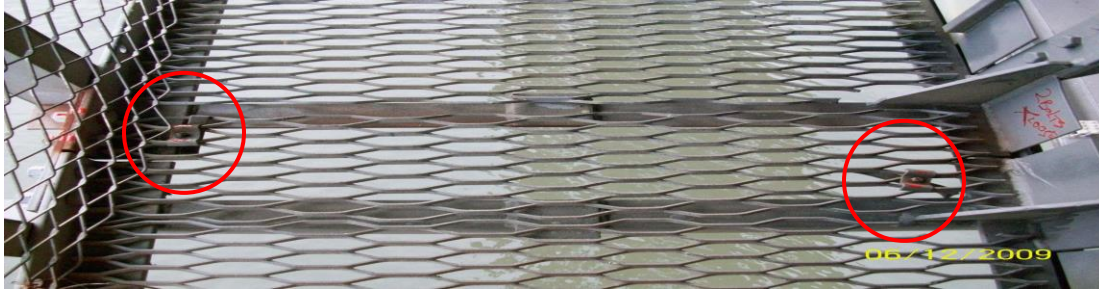
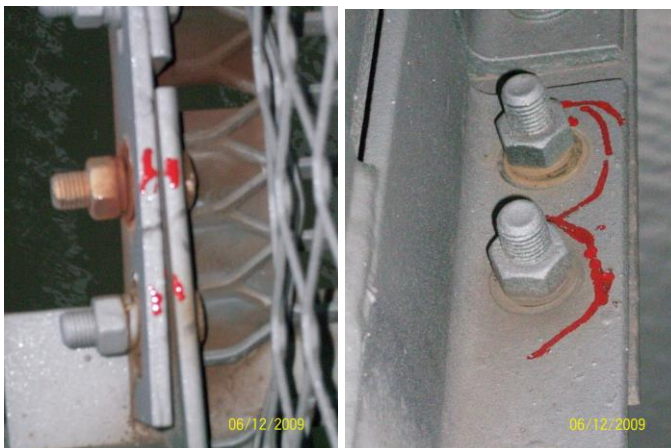
P.P.89 N.E.

2 SPLICE BOLTS LOOSE
(EAST),

2 SPLICE BOLTS LOOSE
(WEST).

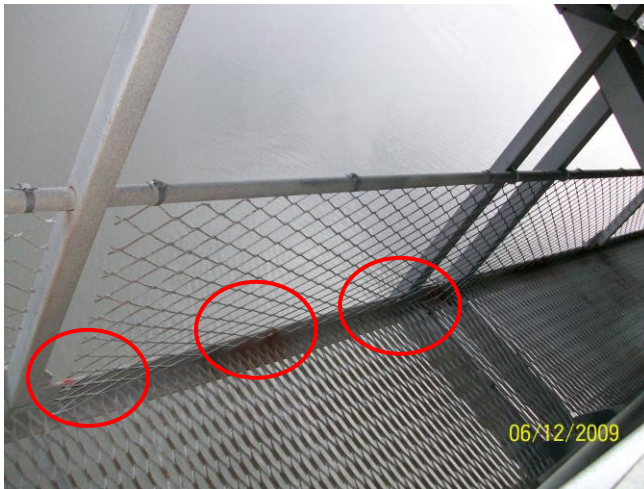
P.P.89 N.E.

3 MESH FIXINGS BROKEN.

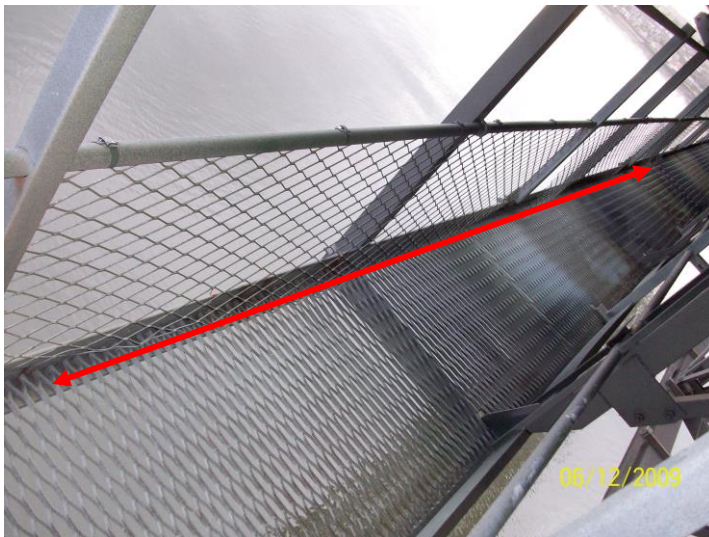
P.P.90-91 N.E.

11 MESH FIXINGS BROKEN.
ALL BOTTOM FIXINGS.

ALSO HAS
2 SPLICE BOLTS LOOSE
(EAST),
2 SPLICE BOLTS LOOSE
(WEST).

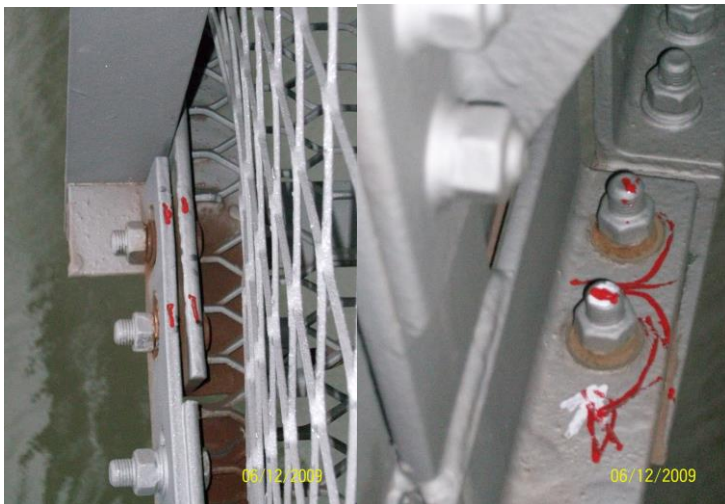
P.P.97 N.E.

2 SPLICE BOLTS LOOSE
(EAST),
2 SPLICE BOLTS LOOSE
(WEST).

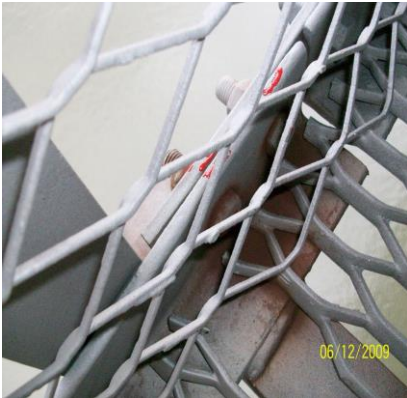
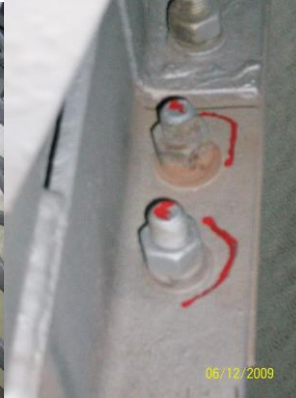
P.P.100 N.E.

2 SPLICE BOLTS LOOSE
(EAST),
2 SPLICE BOLTS LOOSE
(WEST).

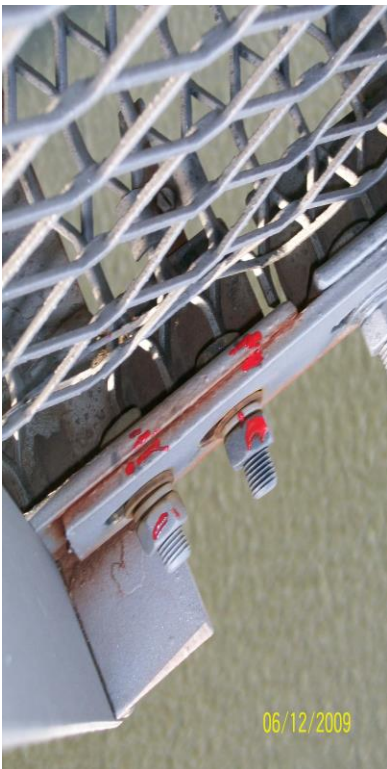
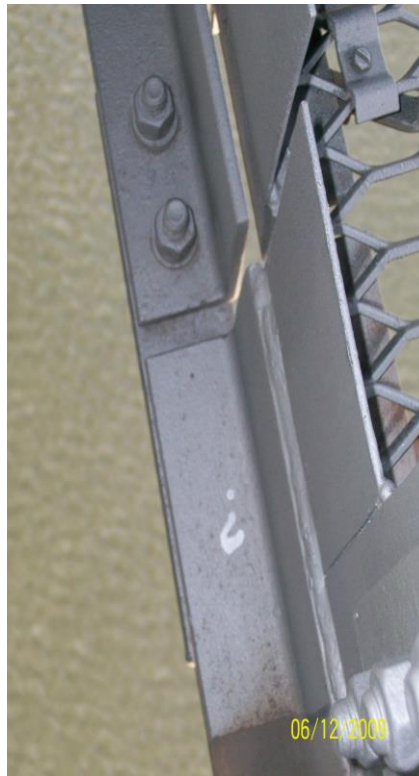
P.P.97 S.E.

2 SPLICE BOLTS LOOSE
(EAST),
INFORMATION
2 SPLICE BOLT HOLES
MISSING (WEST).

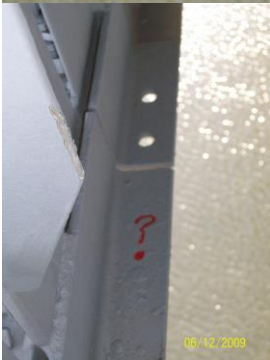
P.P.96 S.E.

INFORMATION
OPPOSITE END.
2 SPLICE BOLT HOLES
MISSING (WEST).

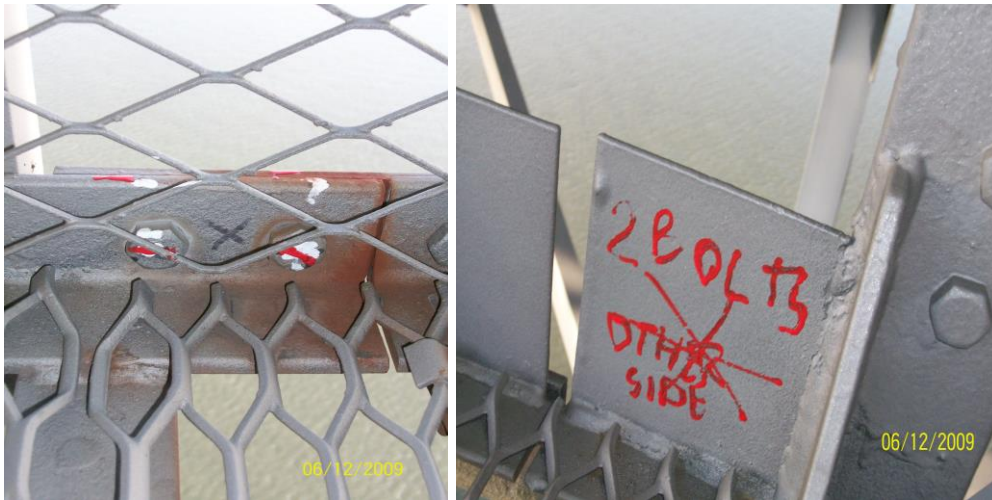
P.P.91 S.E.

2 SPLICE BOLTS LOOSE (EAST), 2 SPLICE BOLTS LOOSE (WEST).

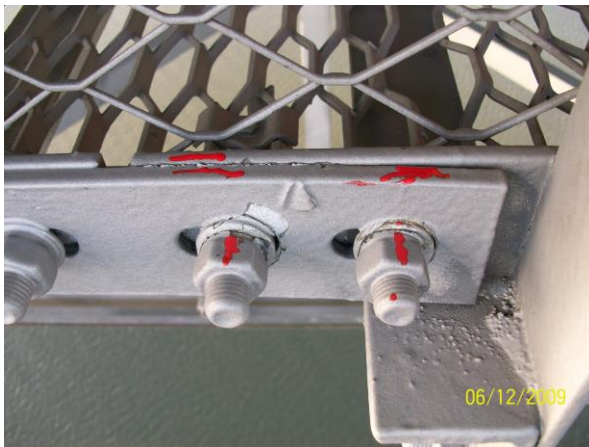
P.P.97 S.E.

EARLIER STAGES OF BOLTS
SHOWING SIGNS OF
BECOMING LOOSE. (EAST).

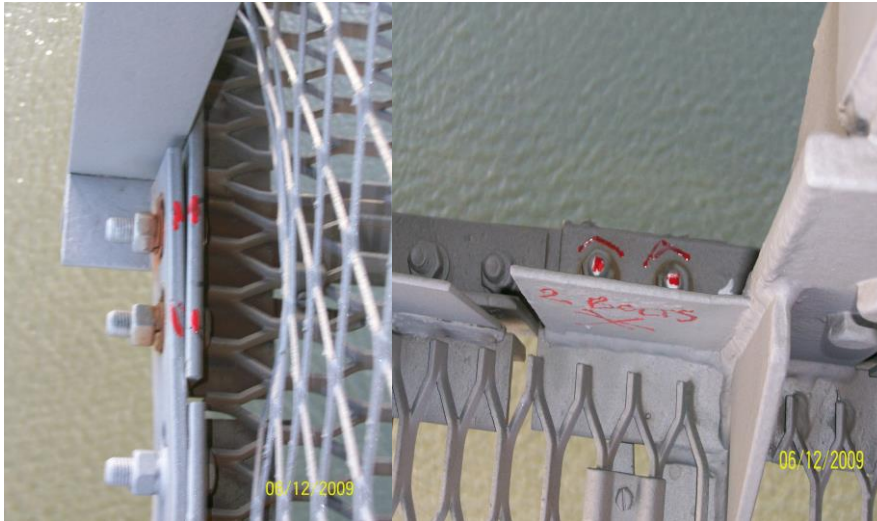
P.P.88 S.E.

2 SPLICE BOLTS
LOOSE (EAST),
2 SPLICE BOLTS
LOOSE (WEST).

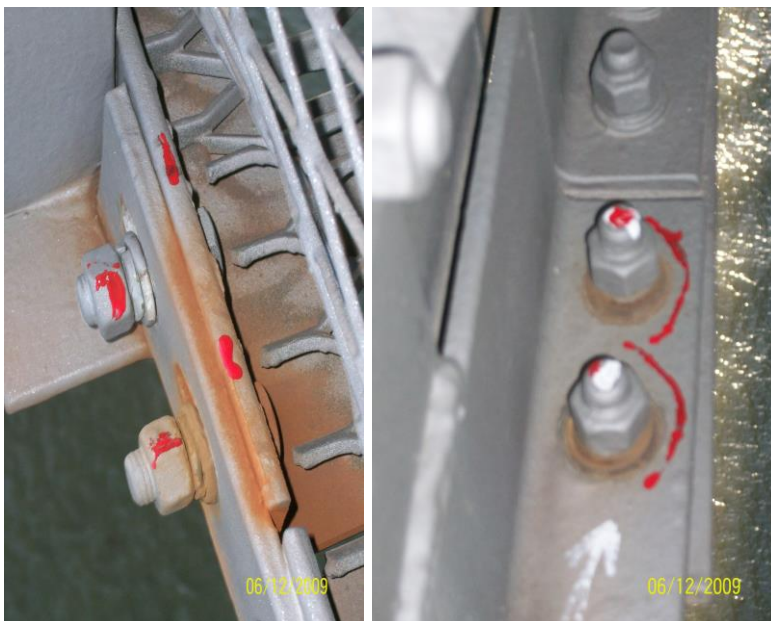
P.P.79 S.E.

2 SPLICE BOLTS LOOSE
(EAST),
2 SPLICE BOLTS LOOSE
(WEST).

MESH ALSO REQUIRES 3
FIXINGS.

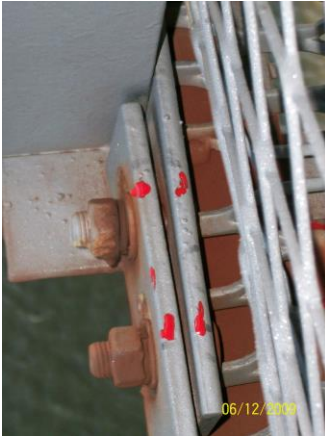
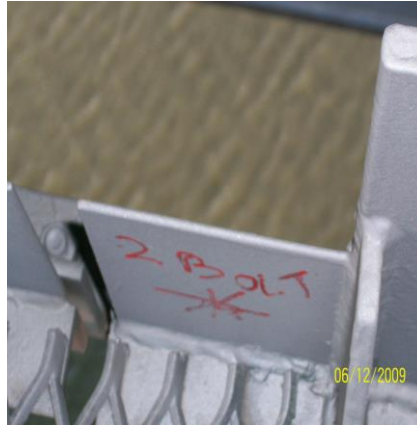
P.P.72 S.E.

2 SPLICE BOLTS LOOSE
(EAST),
2 SPLICE BOLTS LOOSE
(WEST).

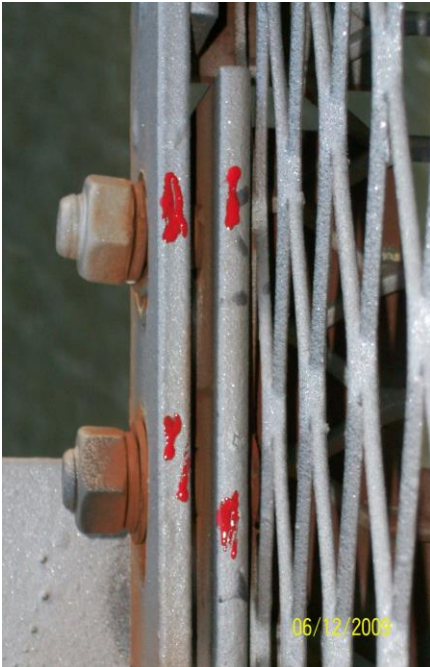
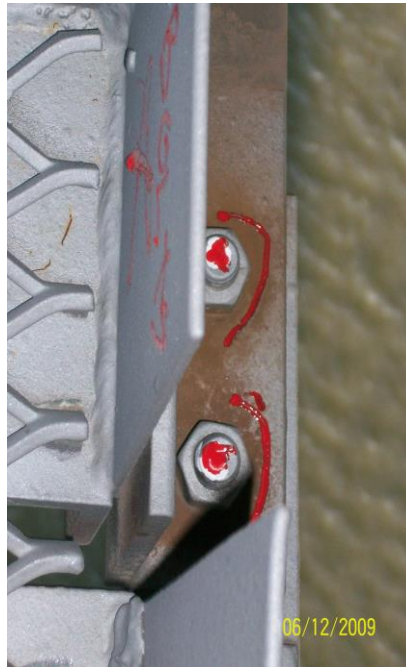
P.P.69 S.E.

2 SPLICE BOLTS LOOSE
(EAST),
2 SPLICE BOLTS LOOSE
(WEST).

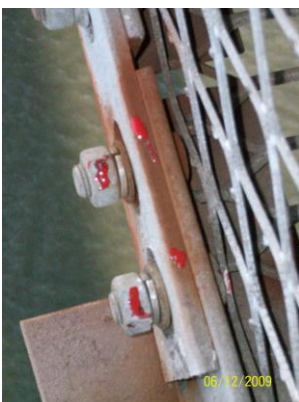
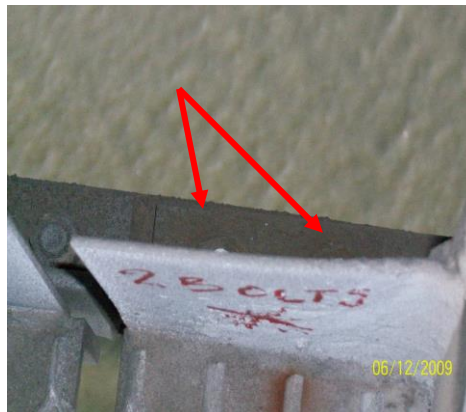
P.P.65 S.E.

2 SPLICE BOLTS LOOSE
(EAST),
2 SPLICE BOLTS LOOSE
(WEST).

**Q. ARE NEW
SPRING/GRIP WASHERS
BEING USED ?**

AS EAST SIDE APPEARS TO
HAVE RECENTLY BEEN
REPAIRED.

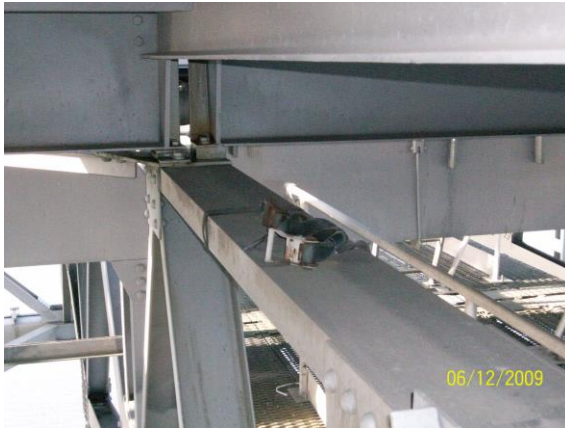
P.P.65 S.E.
REDUNDANT RATCHET
STRAPS REQUIRE TO BE
REMOVED.

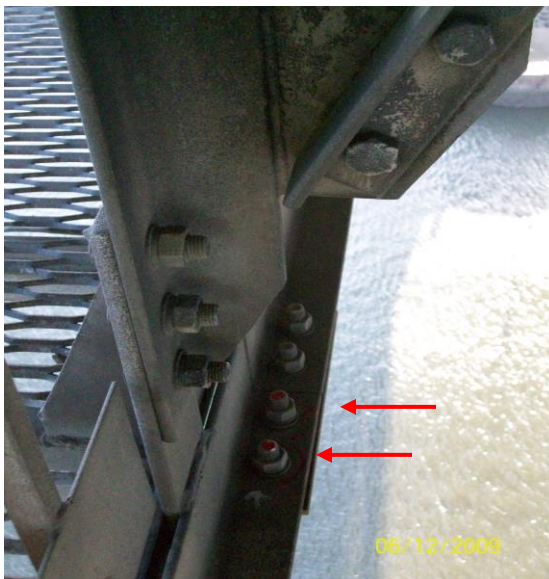
P.P.60 S.E.
2 SPLICE BOLTS LOOSE
(WEST).

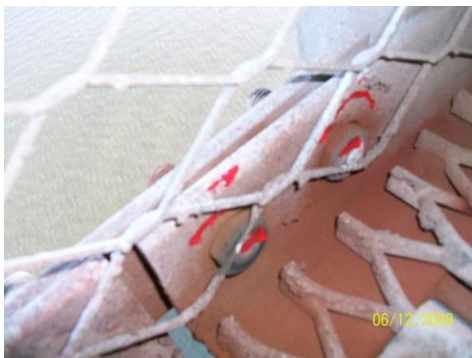
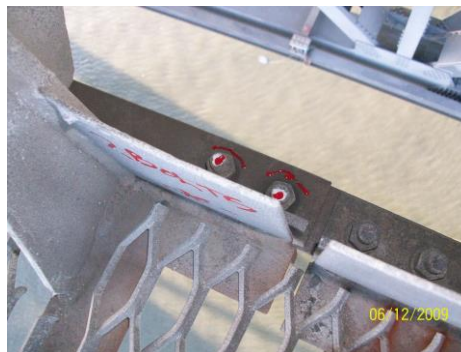
P.P.57 S.E.
2 SPLICE BOLTS LOOSE (EAST), 2 SPLICE BOLTS
LOOSE (WEST).

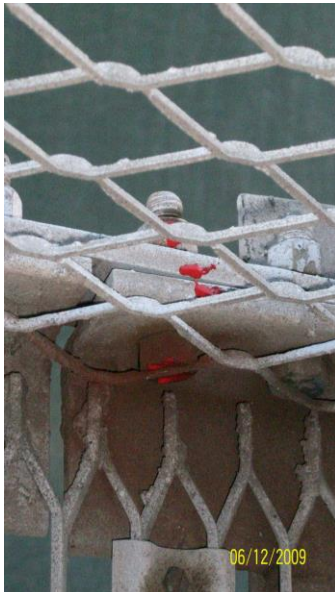
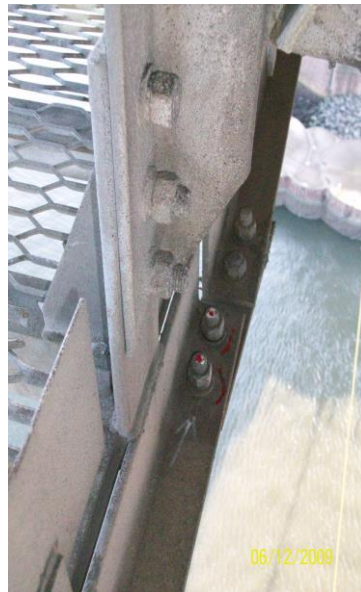
P.P.56 S.E.

1 SPLICE BOLT LOOSE (EAST),
2 SPLICE BOLTS LOOSE (WEST).

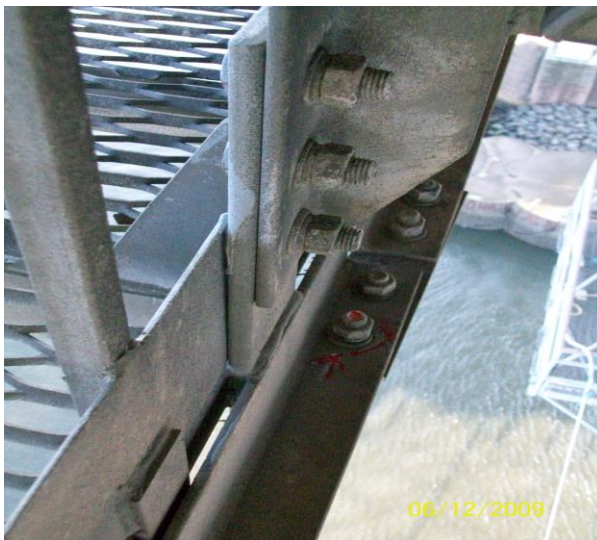
P.P.55 S.E.

1 SPLICE BOLT LOOSE (WEST).

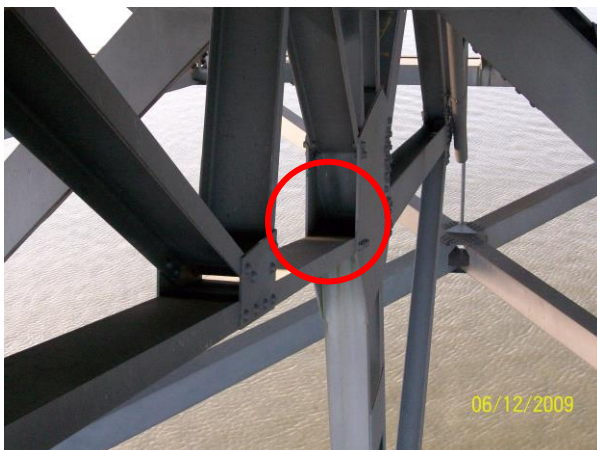
P.P.52 S.E.

BEAM 12 CONNECTION TO
VERTICAL TRUSS HOLDING
WATER/DEBRIS.

N.B. THIS POSITION CAN BE
ACCESSED FROM GANTRY
ACCESS LADDER.

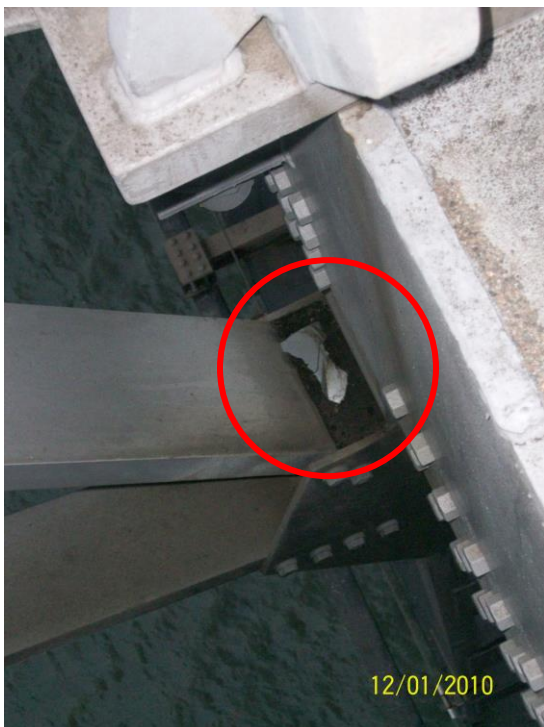
P.P.52 N.E.

BEAM 11 CONNECTION TO
VERTICAL TRUSS HOLDING
WATER/DEBRIS.

N.B. THIS POSITION CAN BE
ACCESSED FROM GANTRY
ACCESS LADDER.
