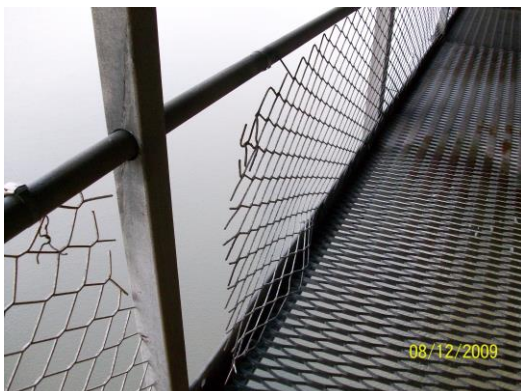
**P.P.46 S.W.**

MESH PANEL LOOSE – 2  
LOCATIONS

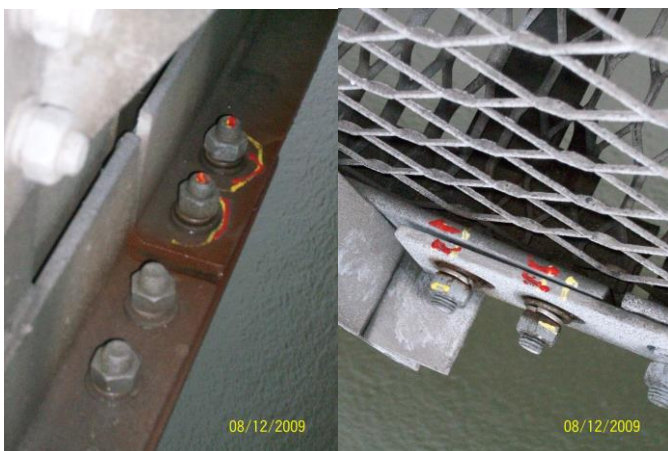
**P.P.57 S.W.**

2 SPLICE BOLTS LOOSE –  
EAST SIDE

2 SPLICE BOLTS LOOSE –  
WEST SIDE

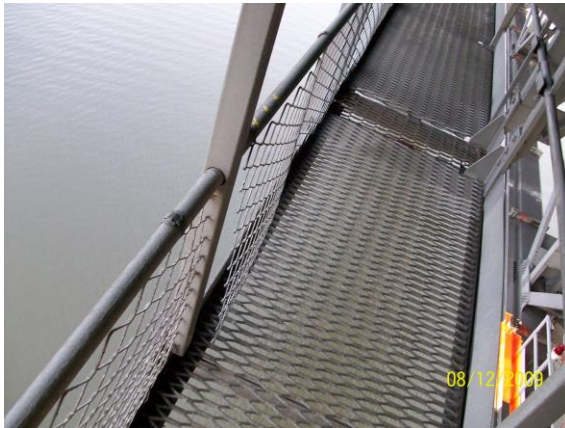
**P.P.72 S.W.**  
MESH LOOSE AT SOUTH  
SIDE OF P.P.

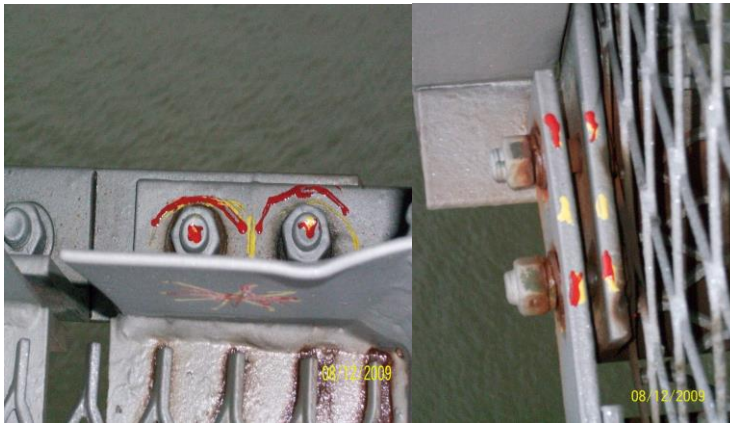
**P.P.72 S.W.**  
2 SPLICE BOLTS LOOSE –  
EAST SIDE

2 SPLICE BOLTS LOOSE –  
WEST SIDE

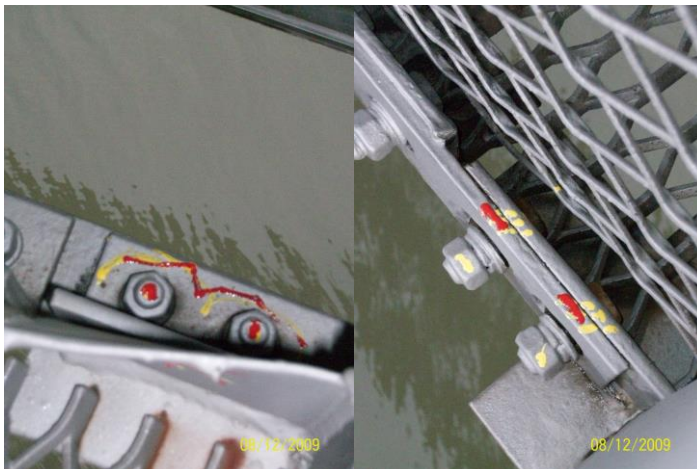
**P.P.78 S.W.**  
2 SPLICE BOLTS LOOSE –  
EAST SIDE

2 SPLICE BOLTS LOOSE –  
WEST SIDE

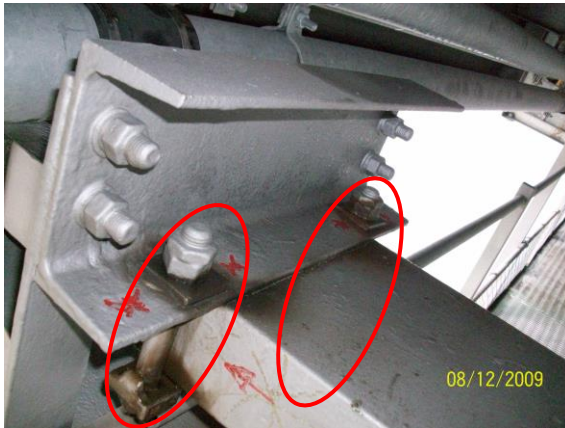
**P.P.87 S.W.**

LINDAPTOR WALKWAY  
CHANNEL ANCHORS TO  
OUTRIGGER LOOSE

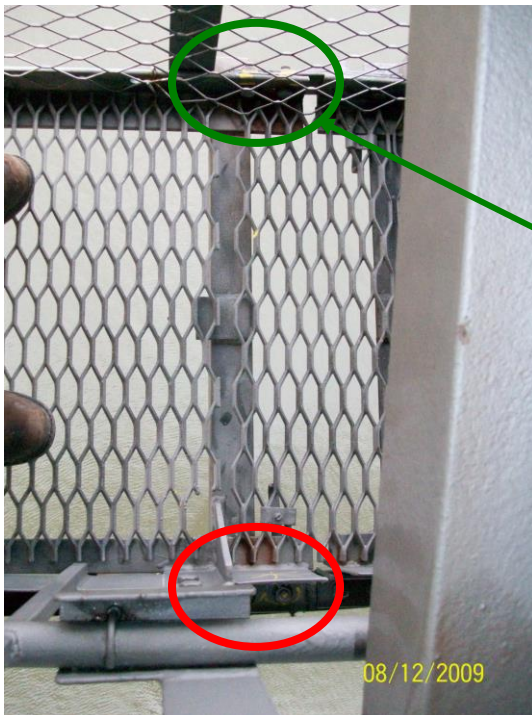
**P.P.88 S.W.**

2 SPLICE BOLTS LOOSE –  
EAST SIDE

**2 SPLICE BOLTS WEST  
SIDE HAVE BEEN  
REPAIRED**

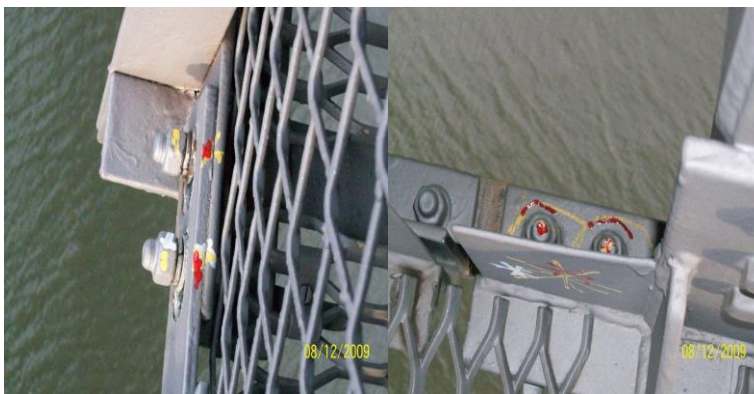
**P.P.100 N.W.**

2 SPLICE BOLTS LOOSE –  
EAST SIDE

2 SPLICE BOLTS LOOSE –  
WEST SIDE

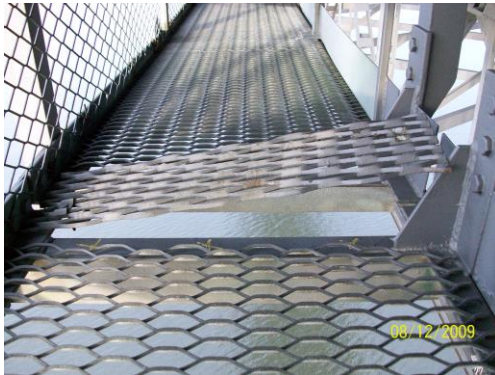
**P.P.97 N.W.**

SMALL FLOOR PANEL REQUIRES  
SECURING

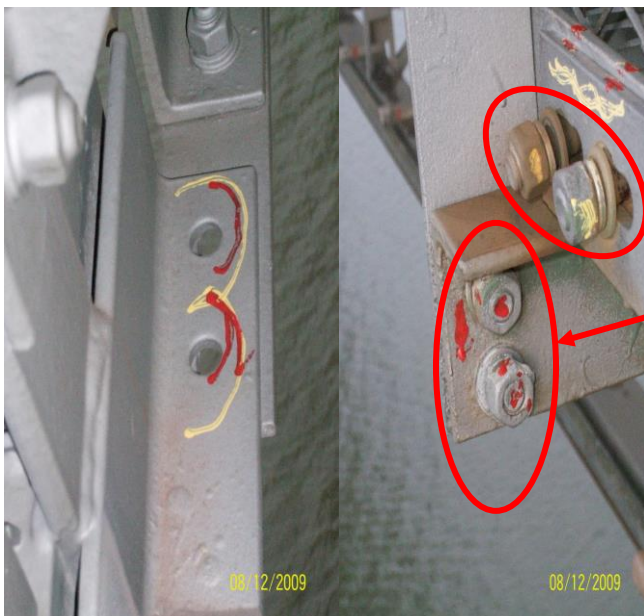
**P.P.95 N.W.**

2 SPLICE BOLTS MISSING –  
EAST SIDE

2 SPLICE BOLTS LOOSE –  
WEST SIDE

2 BOLTS LOOSE ON  
VERTICAL ANGLE

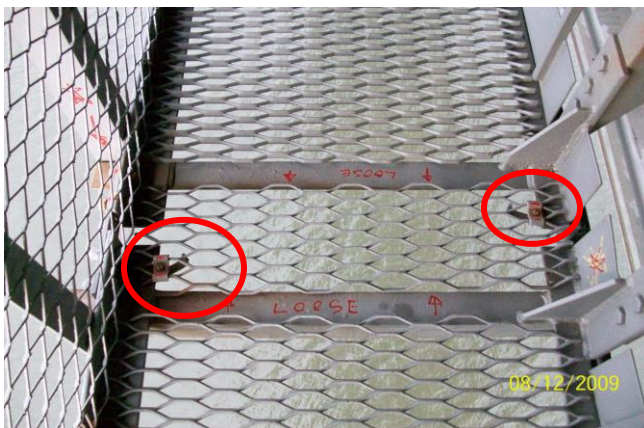
**P.P.95 N.W.**

FLOOR PANEL LOOSE,  
BOTH FLOOR CLIPS  
REQUIRE SECURING

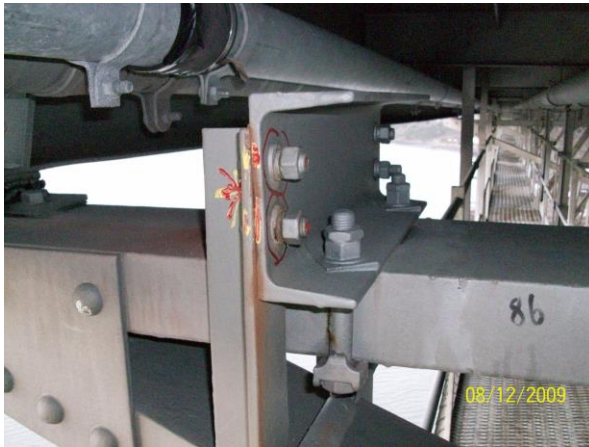
**P.P.86 N.W.**

VERTICAL WALKWAY  
ANGLE SUPPORT 2 BOLTS  
LOOSE AT TOP  
CONNECTION

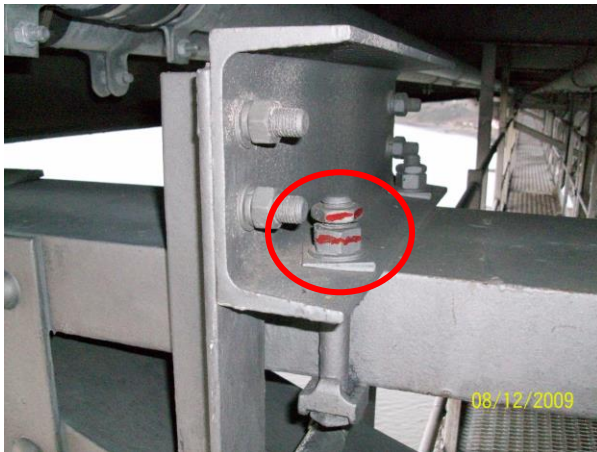
**P.P.78 N.W.**

LOCKING NUT REQUIRES  
TIGHTENING
