INSPECTION DEPARTMENT
South viaduct external inspection. (areas of paint breakdown.
DATE. 09/09/09

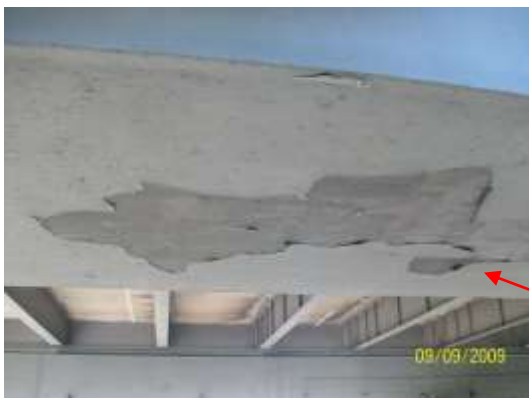
Localised area of paint
breakdown on box
girder soffit section, no
51 (west)

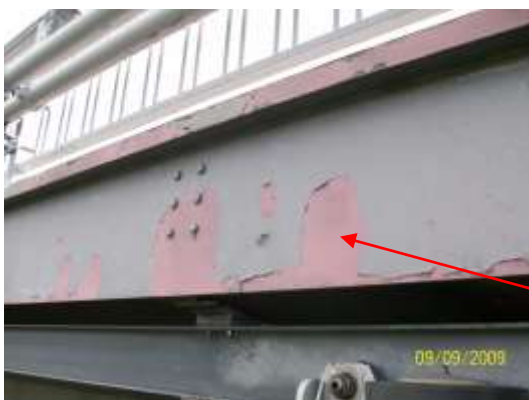
Areas of paint breakdown
throughout viaduct on cycle
track outer edge beam.

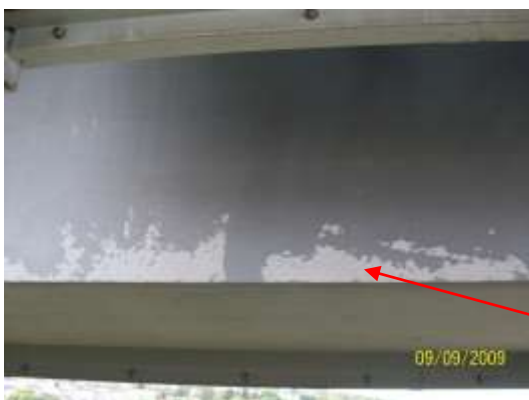
Areas of paint breakdown
located box sections 32,33
& 34x. outer beams 130 x
to 139x.
