INSPECTION DEPARTMENT
Billet Survey Main Span (East)
DATE. 14 th & 15 th . October 2015.

Main Span: North East

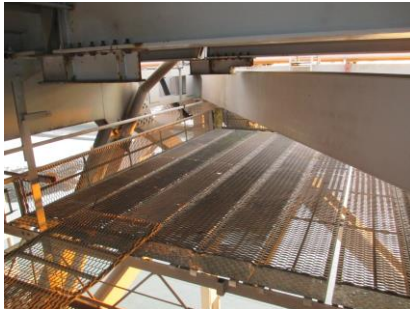
PP 48 - Old style packer system installed. Packer No 1. Missing. Packer wear – down evident on Half joints No 2, 3 & 4. Deck panel movement evident . **Noisy at time of inspection. (platform in place to replace packing system)**

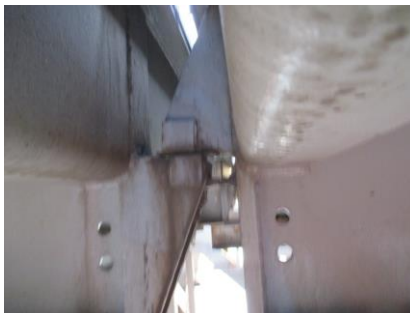
PP 50 - New half joint hard-ox packer system installed. Gaps appearing between packers & lower jaws of half joints. Slight deck panel movement evident. Fitted packers appear to be moving forward on jaws of half joint. Remains satisfactory A/T/O/I.

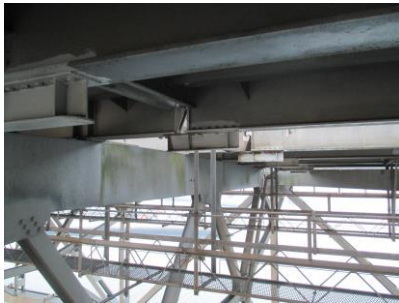
PP 60 - Old style packer system installed. Stringer half joint No.1 & No 4. packer wear-down evident. Bolt sheared on billet to stringer No 4. (East face)

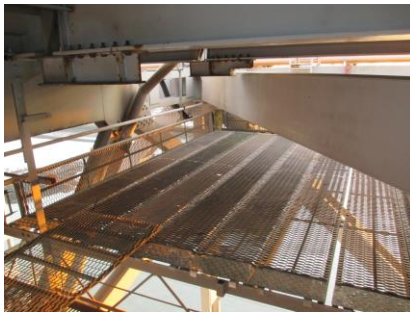
PP 84 - Old style packer system installed. Wear-down evident on Stringer half joint packers No 1-4 . Deck panel movement evident As vehicles of a certain axle weight pass over. **Requires to be done. (platform in place to replace packing system)**
