INSPECTION DEPARTMENT
Billet Survey Main Span (West)
DATE. 2015.04.13.

North West Main Span:

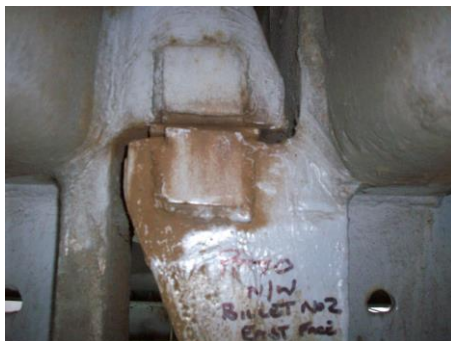
PP. 70. East face. Billet No 2

- PP 68 - Old style packers in place. Half joints remain satisfactory.
- PP 70 - New hardox half joint packing system in place. Billet No 2. Gap & packer movement
Evident. On east face of half joint. (Picture showing current status.)
Remains quiet A/T/O/I.(Will monitor.)

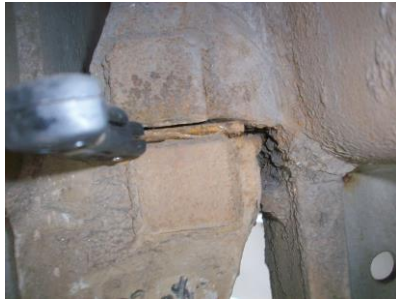
PP. 48. South west Billet No 2. (East face.)

PP 48 - New hardox half joint packing system in place. Billet No 2. Gap & packer movement Evident. Slight noise when heavy vehicles pass over. (Picture showing current status.)
(Will monitor.)

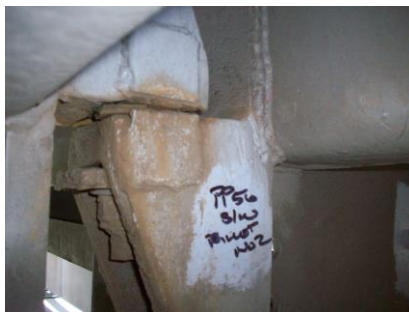
PP. 56. South west Billet No 2

PP 56 - New hardox half joint packing system in place. Billet No 2. Gap & packer movement Evident. Because of the slope on the jaws packers may drop out .Slight noise when heavy vehicles pass over. (Picture showing current status.) (Will monitor.)
