INSPECTION DEPARTMENT
Billet Survey Main Span (West)
DATE. 2015.07.15.

FORTH ROAD BRIDGE

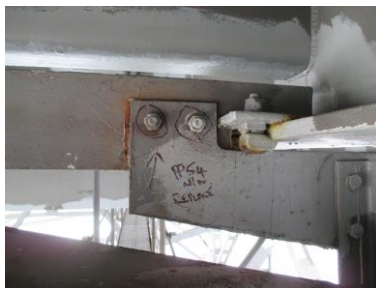
PP. 54 n/w. ( West side hanger plate bolts.)

- PP 52 - Old style packers in place. Half joints remain satisfactory. Slight deck panel movement now evident Will monitor.
- PP 54 - Old style packers in place. Packer wear-down evident on Half joints 1-4 Noisy. Deck Deck panel movement , requires to be done. ( Billet No 4, 2 bolts broken on the west Side. ). Recommend that this location be done A.S.A.P. Deck panel movement has induced loosening of bolts located at on the walkway hanger plate to the support beam. Movement evident. ( Bolts require to be replaced. ) ( new info )

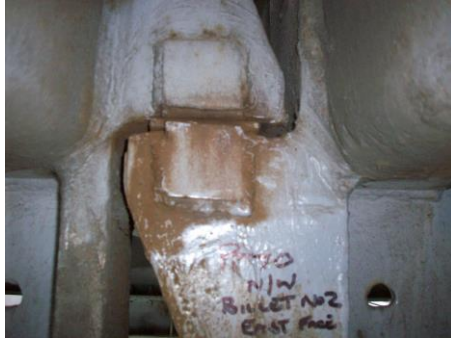
PP. 70. East face. Billet No 2

PP 70 - New hardox half joint packing system in place. Billet No 2. Gap & packer movement Evident. On east face of half joint. (Picture showing current status. ) Remains quiet A/T/O/I.( Will monitor. ) - As inspection date 2015.04.13.

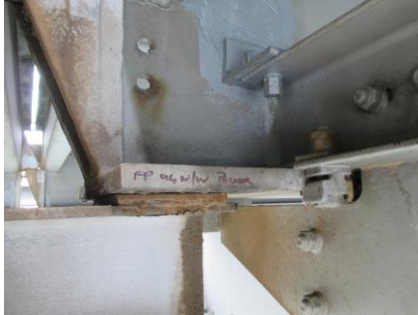
PP. 94. n/w. packing plates.

PP 94 - Packer plates fitted between billet top & stringer soffits. Remains in a satisfactory condition.

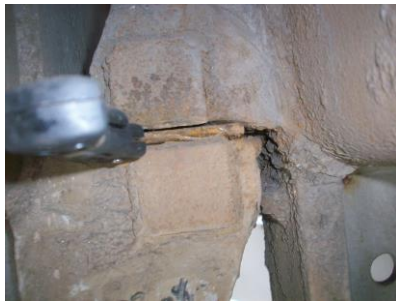
PP. 48. South west Billet No 2. ( East face. )

PP 48 - New hardox half joint packing system in place. Billets No 2. Gap & packer movement Evident. Slight noise when heavy vehicles pass over. (Picture showing current status. ) ( Will monitor. ) As inspection date 2015.04.13.

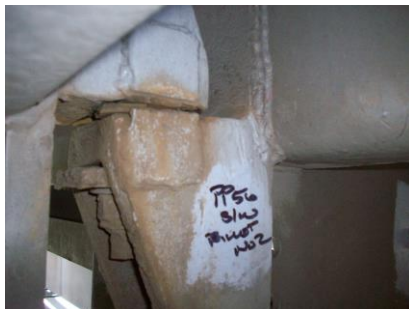
PP. 56. South west Billet No 2

PP 56 - New hardox half joint packing system in place. Billet No 2. Gap & packer movement Evident. Because of the slope on the jaws packers may drop out .Slight noise when heavy vehicles pass over. (Picture showing current status. ) ( Will monitor. ) As inspection date 2015.04.13.

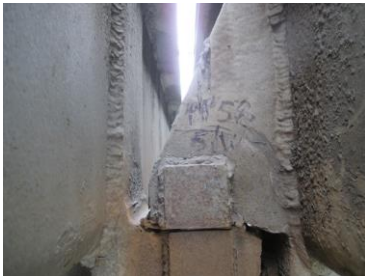
PP. 58. s/w.

PP 58 - New hardox half joint packing system in place. Deck panel movement this inspection. Gaps evident between fitted packers & top jaw of half joint. ( Will monitor.)

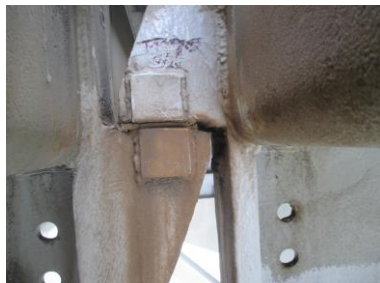
PP. 70 s/w.

PP 70 - New hardox half joint packing system in place. ( deck - panel movement evident this inspection. Sight gaps between packers & top jaw. will monitor ) Half joints remain satisfactory .

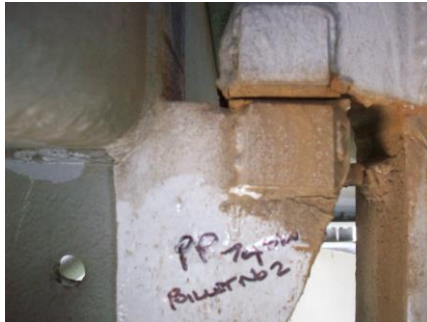
PP. 74. South west Billet No 2

PP 74 - New hardox half joint packing system in place. Billet No 2. Gap & packer movement Evident. Slight noise when heavy vehicles pass over. (Picture showing current status. ) ( Will monitor. )

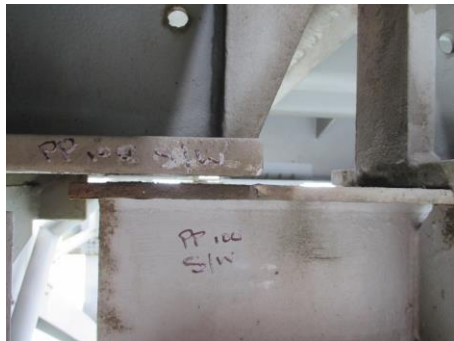
PP. 100.s/w.

PP 100 - Old style packers in place. Half joints No1 & 2. Now noisy when heavy vehicles pass over. Packer plates fitted between top of billet & stringer soffit require to be removed & replaced to eliminate deck panel movement & noise.
