INSPECTION DEPARTMENT
Billet Survey Main Span (West)
DATE. 2015.10.20.

FORTH ROAD BRIDGE

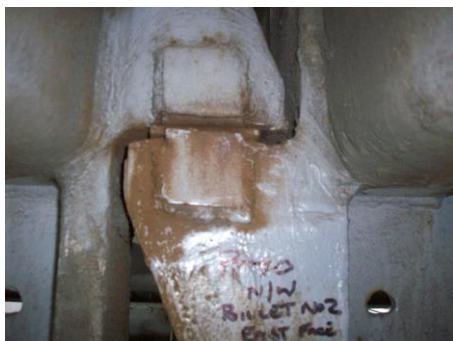
PP. 70. East face. Billet No 2

PP 70 - New hardox half joint packing system in place. Billet No 2. Gap & packer movement Evident. On east face of half joint. (Picture showing current status.)
Remains quiet A/T/O/I . [Will monitor condition](#).

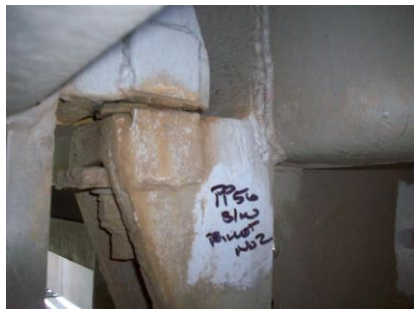
PP. 56. South west Billet No 2. (Picture showing current status.)

PP 56 - New hard-ox half joint packing system in place. Billet No 2. & No 3. Gaps & packer movement evident. These two half joints are noisy As vehicles of a certain axle weight pass over. **Require to be done.**

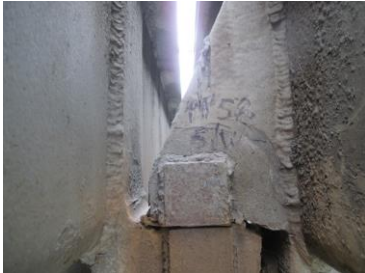
PP. 58. s/w.

PP 58 - New hard-ox half joint packing system in place. Deck panel movement this inspection. Gaps evident between fitted packers & top jaw of half joint. As vehicles of a certain axle weight pass over. **Require to be done.**

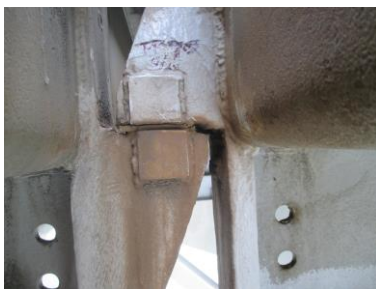
PP. 70 s/w.

PP 70 - New hard-ox half joint packing system in place. (deck - panel movement evident this inspection. Sight gaps between packers & top jaw. Now noisy As vehicles of a certain axle weight pass over. **Require to be done.**

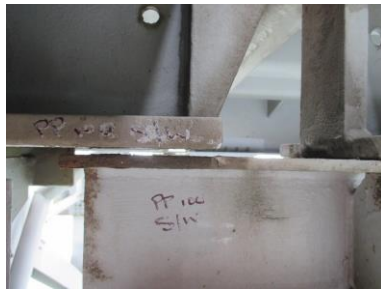
PP. 100.s/w.

PP 100 - Old style packers in place. Half joints No1 & 2. Now noisy when heavy vehicles pass over. Packer plates fitted between top of billet & stringer soffit require to be removed & replaced to eliminate deck panel movement & noise. **Require to be done. (B . Lines being fitted to this location.** A/T/O/I
