On the above date, it was requested that an inspection of billet packing welds was carried out.

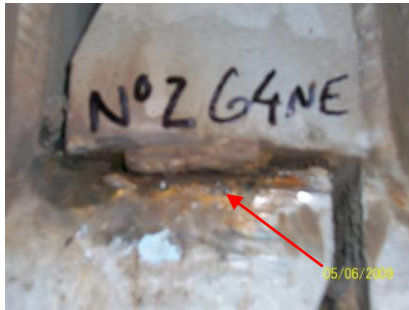
No.2 stringer 64 N.E., weld has been applied above and below, without welding the packer to the joint. This joint has not been successfully packed, as it is still banging.

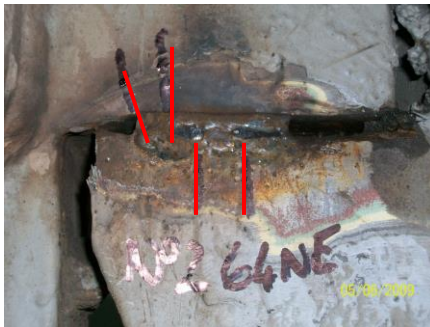
No.2 Stringer 64 N.E., only a small amount of weld actually holding packer to joint. These are indicated between the red lines.

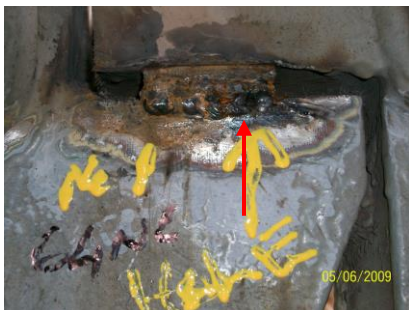
No.1 Stringer 64 N.E. Large hole at end of weld.

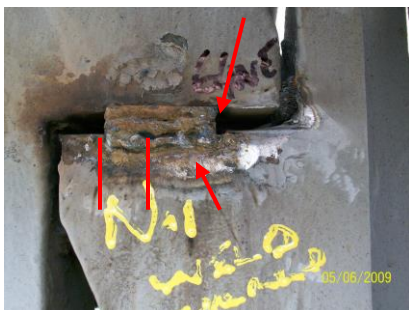
No.1 Stringer 64 N.E. very little weld holding packer in place.

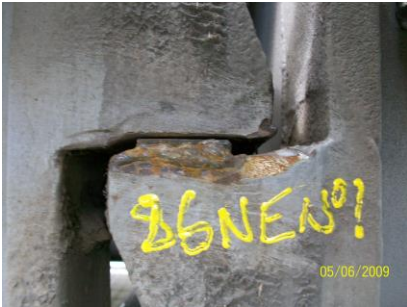
No.1 Stringer 86 N.E. joint has not been packed properly and still has movement.
