Forth Bridge

Comb Joint Options Report

February 2008

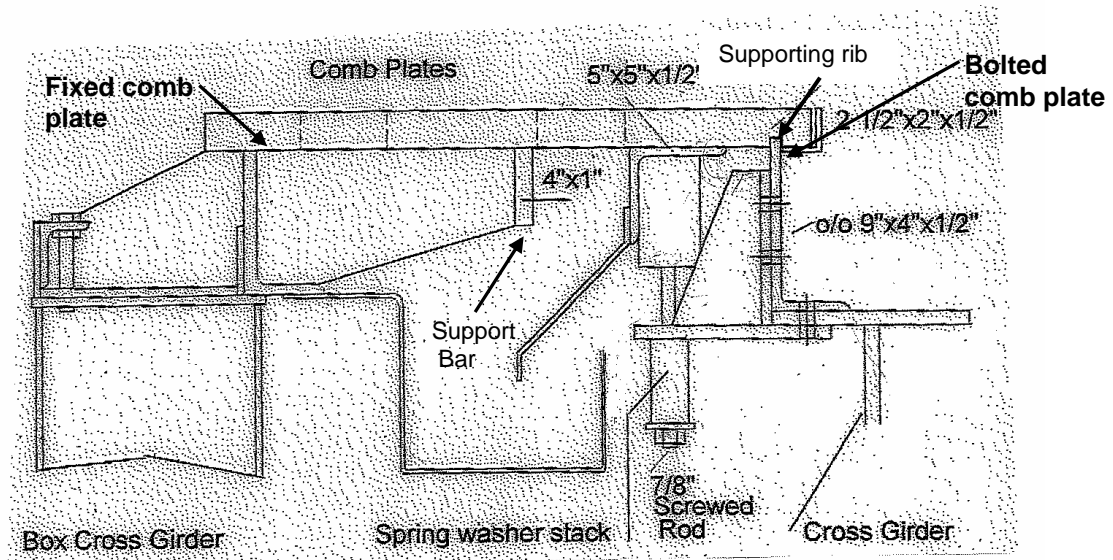
Fig 1 – Typical Section through Comb Joint

The existing comb joint system is showing wear and distortion, primarily of the bolted plates. Movement of the bolted comb plates across the support bar attached to the fixed comb plates has resulted in wear to both the support bar and the underside of the fingers of the bolted comb plates. This wear has caused the fingers of the bolted comb plates to deflect downwards so there is now a difference in level across the joint. The supporting rib at the rear of the bolted plates has also worn, resulting in an overall drop in level across all plates.

Due to the drop in height of the bolted comb plates, the fixed comb plate fingers now protrude up above the bolted comb plates. This has resulted in direct vehicle run over at the exposed ends, causing some wear on top of the fingers.

The refurbishment proposals include the removal and replacement of the bolted comb plates whilst the fixed comb plate remains in place. This will require the replacement of the supporting arrangement which attaches to the transverse deck beams. An additional support bar will be attached to the fixed comb plate to address the wear in the existing bar.
