INSPECTION DEPARTMENT
South main tower expansion joint . SE 3.
DATE: 08/10/11.

◀ Inspection Record Sheet:-		
Subject :- Demag plate set removal	Location: South main tower expansion joint . SE 3.	
Pre-removal Dimensional Checks		
Inspection Record Sheet:- BC. 06/ SSSE. 08/10/11. PLATE SE 3.		
Subject :- Demag plate set removal	Location. South east main tower.SSE 3.	
Pre & Post removal Dimensional Checks		
Pre-removal Checks		
Task	Yes	No

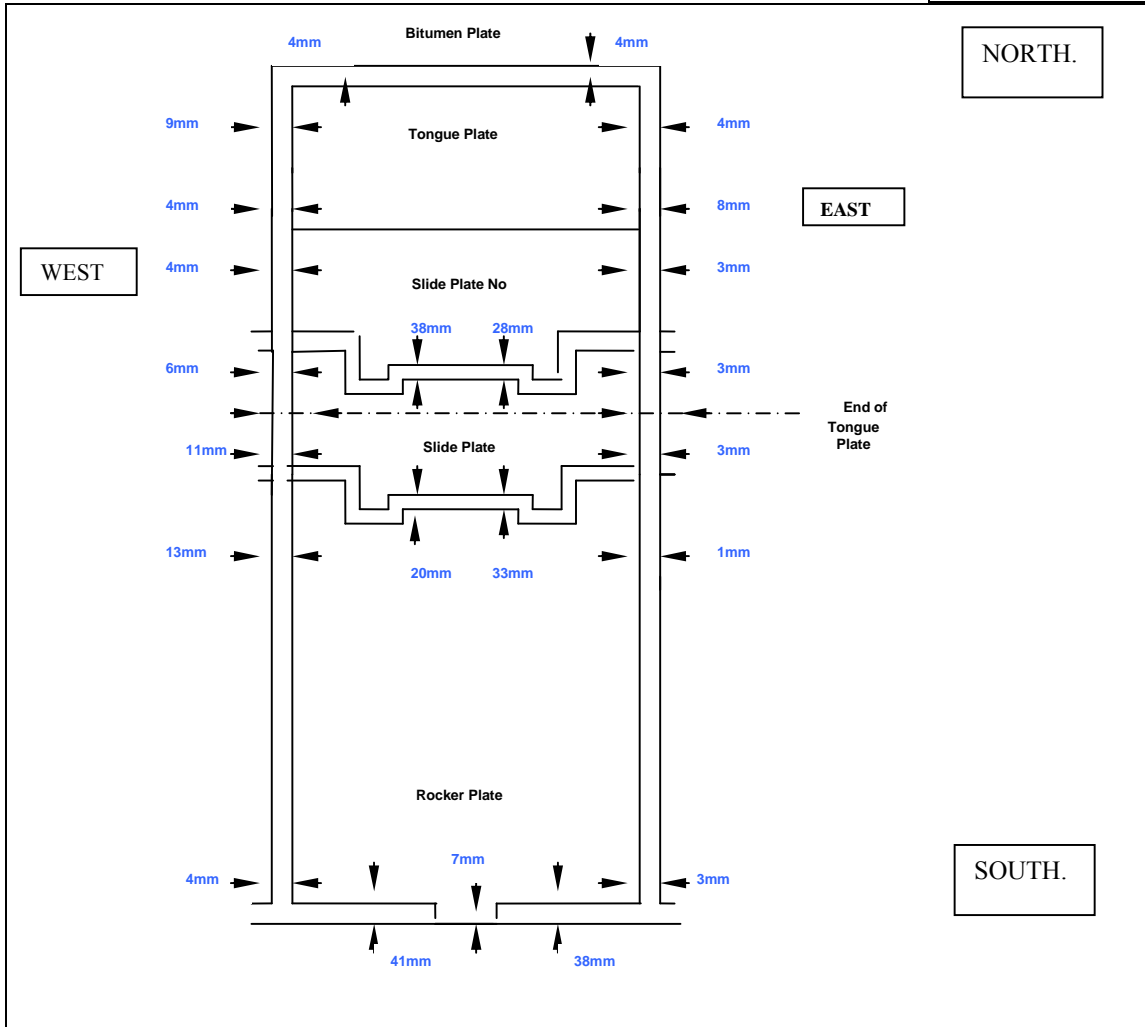
Inspection Record Sheet:-	
Subject :- Demag plate set removal.	
Pre-removal Dimensional Checks	
Inspected by:	
Date:	08/10/11.

* Record top side clearance gaps as identified on survey sht 2 of 4	✓	
* Mismatch between adjacent plates, rocker SE 2 – N. 4 mm . S.12mm	✓	
rocker SE 4 - N. 4 mm . S. 8 mm	✓	
Slide plate No. 1 SE 2 - 5mm Centre	✓	
Slide plate No.1 SE 4 - 2mm Centre	✓	
Tongue plate SE 2 - 4mm . S.6 mm	✓	
Tongue plate SE 4 - 2mm . S.2 mm	✓

* Spring lengths:- rocker plate:- 150 mm	✓	
* Spring lengths:- tongue plate:- east. 82 mm West. 82 mm	✓	
Mismatch between adjacent plates	✓	
Main span end trimmer & rocker plate:- east. 2mm west. 4mm		
Post Removal Checks		
Task	Yes	No
Slide plate cam radius:-		✓

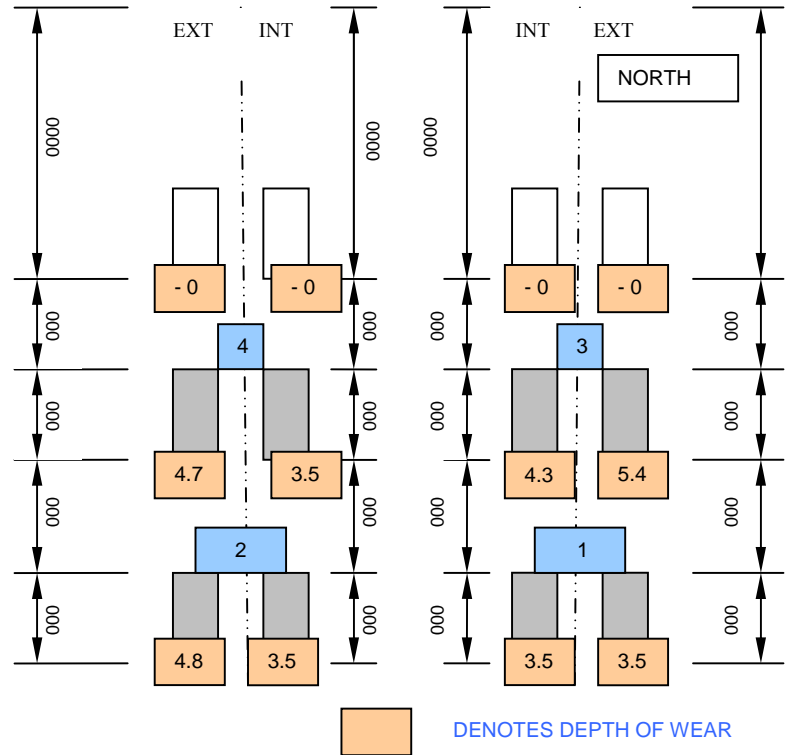
Pin No.	Internal Dia.	External Dia.
1	39mm	39mm
Bush Thkns	Top	N/A
	Bottom	N/A
	North	N/A
	South	N/A
Pin No.	Internal Dia.	External Dia.
2	39mm	39mm
Bush Thkns	Top	N/A
	Bottom	N/A
	North	N/A
	South	N/A
Pin No.	Internal Dia.	External Dia.
3	39mm	39mm
Bush Thkns	Top	N/A
	Bottom	N/A
	North	N/A
	South	N/A
Pin No.	Internal Dia.	External Dia.
4	39mm	39mm
Bush Thkns	Top	N/A
	Bottom	N/A
	North	N/A
	South	N/A

**Bush bore dimensions. :- ( largest across oval, horizontal axis. ) - No dimensions taken**

All wear on one side of bush , ie, either North or South.

Note:- It should be recorded that due to time constraints & inclement weather a decision was taken following discussions with the maintenance manager and bridge inspectors that the above information would not be taken on the plate SE 3. to allow reinstatement

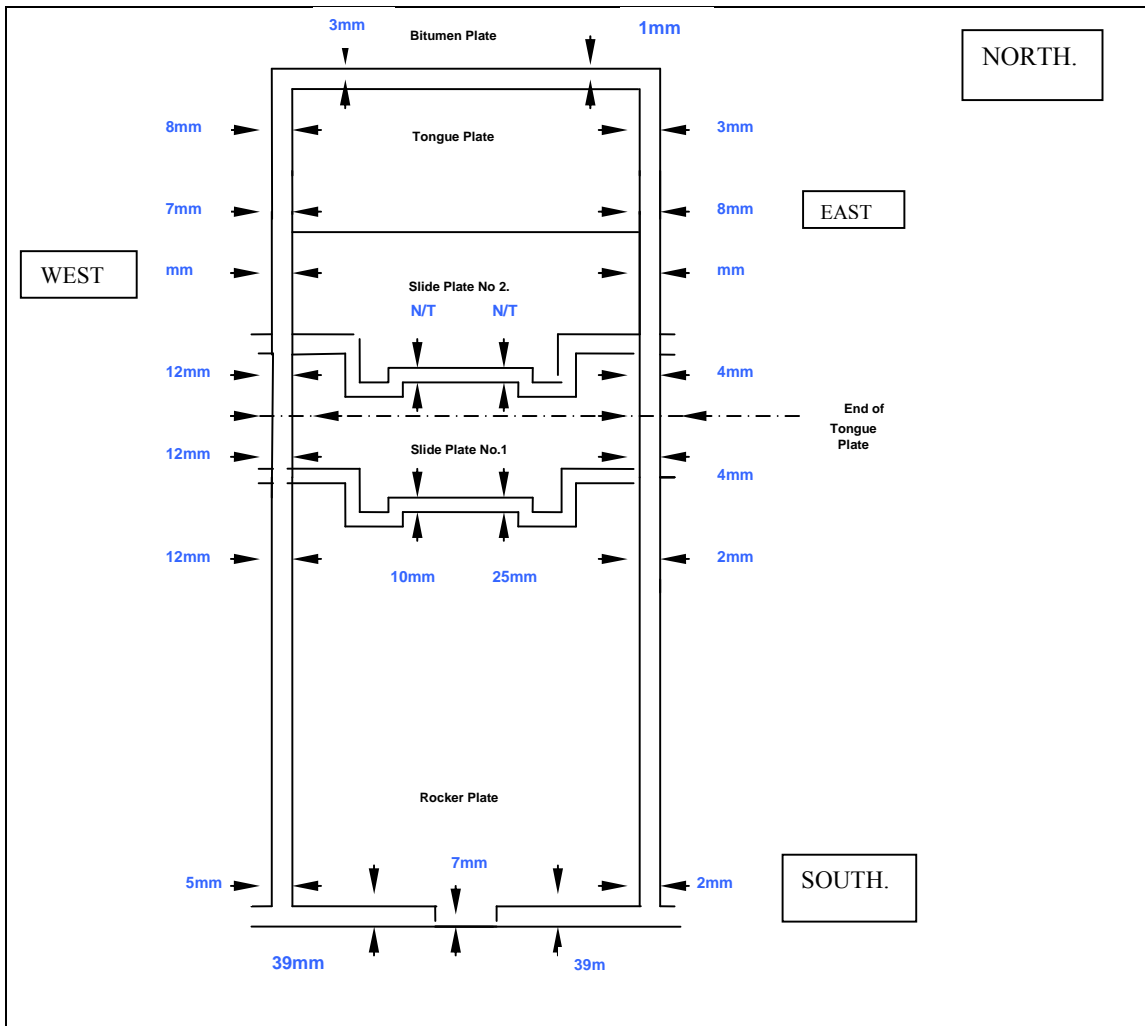
Inspection Record Sheet:-	
Subject :- Demag plate set removal	
Post -removal Dimensional Checks	
Inspected by:	
Date:	08/10/11.

* Bush wall thickness: <u>External only recorded</u> (1) 2-4mm (2) 0-4mm (3) 1-4 mm (4) 2-4 mm	✓	
*Radius girder wear plate thickness:- As per drawing.		✓

* Tongue plate radius length:- As per drawing.		✓
* Tongue plate end thickness:- Worn to nothing	✓	
Remedial & Completion Checks		
Task	Yes	No
* Top side clearance gaps (complete sht 3 of 4)	✓
