INSPECTION DEPARTMENT
DROPPED OBJECT CANOPY INSPECTION.
DATE. 07/11/11.

As requested by management a visual inspection was carried out on the dropped object canopy on the above date. It should be recorded that due to access requirements that certain bolt connections to steel members were not visible from the cycle tracks, this would have required an inspection to be carried out from the carriageway and the use of a manually operated access platform on an additional inspection. It should also be recorded that upper beam connections and relevant fixings were visually inspected by the use of an optical aid to ensure clarity with regards to condition..

The dropped object canopy remains in a satisfactory condition. Below are general observations and comments related to the above .

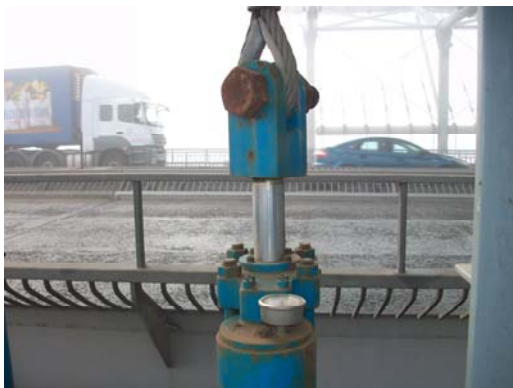
Recommendations state that erection dampener pressures and ram extensions were or should have been 15- 20 bar and 20-30 mm respectively. However there are 12 in No locations on both the main-span and side-span side which exceed the above on the ram extension measurements and all locations exceed the above on dampener pressures. Highlighted below are three locations which are well in excess,

Dampener 16 south, main span side.
40 bar pressure, ram extension 142 mm.

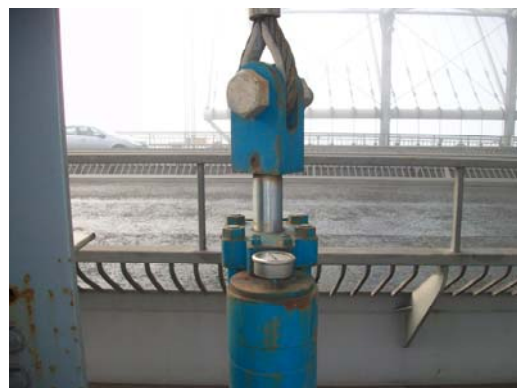
Dampener 15 south, main span side.
30 bar pressure ram extension 110mm

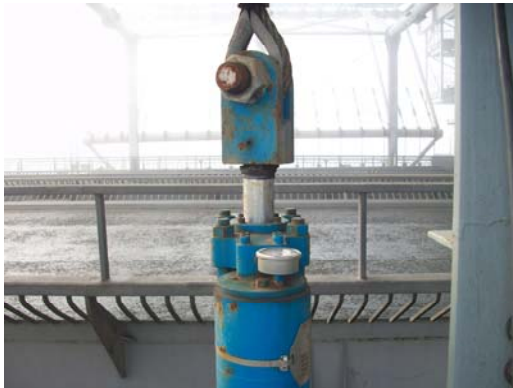
Examples of Excessive
dampener ram extensions.
Main span side.

Dampener 10 south, main span side.
30 bar pressure ram extension 105mm

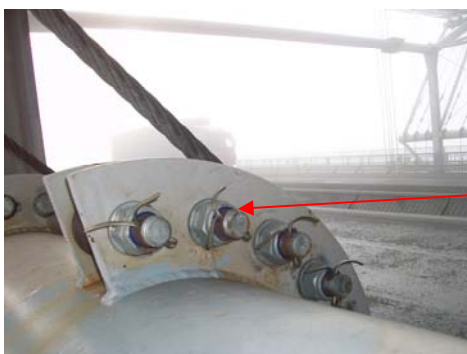
Visually all remain intact secure and in a satisfactory condition. There is as to be expected due to exposure to weather conditions corrosion evident on guide roller wheels evident on inspection..

Photograph showing wire
roller guide connections and
fixings to beams, intact and
secure.

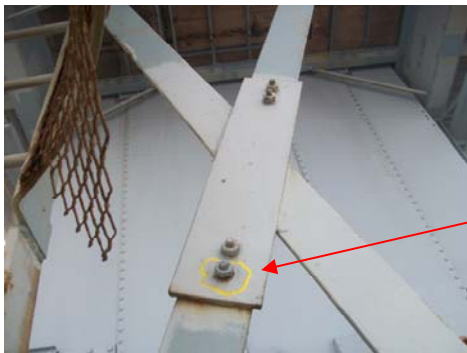
Access stair (West) & emergency stair (East). Both remain in a satisfactory condition , Loose bolts were found at locations as referenced on photographs. It should be stated that both remain intact and secure , reference is made to movement only.

Photograph showing cross bracers on east emergency stair. Small 12mm bolt loose , movement evident, nut intact and secure.

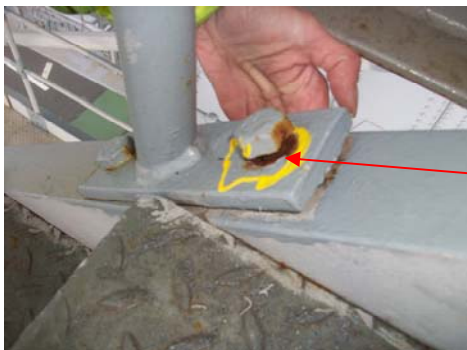
Photograph showing stair handrail to stringer connection on the west access stair , level 3. bolt loose on the west side movement evident. nut intact and secure.

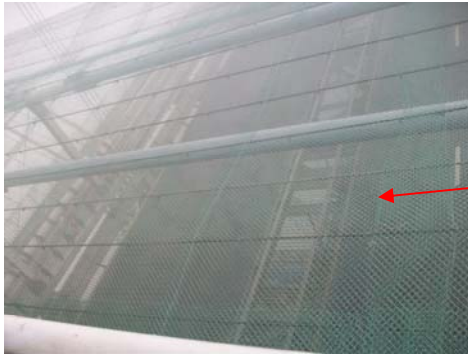
D.O.C. safety netting & outer handrails. : Both remain in a satisfactory condition, on both main-span & side span sides . All associated fixings remain intact and secure, with netting being free from any debris at time of inspection.

Photograph showing D.o.c. netting intact , secure & free from debris.

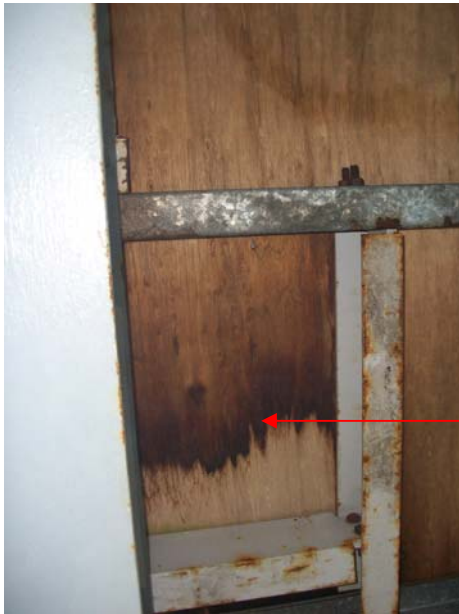
D.O.C. Deck Panels. : All panels remain in a satisfactory condition, with no signs of board distortion / board de-lamination or areas of damage evident on upper painted working area. There are small localized areas of paint breakdown / removal evident throughout . On the underside or soffit panels there is evidence of water staining / discoloration evident. Plywood panels not painted.

Photograph showing discolouration / staining on underside of DOC. Boards
