INSPECTION DEPARTMENT
Main tower to cycle track expansion joints.
DATE. 13/04/11

REPORT No 323.

EXPANSION JOINTS MAIN TOWER TO CYCLE TRACK

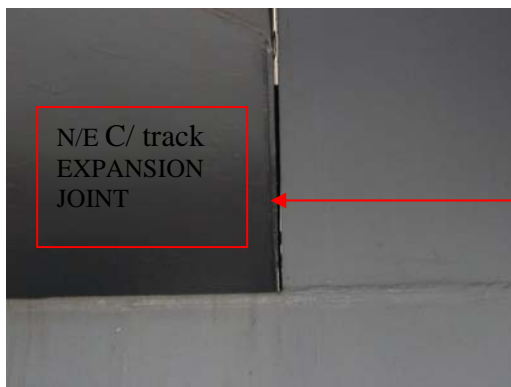
Additional Information .: This supplied information has been investigated before and senior management are aware. Grinding noise apparent on North East (main tower side) at time of inspection. (please refer to attached sheet with photographs showing comparison gaps between N/E & SW.

Grinding noise being generated by tower movement at time of inspection. Metal to metal.

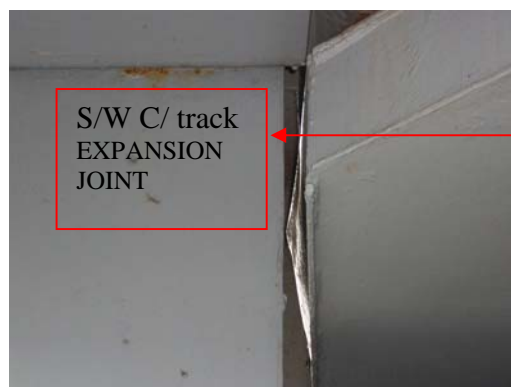
Gap differences between north east main tower and the south west main tower – main-span sides . Noise being generated by movement on the north east main tower side.
