**PROJECT:** Forth Bridge Bearing Replacement Feasibility

**Report Title:** Preliminary Feasibility Report

# **FORTH BRIDGE BEARING REPLACEMENT FEASIBILITY**

## **PRELIMINARY FEASIBILITY REPORT**

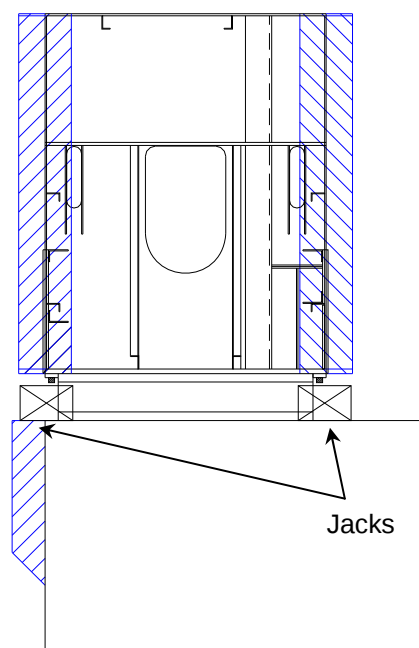
Figure 1: Option 1 - Section through box girder and pier. Additions are marked in blue.

The assessment of the web capacity for the jacking loads indicated that the webs would not have sufficient capacity to resist the direct patch loading on the webs and would require internal and external strengthening. This option would also require construction of corbels on the east/west sides of the piers affecting the appearance of the structure. Figure 1 shows the additional areas requiring strengthening for this option. However, it is possible to design the stiffener in such a way that it could fit in behind the existing services, though access to tighten the bolts used in the assembly might be difficult.

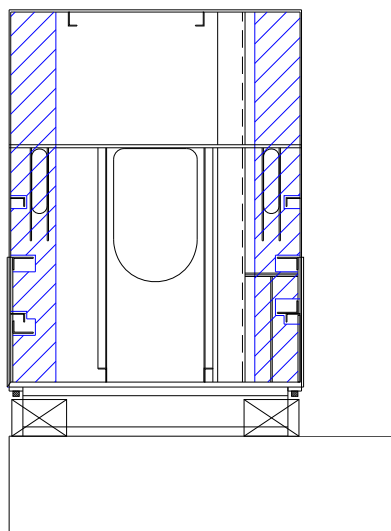
Figure 2: Option 2 - Section through box girder and pier. Additions are marked in blue.

The second option consists of positioning the jacks under the box on the existing bearing shelf or on corbels added to the front and back of the pier. This requires the box bearing stiffeners to be constructed above the jacking position inside of the box. The stiffener has been designed to consist of small component parts as the ease their transportation and installation into the box girder. The stiffener is designed to allow cut-outs around the existing longitudinal stiffeners, and therefore does not affect the steel currently in the box.

The pier may require corbels to be built on the north and south faces of the pier to allow for the positioning of the jacks. This will depend on the location of the current steelwork in the box girders and the locations of the bearings on the piers.

Current deck services interfere with this option and would require re-routing. We understand that this would present considerable physical and administrative difficulties. This is further discussed in section 4.4.

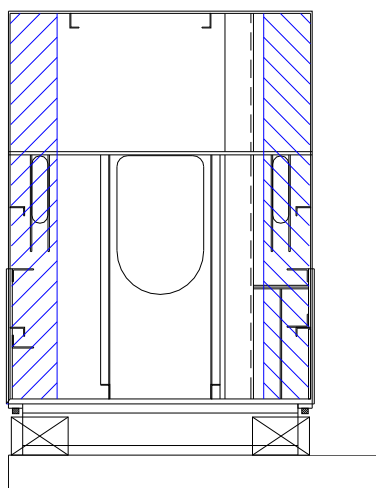
Figure 3: Option 3 - Section through box girder and pier. Additions are marked in blue.

This option is similar to option 2, except that cut-outs for the existing longitudinal stiffeners have not been included. Smaller bearing stiffeners are therefore required, which would mean that less steel would have to be assembled inside the box. The disadvantage is that the loading on the structure would have to be restricted during the installation of the stiffeners as the longitudinal stiffeners would be discontinuous during the construction phase.

Current deck services interfere with this option and would require re-routing. We understand that this would present considerable physical and administrative difficulties. This is further discussed in section 4.4.

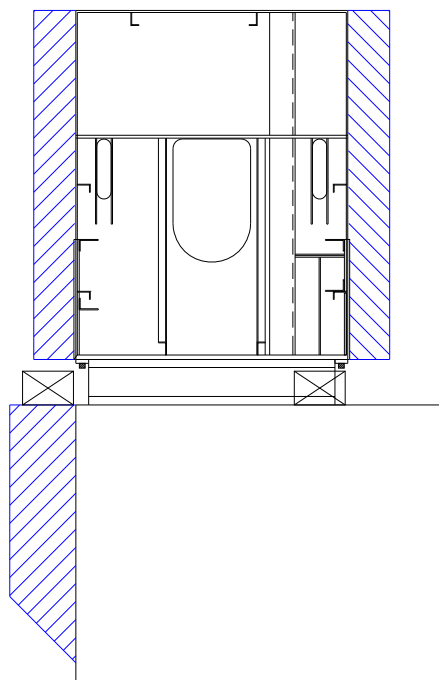
Figure 4: Option 4 - Section through box girder and pier. Additions are marked in blue.

For option 4, the stiffeners are placed on the outside of the box. This would minimise the amount of work required inside the box, and would mean that the stiffener could be assembled in one piece off site. This option would mean that an additional concrete corbel would be required at the edge of the pier. As the bearing stiffeners are only required during the replacement of the bearings, it would be possible to

remove the steel stiffener section after the replacement of the bearings. This would leave holes in the web which would have to be filled after the removal of the steelwork. The concrete corbels would remain in place and would therefore become a permanent part of the structure. As this would affect the permanent appearance of the structure, this would likely involve planning approval being required from Historic Scotland. An additional concern is that the external drainage hole in the pier will clash with the external bearing stiffener steel, and would therefore require that the drainage channel is moved. The only realistic possibility would be to move the pipe to the outside of the pier which may be visually unacceptable.

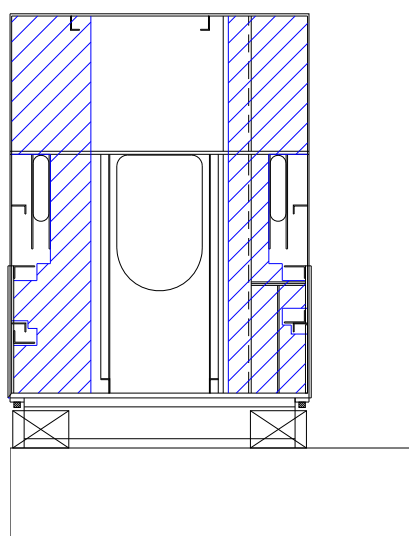
Figure 5: Option 5 - Section through box girder and pier. Additions are marked in blue.

Similar to option 3, this option involves the stiffener being assembled on the inside of the box. Allowances have been made for cut-outs for all the longitudinal stiffeners and the services ducts. Therefore, this option leads to the widest stiffener considered so far, with each stiffener section measuring 550mm wide.

Having received the information for the installation of the dehumidification system, option 5 also now becomes unworkable as it clashes with the location of the new cabling required in the boxes. This cabling cannot apparently be relocated at this stage.

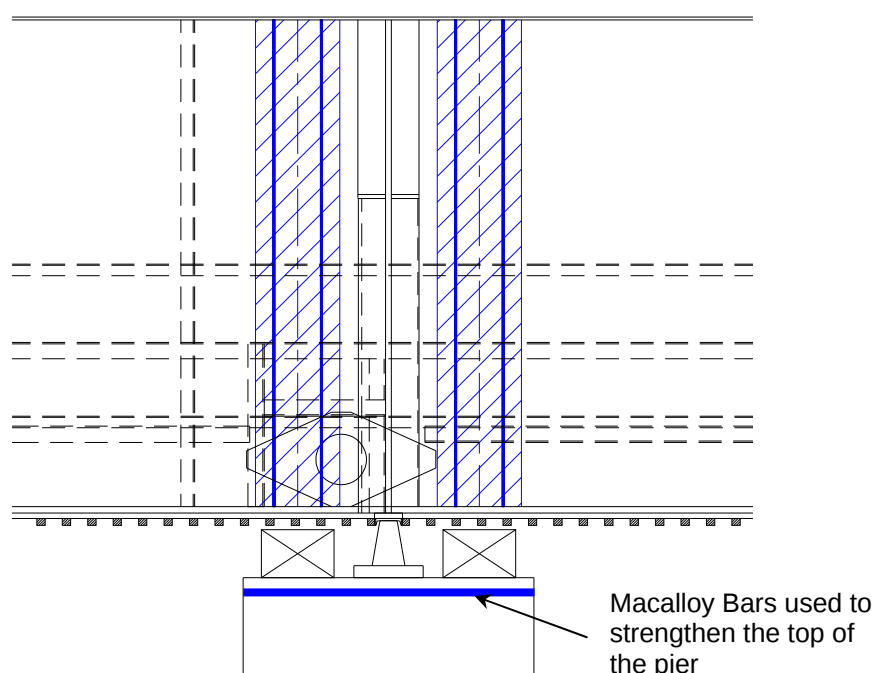
Figure 6 :Elevation through box, Pier strengthening without corbels.  
Additions are marked in blue.

Where bearings require replacement, jacks will be required at the edges of the piers. The concrete stresses can be controlled to within  $0.4f_{cu}$ , and therefore additional reinforcement is not required to resist bursting forces immediately under the jacks.

Using a strut and tie model, the top of each pier was analysed to assess the capacity of the top steel under jacking loads. It was found that the reinforcement was inadequate to restrain the forces in the concrete due to the jacks; also there was inadequate reinforcement to resist edge sliding as set out in Annex J of EN 1992-2:2005. Therefore, where bearings are replaced, strengthening of the pier will be required making allowance for any delamination found in the inspection and investigation of the structure. Figure 6 show the strengthening and bearing stiffener locations at the pier.

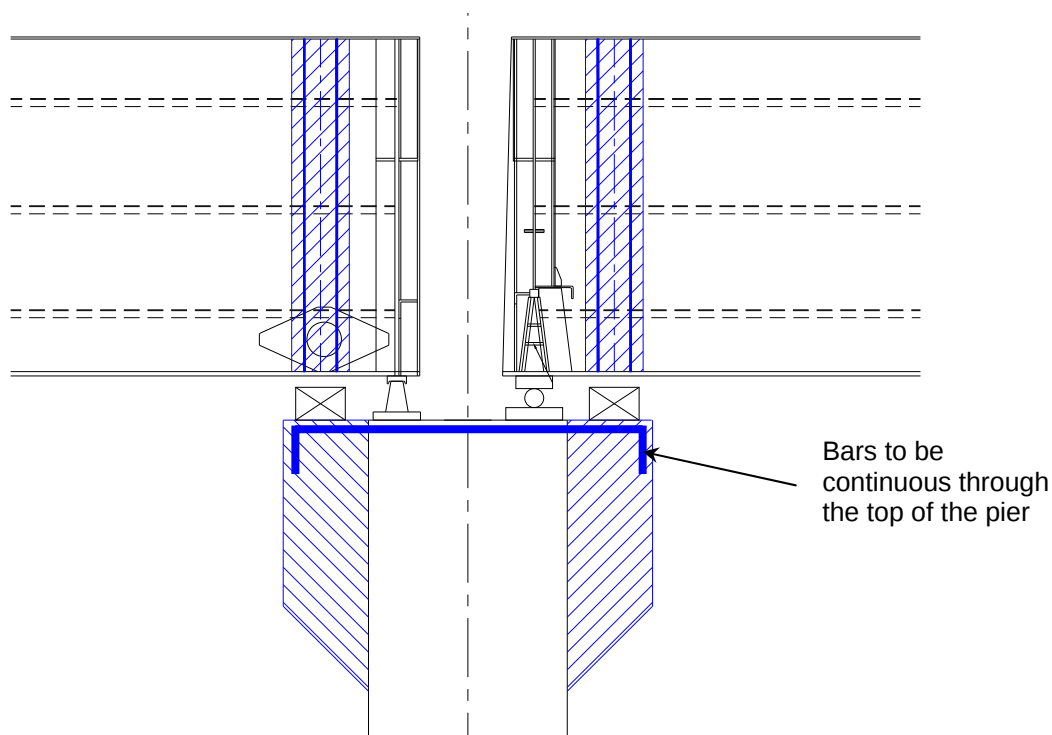
Figure 7: Elevation through box, Pier strengthening with corbels.  
Additions are marked in blue.

Where corbels are required due to space restrictions at the top of the pier (Pier S3) this will affect the current appearance of the pier, and further consideration will be required for the aesthetics of the structure. This option will also require that the bars are inserted through the top of the pier to provide continuity into the corbel and additional capacity in the top of the pier. A preliminary design was done for the corbel design, where a minimum corbel depth of 1.5m was established.

As corbels will be required for the shared pier, it may not be visually acceptable to modify only one pier. Therefore corbelling may be required on all piers. Appendix C provides some VR images of the corbels which should be discussed with Historic Scotland.

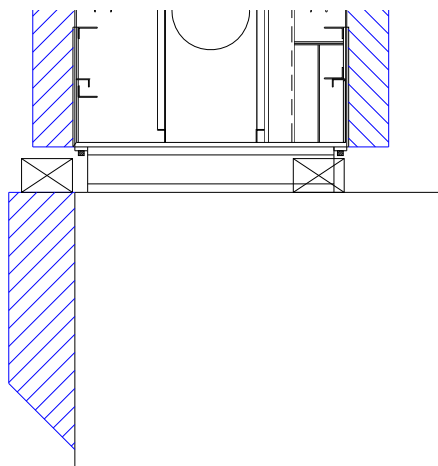
Figure 8: Elevation through box, Pier strengthening with side corbels.  
Additions are marked in blue.

Pier option 3 (Figure 8) involves the addition of corbels to the sides of the pier to accommodate a jacking point either directly underneath the web or just outside the web. The main consideration of this option is the visual effect of the corbels on the piers.

An additional advantage of this option will be to prevent the spalling which currently occurs on the outside face of the piers below the bearings. This spalling is likely to be due to the bearing being located near the edge of the pier. This option would increase the width of the pier and therefore reduce the risk of future concrete spalling after concrete repair.

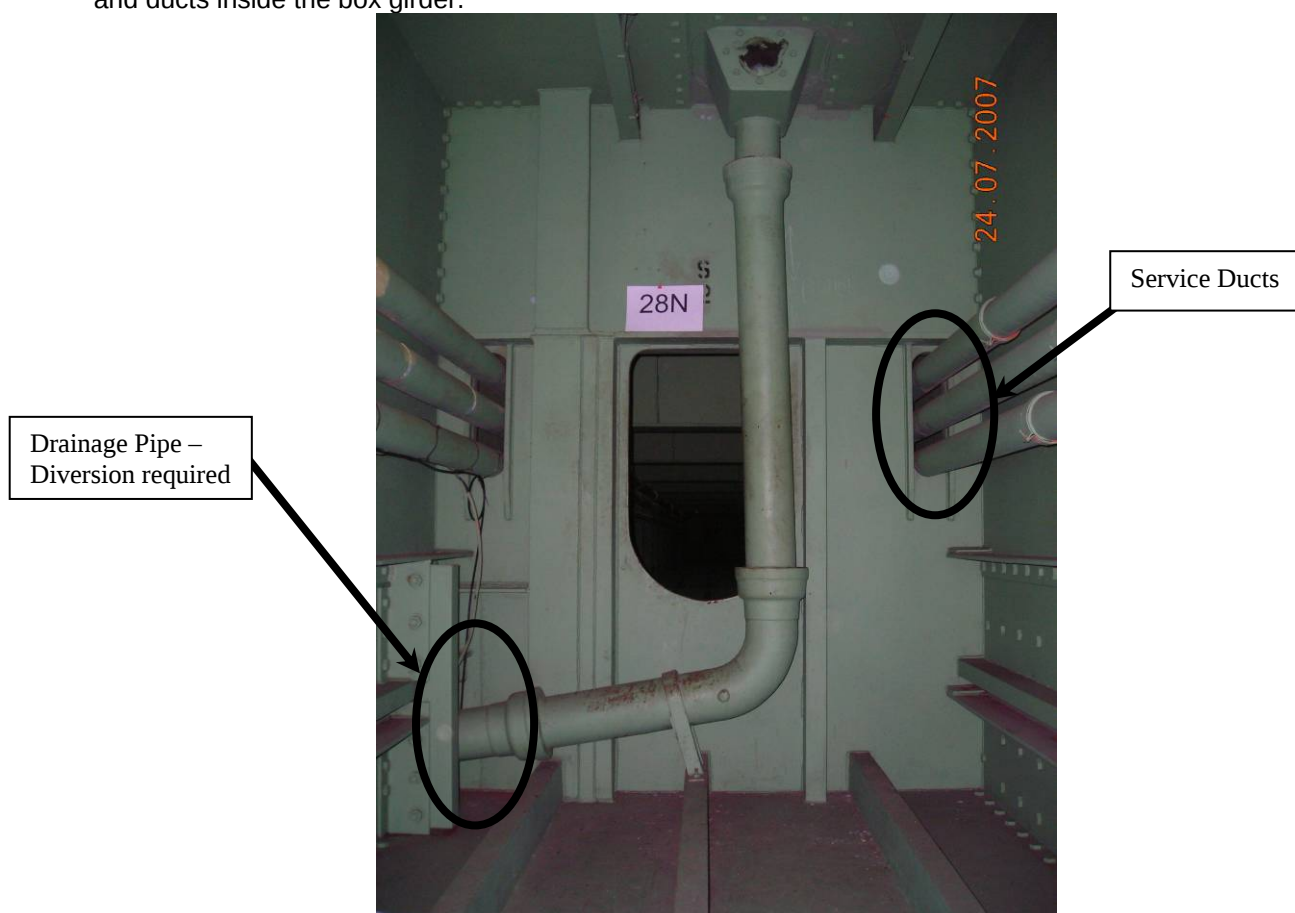
Figure 9: Typical Box Girder Diaphragm

All options include the construction of internal jacking stiffeners which will clash with the internal pipes and ducts inside the box girder.
