| INSPECTION DEPARTMENT |
|---|
| Main tower expansion joint ( North ) only. Inspection report No 318. |
| DATE. 09/02/11 |

MAIN TOWER EXPANSION JOINTS ( North only )

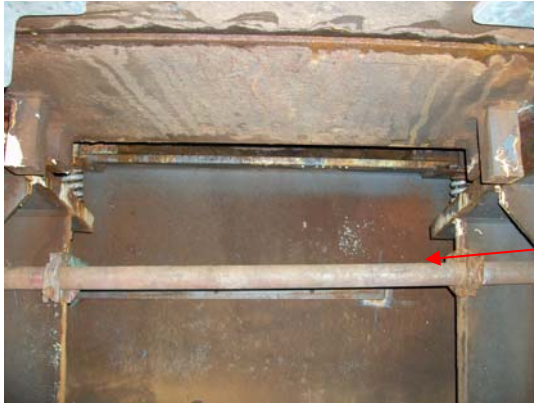
Bracer scaffold tube & fixings remain located between cell radius arms in every cell located on main-span & side-span. require to be removed.

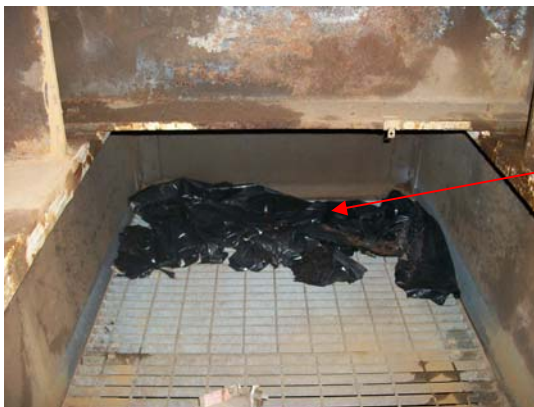
Rubbish & plastic bags located in cells, require to be cleaned out

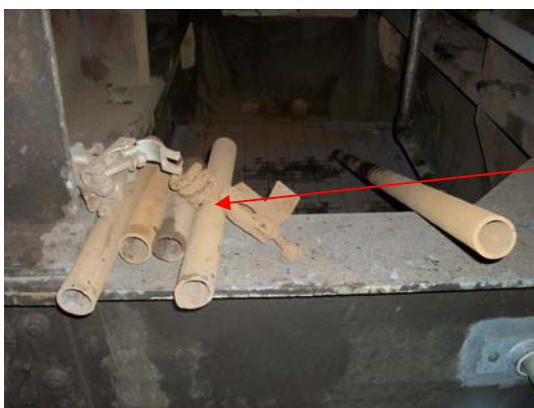
Tube & fitting off- cuts & fixings located on cell ledges , require to be removed.

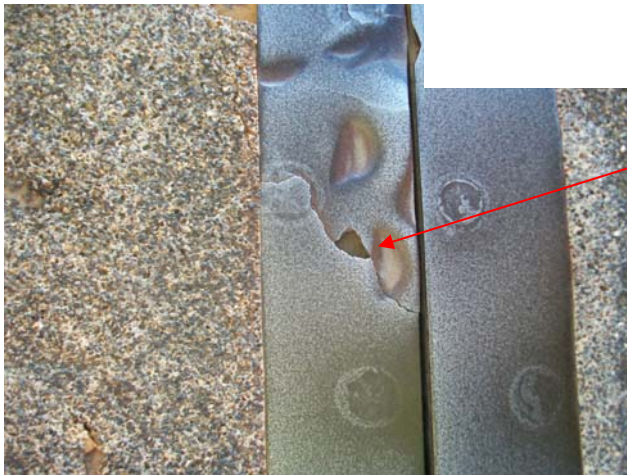
**Surface plates. :** Surface plate located above cell ME2. Perimeter steel plate suffering from wear-down. During inspection slight noise of possible damage indicated. On inspection from above suspicions confirmed. Transverse weld crack located East to West approx 80 mm on east side. ( Photographs recorded and given to maint inspector for repair to be carried out on next southbound closure. )

Surface plate located on main-span east. Damage and wear – down evident, Transverse weld crack approx 80- 100 mm .Requires to be repaired.

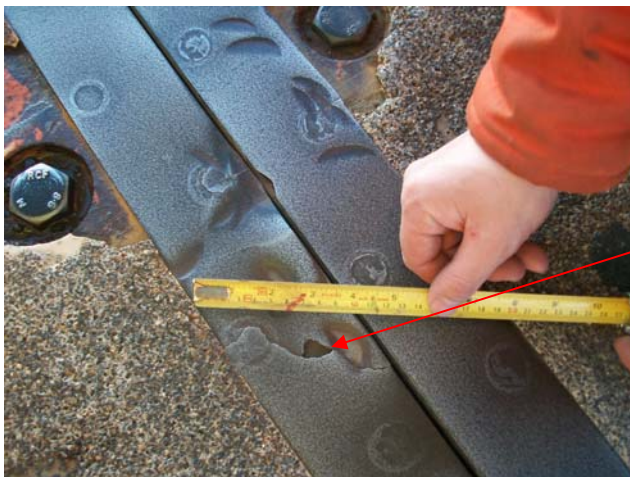
Surface plate located on main-span east. Damage and wear – down evident.
