## GENERAL INSPECTION REPORT

REPORT No. 277

DATE: 27/10/2009 TO 04/11/2009

VIADUCT EXTERNAL (NORTH)

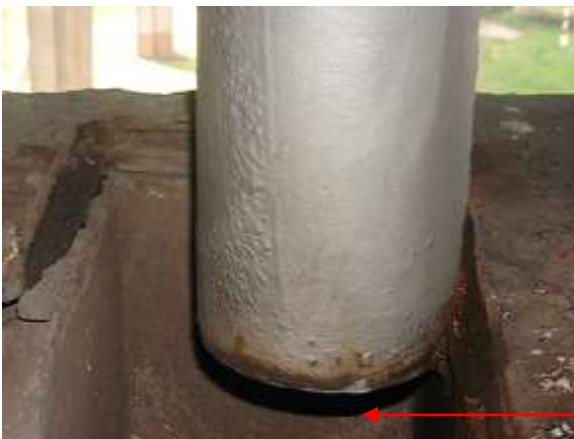
**Pier top drains covers & frames.** : All drain covers & frames both east & west are either missing, suffering from deterioration, heavy corrosion. & frame displacement, all require to be replaced.

Drain cover missing on pier  
top drain.

Will drain covers on pier tops be replaced as part of capital works to replace North viaduct bearings.

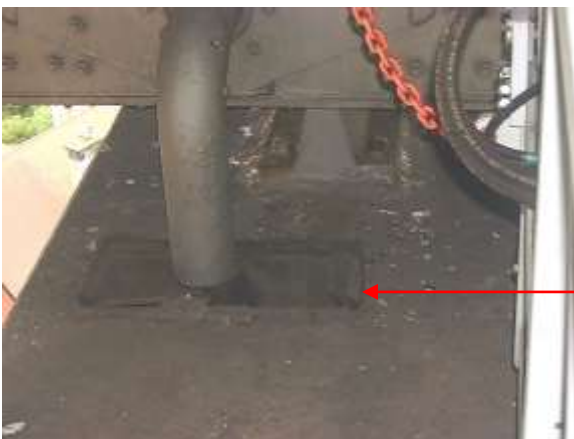
Drain cover framework  
missing/distorted /heavily corroded  
on pier top.

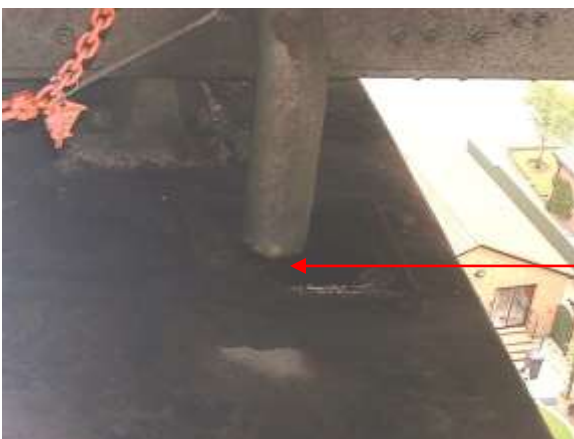
Drain cover  
heavily  
corroded on  
pier top

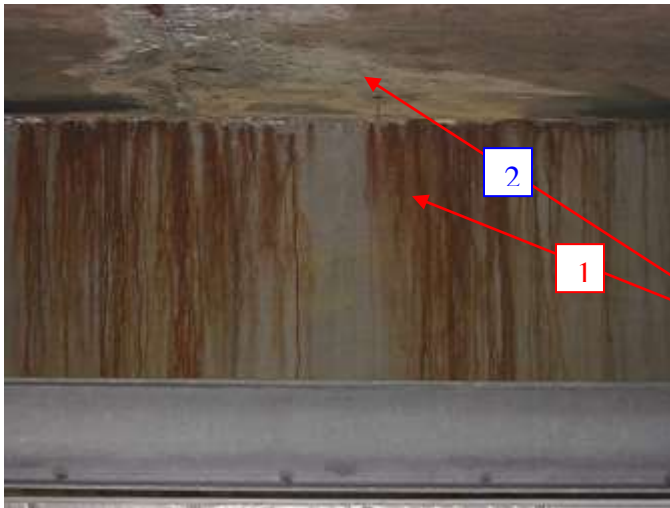
**Box girders. E&W** : Deterioration continues. There are several areas throughout the box girders more specifically the East outer face where corrosion /heavy staining/discoloration are more prominent this inspection. At these areas generally there are water marks and damp patches evident on the deck soffit.. Transverse Past repairs have been carried out on the transverse joints on the cycle track surfacing. Could it be that now they are losing their adhesion to the original surface below and allowing the passage of water into the concrete deck below.

**1** denotes Areas of heavy discoloration / staining evident throughout the North east box girder outer ( East face. )

**2** denotes Areas of water marks /damp areas evident at time of inspection.

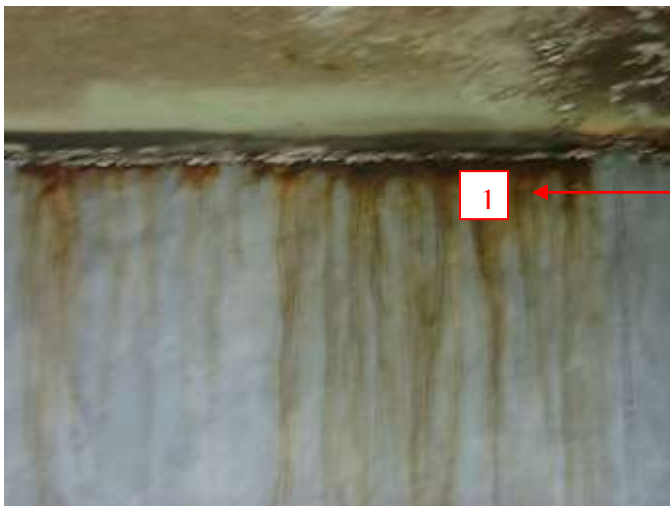
Water stain / damp marks evident on the soffit of the east cycle track concrete would suggest that water is being directed by the camber on the surfacing being projected downwards and inwards, bearing in mind that transverse repairs to cycle track joints have been carried out in the past. Could it be that some of these repairs have lost their adhesion to the existing original material below allowing the passage of water through to the soffit of the concrete and on to the face of the box girder causing the heavy staining and discolouration as shown on the photographs.

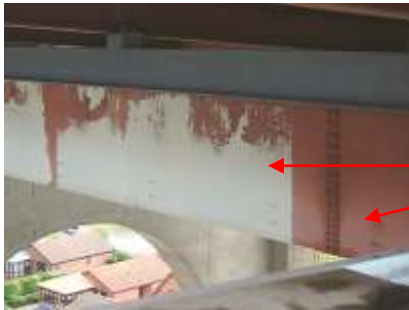
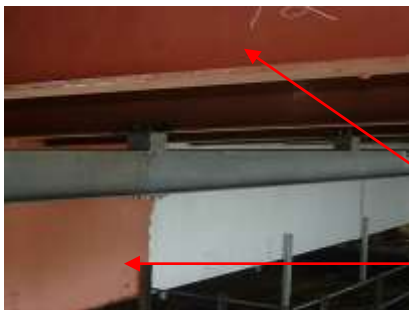
**Outriggers & Beams.** : Deterioration continues. Edge breakdown & paint breakdown remains apparent on both outriggers & beams. Medium to heavy corrosion evident throughout.

Areas of paint breakdown /  
unpainted box girder & outrigger  
beams.

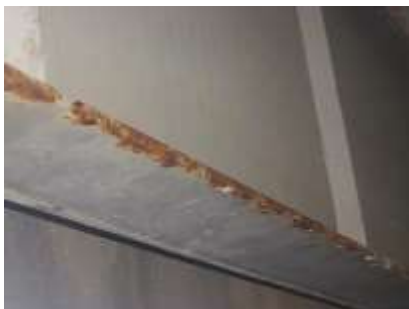
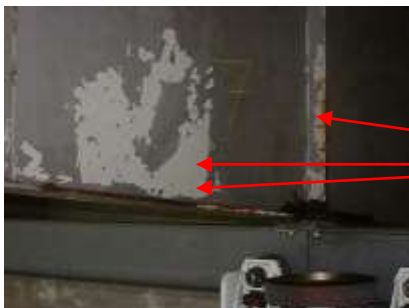
Areas of paint breakdown &  
corrosion evident on outrigger  
& crossbeam edges. & box  
girder face.
