INSPECTION DEPARTMENT
Viaduct externals. N & S. General report No 311.
DATE. 23/11/10.

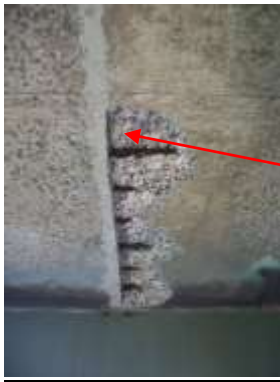
Viaduct concrete soffits. : No inspection of the South cycle track or carriageway deck soffits carried out. The North West cycle track soffits remain as previous inspections . Spalled areas identified to be removed by FRB employees through an ongoing programme of works. On the North East cycle track soffits previous recorded areas of spalling were removed by Bridge inspectors. These areas require to be made good to protect exposed corroding reinforcement bars from further deterioration.

Photographic example of repairs required to be carried out on the North East viaduct cycle track soffit.

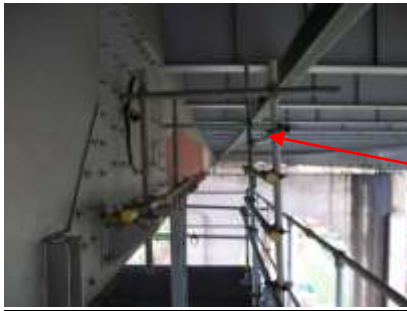
Box girder access hatches. : Box girder access side access hatches located on both North & South box girders still have temporary tube & fitting access entry protection in place. This requires to be removed and a permanent installation erected. New handrail system been fitted on both North & South permanent staging platforms on the inner of both East & West sides.

Temporary tube & fitting remains in place at box girder access hatches both North & South.

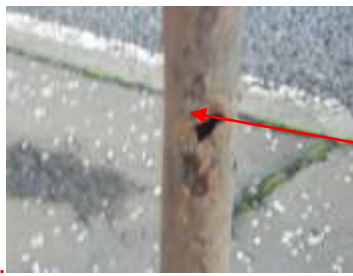
Abutment Barrier/Handrail (west side):

It has been noted since as far back as December 2004 that the barrier/handrail is severely corroded, and many of the posts are holed. In February 2009 an individual report was submitted for ESM to review with regard to this matter, but no progress has been made to date.

Photographic example of deterioration of handrails at the North West abutment.

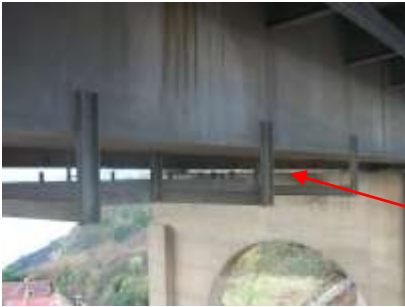
Redundant platform steelwork. Located at box girder sections 44 & 44x there are two redundant platforms formerly used for access to box girder internals via the viaduct central reserve access /egress hatch to the viaduct gantries when positioned at this location. . It should be recorded that these platforms are no longer required and that they have been **disfigured** during the installation of the new viaduct gantry units and runway beams **and no longer comply with current legislation. Access via the central reservation is at time of inspection secured by padlock. No access to this hatch is permitted by any FETA personnel or by contractors employed by the Forth estuary transport authority.**

View of Redundant platforms
located both East& West sides of
boxes 44 & 44x.
