INSPECTION DEPARTMENT
Main tower expansion joint ( North ) only. Inspection report No 318.
DATE. 09/02/11

REPORT No 318.

MAIN TOWER EXPANSION JOINTS ( North only )

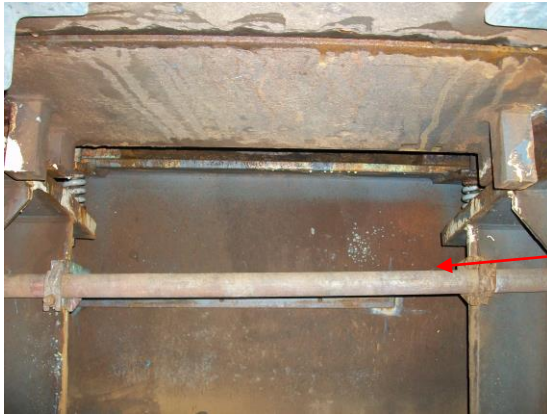
Bracer scaffold tube & fixings remain located between cell radius arms in every cell located on main-span & side-span. require to be removed.

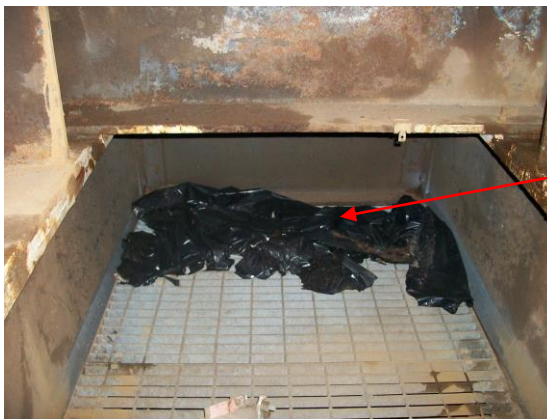
Rubbish & plastic bags located in cells, require to be cleaned out

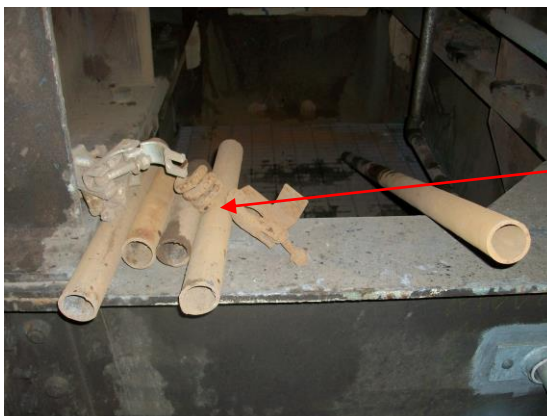
Tube & fitting off- cuts & fixings located on cell ledges , require to be removed.

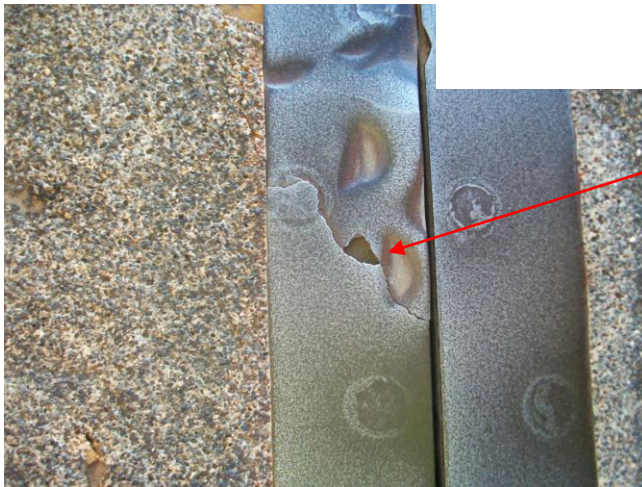
**Surface plates. :** Surface plate located above cell ME2. Perimeter steel plate suffering from wear-down. During inspection slight noise of possible damage indicated. On inspection from above suspicions confirmed. Transverse weld crack located East to West approx 80 mm on east side. ( Photographs recorded and given to maint inspector for repair to be carried out on next southbound closure. )

Surface plate located on main-span east. Damage and wear – down evident, Transverse weld crack approx 80- 100 mm .Requires to be repaired.

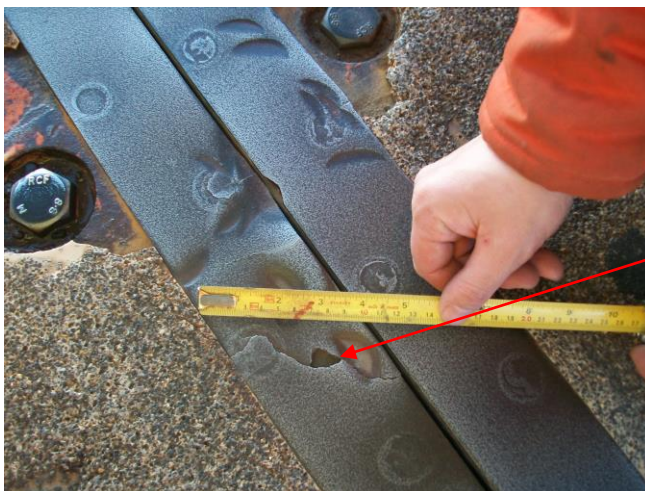
Surface plate located on main-span east. Damage and wear – down evident.
