INSPECTION DEPARTMENT
Main cable inspection.
DATE. 21 st – 30 th October.2013.

Following the completion of the cable band bolt replacement contract in September 2013, an inspection of the main cable was carried out by bridge inspectors. Inclement weather conditions delayed inspection time. General findings were as follows. :

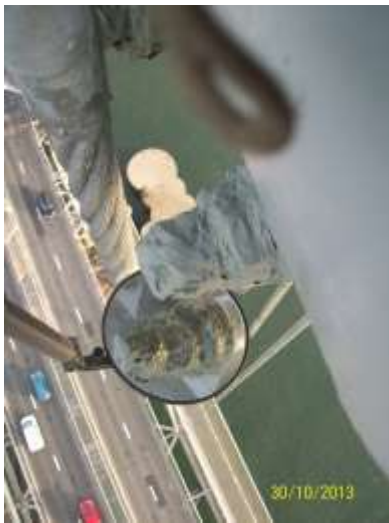
Cable bands bolts. : As introduction, all cable band bolts & nuts were replaced during 2012 & 2013 by contractors C. Spencer Ltd. No evidence or reason to find any defects this inspection. New paint protective coating applied to nut faces during bolt replacement contract on certain bolts throughout the structure will make it difficult to detect any defects.

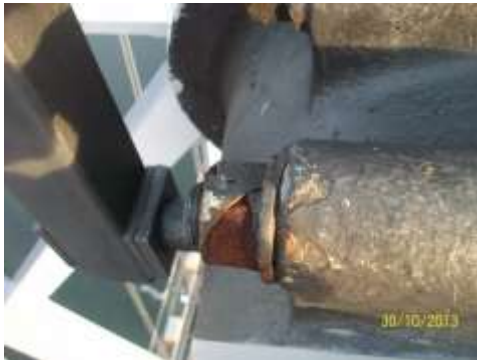
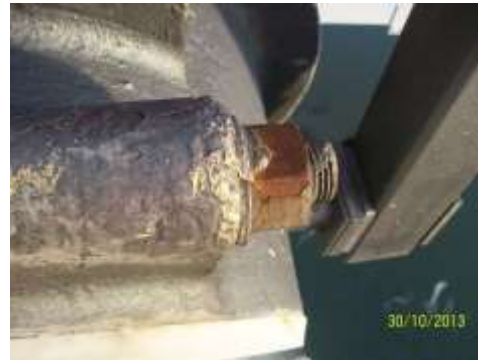
Main/ Side tower sleeves. : . All sleeves remain in a satisfactory condition. Cable bands immediately below all main tower sleeves, bolts have slight to medium corrosion evident , protective paint covering broken down.

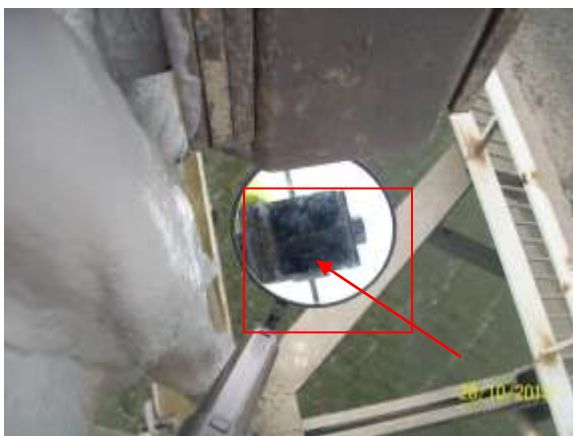
Handstrand stanchions. : All hand-strands & bolt fixings throughout the main cable remain in a satisfactory condition. At PP 92 on the south east main span & north east main span the internal locking nuts on the east & west face in the underside of the hand-strand stanchion (which is box section) are not on the threaded bolt. (could this been when handstrand stanchions were removed to allow main cable gantry access and not been put back in place) . Outer nuts remain in place and secure.

Locking nut position for
hand-strand internal face
