INSPECTION DEPARTMENT
Main tower inspection.
DATE. 18/12/2013.

(E2.1 Bridge)
Report No 413.
Main Towers north & south.

Date: 02.09.13 to 20.11.13

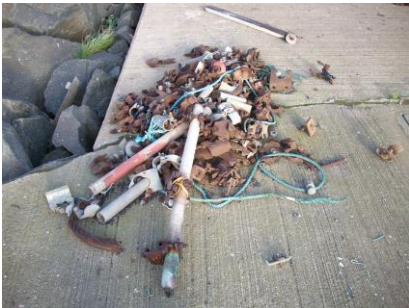
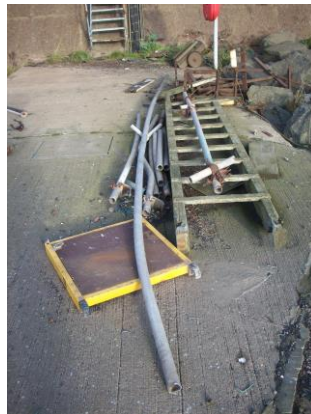
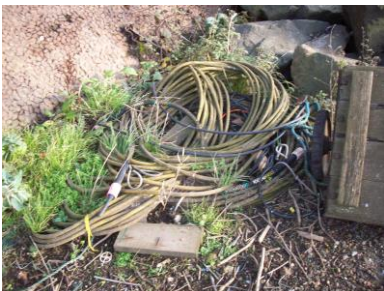
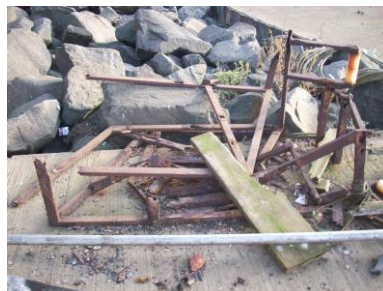
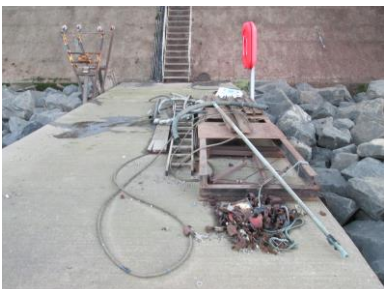
Housekeeping Pier defences .: Both the main tower Pier defences north & south remains a graveyard for contractors materials . FRB. have inherited a variety of materials & scrap left by contractors who have carried out contracts for the organization in the past. Discussions have taken place with the maintenance manager with regards to the removal of the above, and it is expected a program of works to remove and clean up the pier defences will take place in 2014. Further discussions to take place.

Photographs showing excess materials from previous works carried out on the North & South pier defences, and areas above on the suspended structure which have not been removed following completion of works.

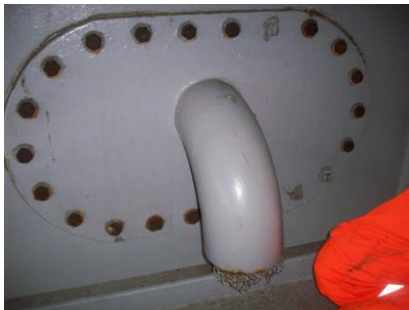
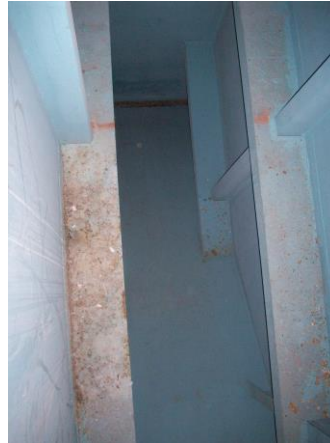
Main tower cycle track brackets N & S. All main-span & side-span access hatches located on the respective faces for entry were removed and all were visually inspected. Evidence of slight corrosion and discoloration present at the bracket base. internal paintwork remains in good condition. Information recorded last inspection stated that some water was present at time of that inspection. The possible reason for this was that previous to the inspection being carried out the hatches had been left off and the internals exposed . New gaskets were fitted & hatch covers replaced. This inspection hatch covers were refitted by bridge inspectors and at the request of the maintenance manager, the perimeter of the hatches were re-sealed with a non hardening compound to prevent the possibility of possible water ingress.

Photographs showing general condition of North main tower internals of the main tower cycle track brackets.

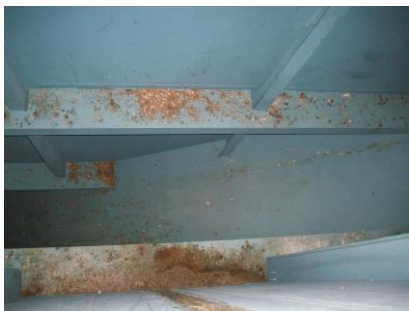
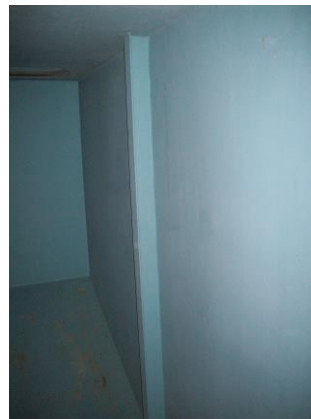
Photographs showing general condition of South main tower internals of the main tower cycle track brackets.

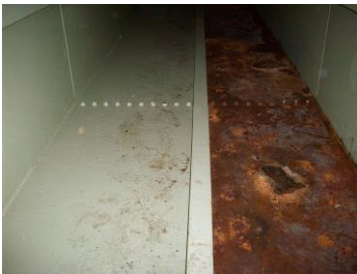
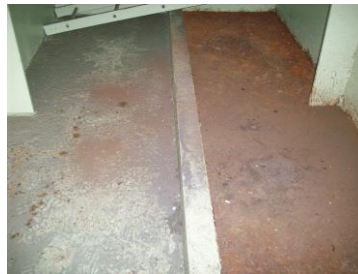
Main tower expansion joints crossover internals . : Information recorded last inspection stated that a relevant amount of water was present on the floor with road surface debris and corrosion of the floor panels evident at time of that inspection. The possible reason for this was that previous to the inspection being carried out the hatches had been left off and the internals exposed . On instruction new gaskets were fitted & hatch covers replaced. It was recorded that following the inspection dewatering was required and that a program of works would be implemented to remove corrosion on the floor panels and the full box girder re-painted , this action was never carried out. This inspection showed no water evident. Heavy corrosion / discoloration remains on certain floor panels throughout the girder internal.

Photographs showing general condition of North main tower expansion joint internals.

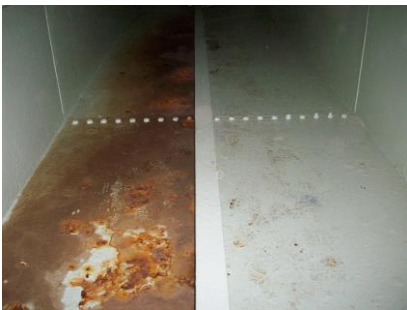
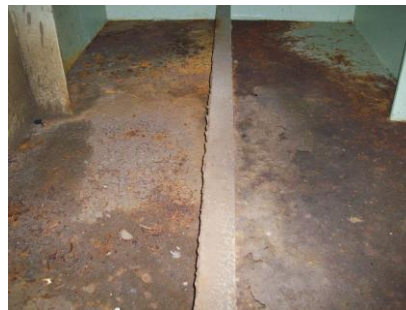
Photographs showing general condition of South main tower expansion joint internals.

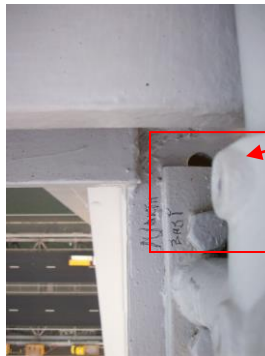
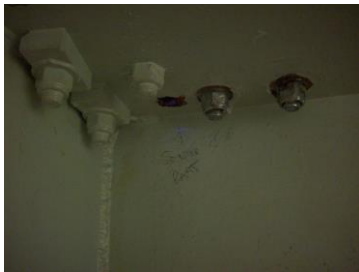
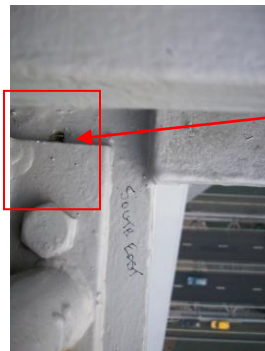
Photographs showing North main tower top crossover internal / external areas of water ingress. Bolts missing. Protective handrail fixing brackets.

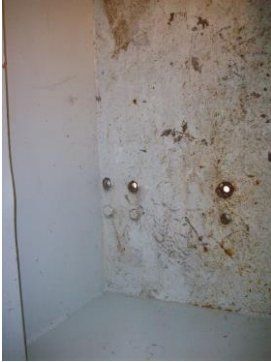
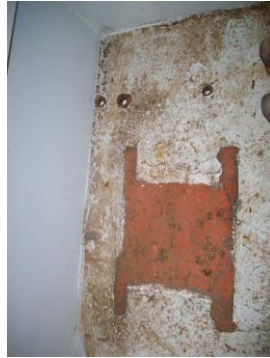
Photographs showing bolt holes & unpainted floor surface areas in North main tower top crossover internal

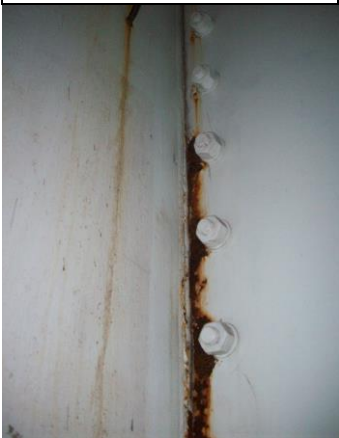
Main tower north (west leg) in "E" cell
South west corner.

Corrosion. : Tower internal bases .: There are two areas located in the North main tower where staining runs from approximately 5 metres above this area in the line of bolts where medium to heavy corrosion is evident on the corner faces of the steel , this is also evident on the base floor-plate and fixings. These are located in the west leg “ Cell “ E” base (base dry) & the east leg Cell “ D” base (base dry). Please refer to relevant Photographs & structure numbers for information.

Photographs showing corrosion / staining in areas below.

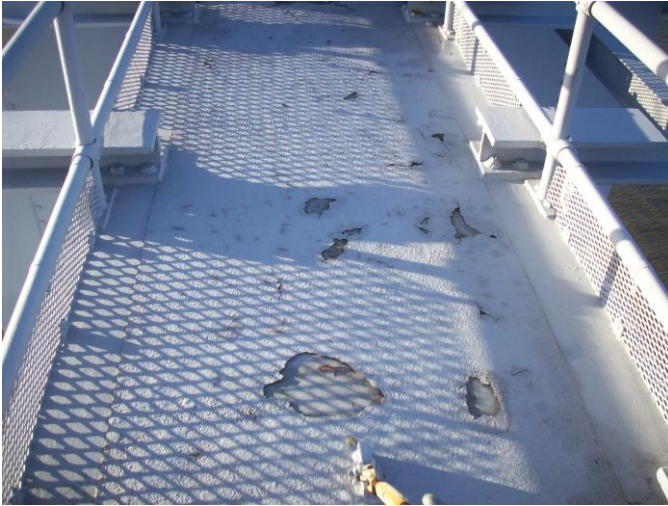
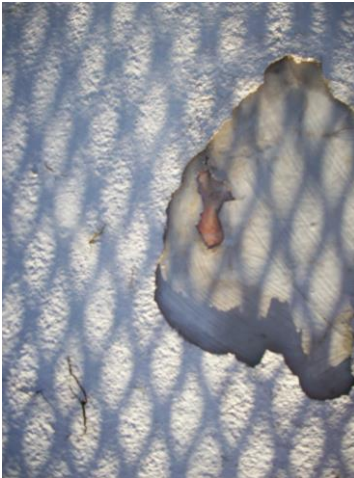
Paintwork. : . Externals as main tower introduction, however there is an area of paintwork on the south main tower external crossover at the tower top on the west side where the painted surface has broken down over an area of approximately 8 to 10 meters square. This area requires to be removed as surface corrosion is evident on floor panels where breakdown. Internals generally remain in a satisfactory condition . On the south main tower top crossover internal however there are areas where bolts have been removed/drilled and the surrounding perimeter paintwork has been removed and corrosion is evident at these locations. As recorded defects last inspection stating corrosion and water was evident in shelves located at "C" level in certain cells , this inspection no water evident at time of inspection, corrosion/ discoloration remains. Please refer to relevant Photographs & structure numbers Please refer to relevant Photographs & structure numbers .

View of defective area of paintwork on the South main tower top crossover external.
