INSPECTION DEPARTMENT
Main tower inspection.
DATE. 18/12/2013.

(E2.1 Bridge)
Report No 413.
Main Towers north & south.

Date: 02.09.13 to 20.11.13

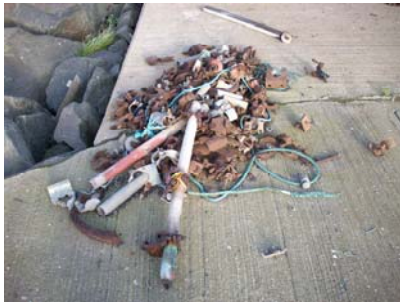
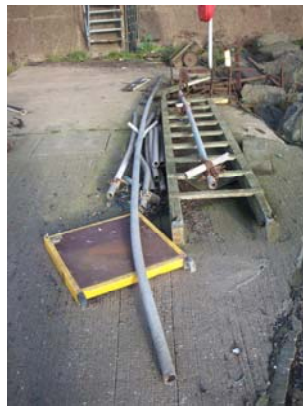
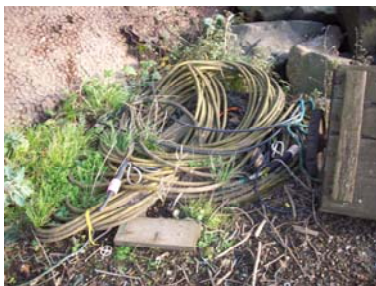
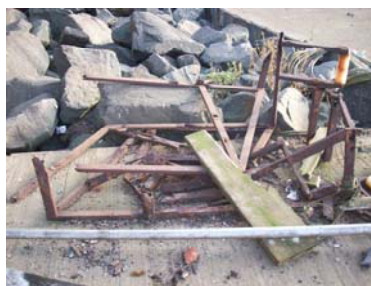
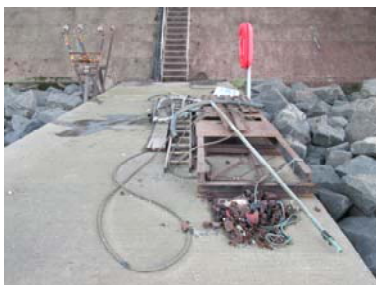
Housekeeping Pier defences .: Both the main tower Pier defences north & south remains a graveyard for contractors materials . FRB. have inherited a variety of materials & scrap left by contractors who have carried out contracts for the organization in the past. Discussions have taken place with the maintenance manager with regards to the removal of the above, and it is expected a program of works to remove and clean up the pier defences will take place in 2014. Further discussions to take place.

Photographs showing excess materials from previous works carried out on the North & South pier defences, and areas above on the suspended structure which have not been removed following completion of works.

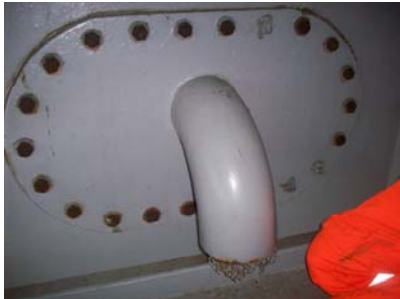
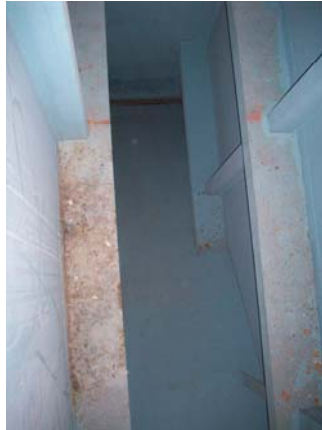
Main tower cycle track brackets N & S. All main-span & side-span access hatches located on the respective faces for entry were removed and all were visually inspected. Evidence of slight corrosion and discoloration present at the bracket base. internal paintwork remains in good condition. Information recorded last inspection stated that some water was present at time of that inspection. The possible reason for this was that previous to the inspection being carried out the hatches had been left off and the internals exposed . New gaskets were fitted & hatch covers replaced.

Photographs showing general condition of North main tower internals of the main tower cycle track brackets.

This inspection hatch covers were refitted by bridge inspectors and at the request of the maintenance manager, the perimeter of the hatches were re-sealed with a non hardening compound to prevent the possibility of possible water ingress.

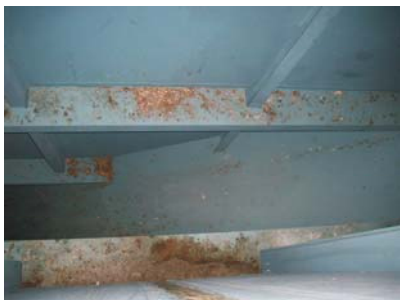
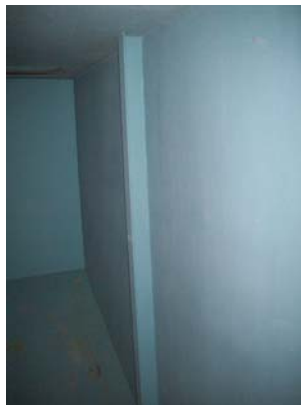
Photographs showing general condition of South main tower internals of the main tower cycle track brackets.

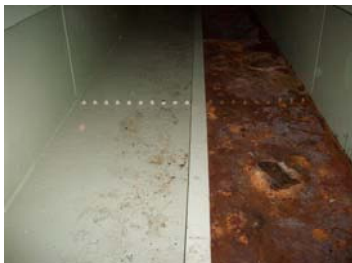
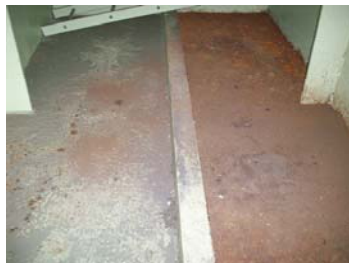
Main tower expansion joints crossover internals . : Information recorded last inspection stated that a relevant amount of water was present on the floor with road surface debris and corrosion of the floor panels evident at time of that inspection. The possible reason for this was that previous to the inspection being carried out the hatches had been left off and the internals exposed . On instruction new gaskets were fitted & hatch covers replaced. It was recorded that following the inspection dewatering was required and that a program of works would be implemented to remove corrosion on the floor panels and the full box girder re-painted , this action was never carried out. This inspection showed no water evident. Heavy corrosion / discoloration remains on certain floor panels throughout the girder internal.

Photographs showing general condition of North main tower expansion joint internals.

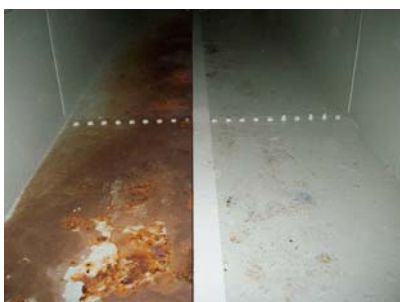
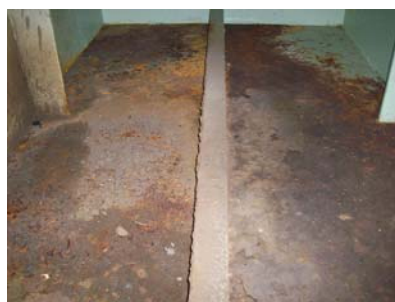
Photographs showing general condition of South main tower expansion joint internals.

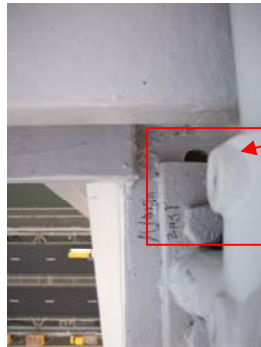
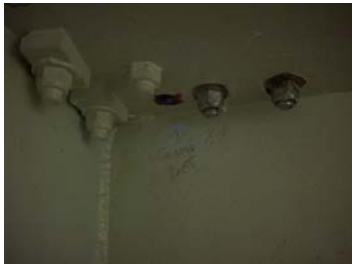
Photographs showing North main tower top crossover internal / external areas of water ingress. Bolts missing. Protective handrail fixing brackets.

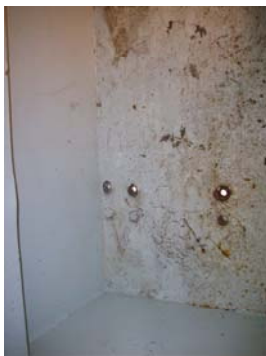
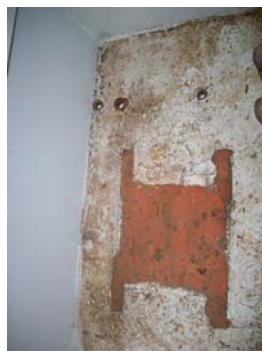
Photographs showing bolt holes & unpainted floor surface areas in North main tower top crossover internal

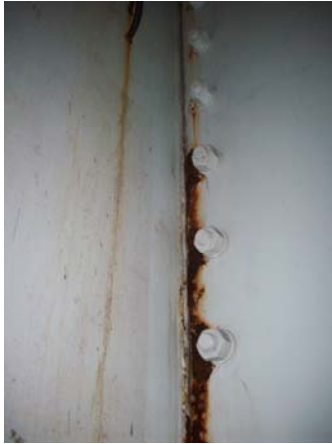
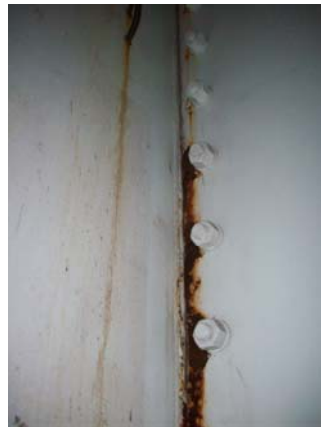
Main tower north (west leg) in "E" cell South west corner.

Corrosion. : Tower internal bases .: There are two areas located in the North main tower where staining runs from approximately 5 metres above this area in the line of bolts where medium to heavy corrosion is evident on the corner faces of the steel , this

is also evident on the base floor-plate and fixings. These are located in the west leg " Cell " E" base (base dry) & the east leg Cell " D" base (base dry). Please refer to relevant Photographs & structure numbers for information.

Photographs showing corrosion / staining in areas below.

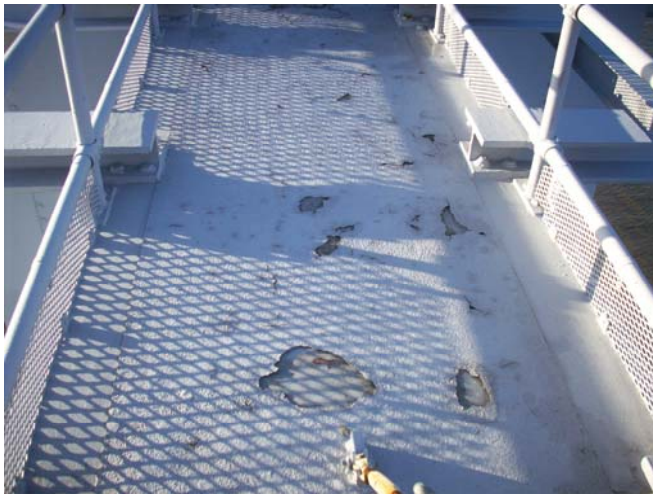
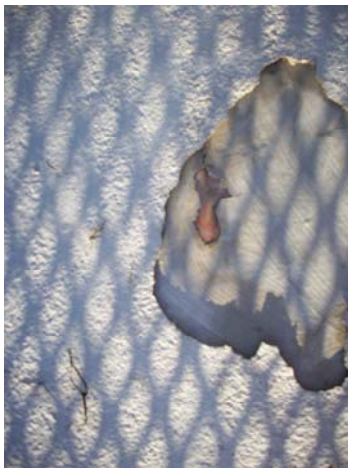
Paintwork. : . Externals as main tower introduction, however there is an area of paintwork on the south main tower external crossover at the tower top on the west side where the painted surface has broken down over an area of approximately 8 to 10 meters square. This area requires to be removed as surface corrosion is evident on floor panels where breakdown. Internals generally remain in a satisfactory condition . On the south main tower top crossover internal however there are areas where bolts have been removed/drilled and the surrounding perimeter paintwork has been removed and corrosion is evident at these locations. As recorded defects last inspection stating corrosion and water was evident in shelves located at "C" level in certain cells , this inspection no water evident at time of inspection, corrosion/ discoloration remains. Please refer to relevant Photographs & structure numbers Please refer to relevant Photographs & structure numbers .

View of defective area of paintwork on the South main tower top crossover external.
 G:\Inspection Records\FETA inspection records for Main Towers\General
 Reports\General report. No 413. Main towers N & S. 2013. 12.18..doc
