INSPECTION DEPARTMENT
Main cable inspection.
DATE. 10.06.14 to 12.06.14

(E2.1 Bridge)
REPORT No. 435
MAIN CABLE

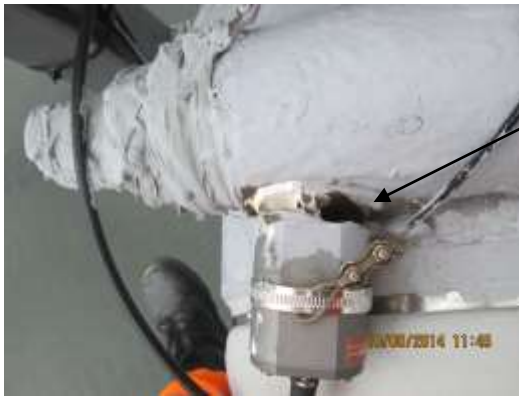
Cable bands. : All cable bands throughout the structures main cable remain in a satisfactory condition. The acoustic monitoring sensor which is attached to the north face of the cable band at PP. 30 North west side span is a little loose, requires to be re-attached. This defect was reported during the last main cable / paint inspection.

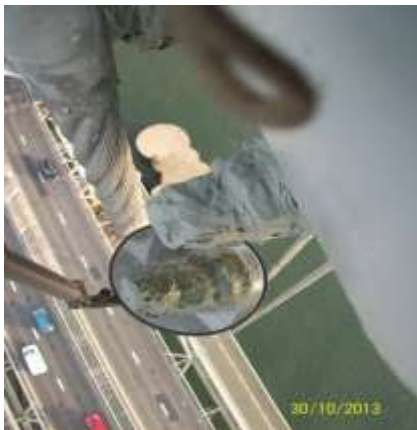
Cable bands bolts. : Cable band bolts and nuts that were replaced showing no signs of any defects this inspection, however, it should be noted that the new paint protective coating that was applied to the nut faces is making it difficult to detect any defects.

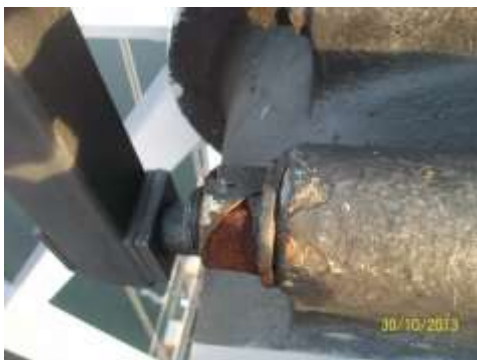
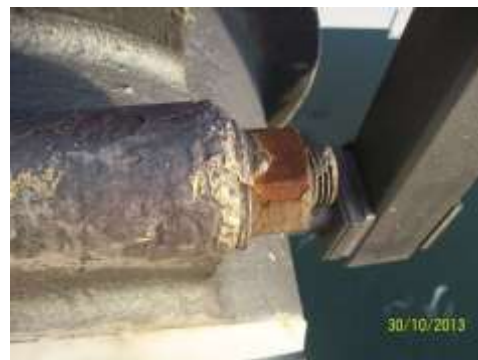
Main/ Side tower sleeves. : All sleeves remain in a satisfactory condition. Cable bands immediately below all main tower sleeves, bolts have slight to medium corrosion evident, protective paint covering broken down.

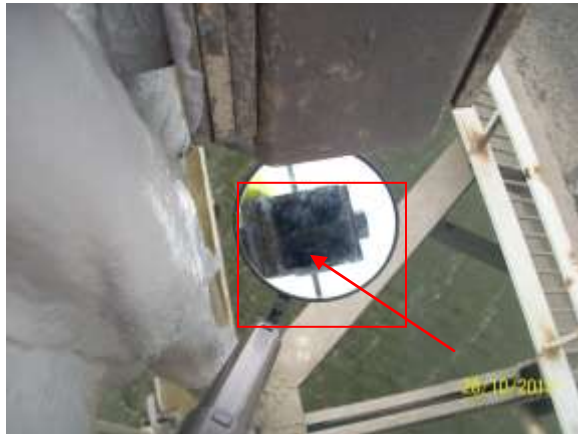
Locking nut position for
hand-strand internal face

Handstrand stanchions. : All hand-strands & bolt fixings throughout the main cable remain in a satisfactory condition. At PP 92 on the south east main span & north east main span the internal locking nuts on the east & west face in the underside of the hand-strand stanchion (which is box section) are not on the threaded bolt. (this could have been when handstrand stanchions were removed to allow main cable gantry access and not been put back in place). Outer nuts remain in place and secure.

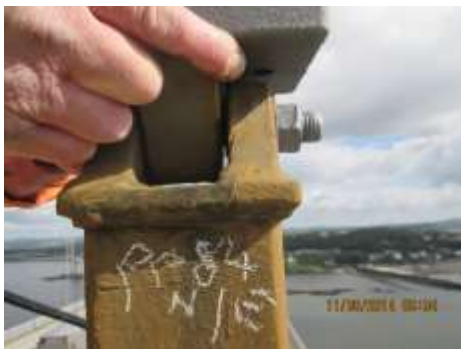
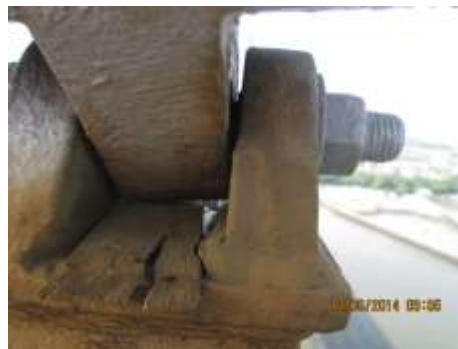
Handstrand cable casting clamp / post connections. : All remain in situ. All welds to hand-strand stanchions remain satisfactory, no defects found. Following survey carried out in 2007 with regards to movement / noise levels on the above, no work has been carried out. Approx 50% of wedges installed following survey remain in position. A program of works will be implemented to remove & replace existing wedges and to install new where required. Following this inspection, with information related to the above, again I raise the concern with regard to the internal condition of the bolt shank and the condition / deterioration / wear- down of the clamps phosphorous bronze sleeve and washers. It is of my opinion that if possible one of the worst examples should be removed and examined to ascertain its current condition, and to use this example to determine the wear- down of other locations.

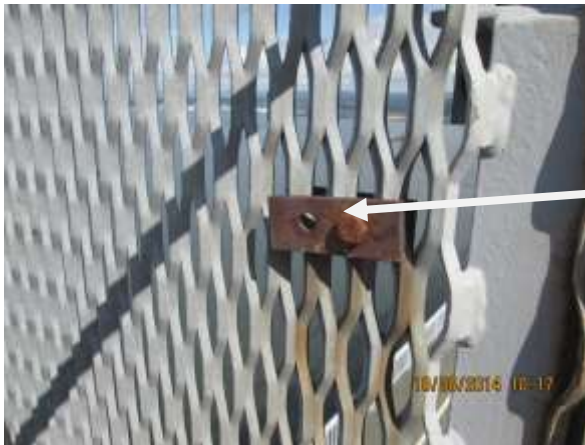
Main cable gates. : All main cable access gates generally remain in a satisfactory condition. Medium corrosion is evident on all plates & bolts . There is one bolt missing (which requires to be replaced.) at PP. 86 Main span north west.
