INSPECTION DEPARTMENT
Main cable inspection.
DATE. 06.04.15 to 09.04.15

(E2.1 Bridge)
REPORT No. 468
MAIN CABLE

DATE: 06.04.15 to 09.04.15

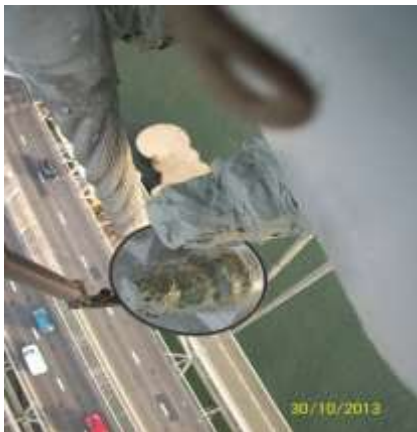
Cable Bands Bolts: Cable band bolts and nuts that were replaced showing no signs of any defects this inspection, however, it should be noted that the new paint protective coating that was applied to the nut faces still makes it difficult to detect any defects.

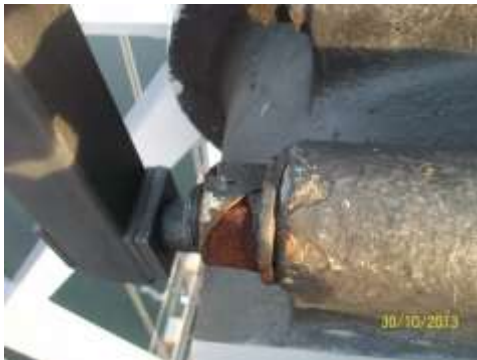
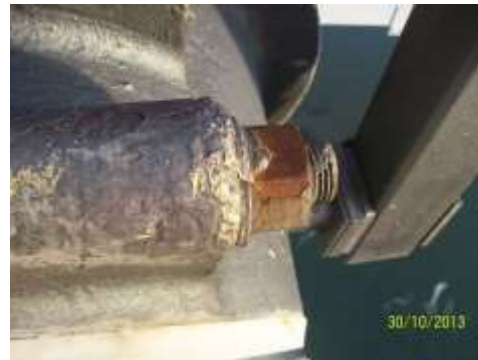
Main/Side Tower Sleeves: All sleeves remain in a satisfactory condition. Cable bands immediately below all main tower sleeves, the bolts have slight to medium corrosion evident, protective paint covering broken down.

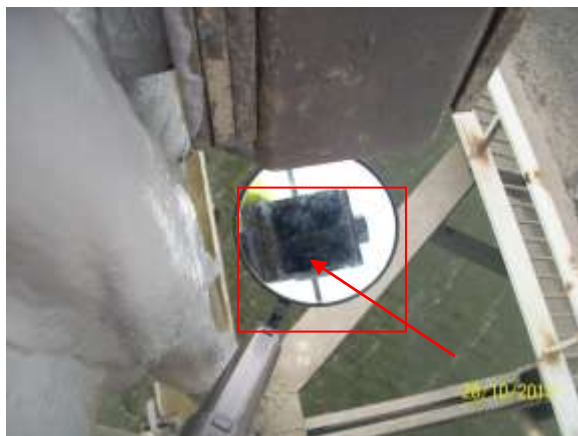
Handstrand Stanchions: All hand-strands & bolt fixings throughout the main cable remain in a satisfactory condition. At PP 92 on the south east main span & north east main span the internal locking nuts on the east & west face in the underside of the hand-strand stanchion (which is box section) are not on the threaded bolt. (this could have been when handstrand stanchions were removed to allow main cable gantry access and not been put back in place). Outer nuts remain in place and secure.

Locking nut position for
hand-strand internal face

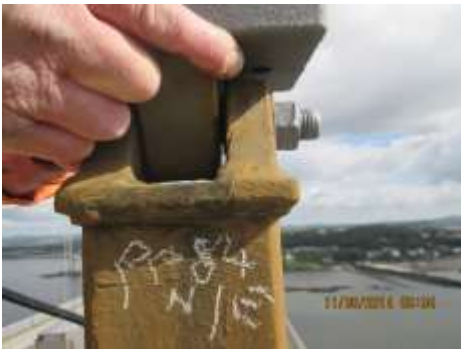
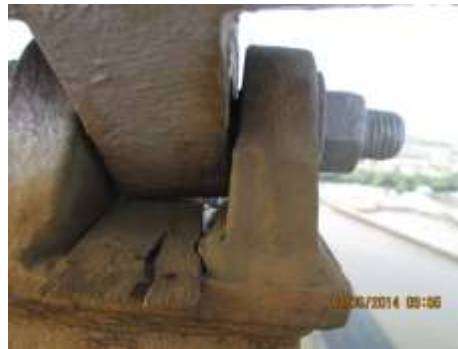
Handstrand Cable Casting Clamp/Post Connections: All remain in situ. All welds to hand-strand stanchions remain satisfactory, no defects found. Following survey carried out in 2007 with regards to movement / noise levels on the above, no work has been carried out. Approx 50% of wedges installed following survey remain in position. A program of works will be implemented to remove & replace existing wedges and to install new where required. Following this inspection, with information related to the above, again concern should be raised with regard to the internal condition of the bolt shank and the condition / deterioration/wear- down of the clamps phosphorous bronze sleeve and washers; if possible one of the worst examples should be removed and examined to ascertain its current condition, and to use this example to determine the wear- down of other locations.
