Following the finding of a defective nut located on the live side of the cable band ( East side ) at PP 32 n/e during the main cable dehumidification contract, the defective bolt ( bolt 5Bö ) in the cable band sequence at this location was removed ( Friday 14/09/09 ) & replaced Saturday (15/09/09 ). Using a recorded bolt **RA CO258** with nuts **RA CN 00552** & **RA CN 0591**. All went well with no problems recorded during the bolt replacement.

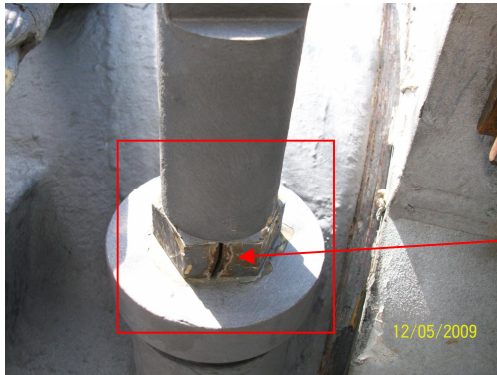
Nut defect. Located on the live side .

( East side )

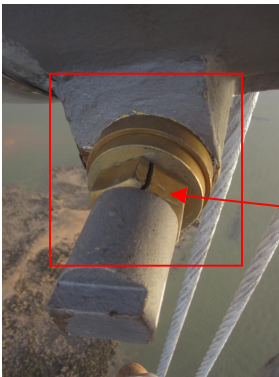
Following a cable walk by contractors carrying out visual checks on dehumidification main cable sensors, it was found that at the same location the nut located on the dead side ( West side ) had failed , this was recorded and reported to bridge management.

Nut defect. Located on the dead side .

( West side )

Following the procurement of suitable access platform equipment it was decided that the replacement of the defective nut would be scheduled for replacement on Thursday 30/09/10. It should be recorded that before the temporary cable band could be positioned FRB staff were instructed to carry out the removal of the main cable wrapping. This was carried out successfully and the temporary cable band was located in position.

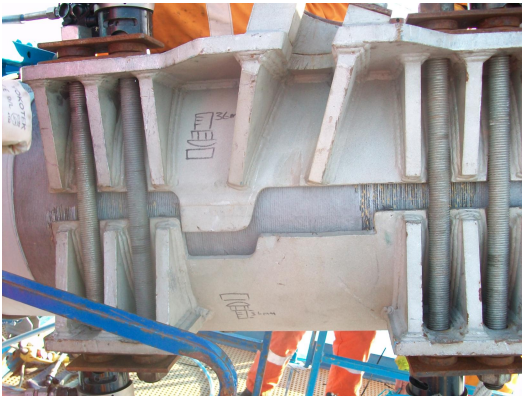
Photograph showing view of ( West side ) temporary cable band located on main cable.

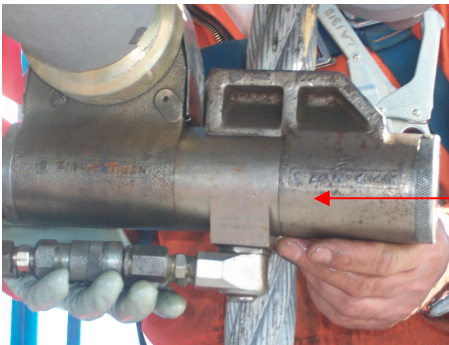
CT. 6 torque tool applied to live side of bolt

CT 6 torque tool required to de-tension defective nut located on bolt fitted. This was fitted to the live side.

11.35 am. De- tensioning of defective bolt took place. ¼ turn system as used in previous bolt replacements applied until load was removed from defective bolt.

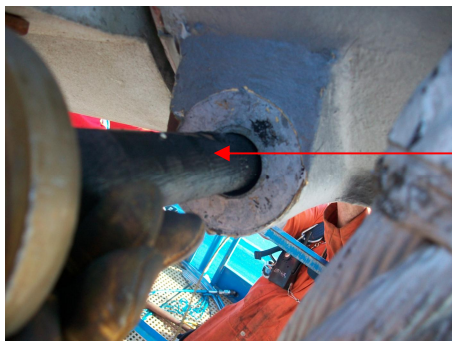
Bolt being removed from its seating location from the dead (west side )

11.45 am . De-tensioning complete . Bolt released and bolt removed from cable band . No problems encountered with removal.
