INSPECTION DEPARTMENT
INSPECTION. Main cable bolt & nut inspection. North East side span.
DATE. 04/10/10.

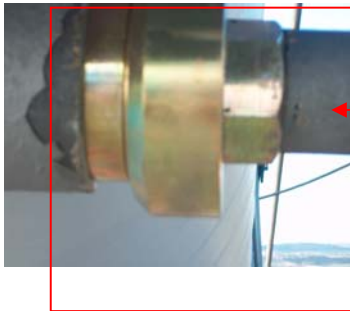
This follows the second replacement of cable band bolt [“B”at PP 32 N/E .](#) on **Thursday 30/09/10.** All cable band nuts & bolts were found to be in a satisfactory condition with no defects being found. Photographs below show the live side of replaced bolt. No photographs showing the dead side of the bolt were taken. A thorough inspection of the condition of the nut on the dead side was carried out. Both bolts & nuts found to be in a satisfactory condition. All photographs can be found on BC. 04. Whilst completing the inspection of the north east side span it should be recorded that a small hole in the cable wrapping was found at PP40 N/E on the upper (south side of the cable band seal.) Photographs were taken by bridge inspector L.Coyle.

Photograph showing the South face of
The live side of replacement bolt &
washers.

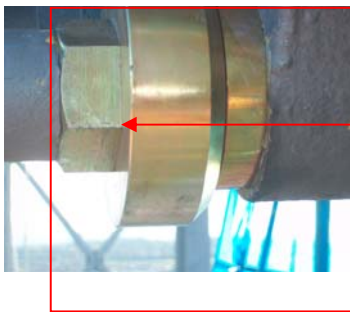
Photograph showing the North face
of the live side of replacement bolt
& washers.

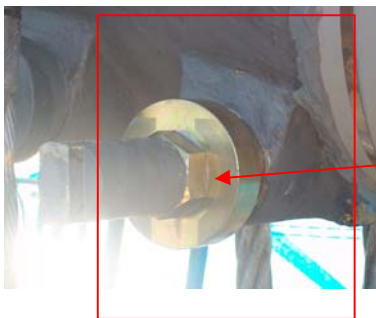
Photograph showing the front face of
The live side of replacement bolt &
washers.

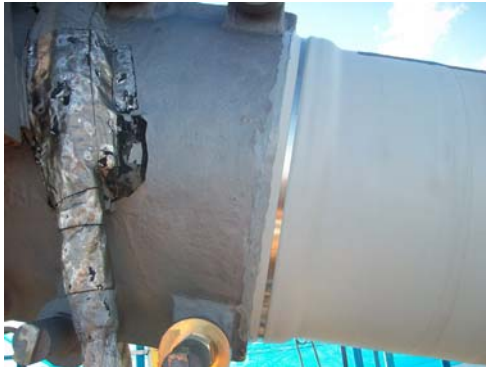
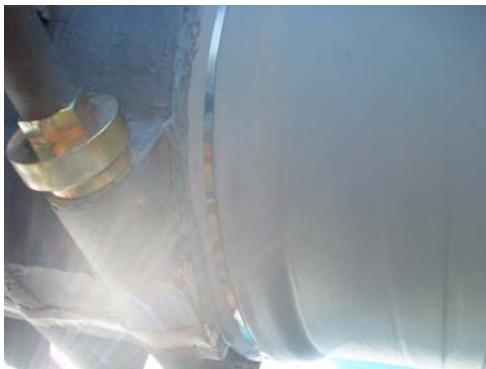
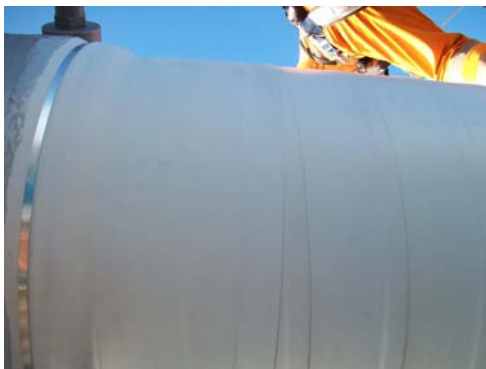
Photographs below show the re-wrapping of the exposed area of the main cable where the temporary cable band was positioned to allow the bolt replacement to be carried out. All wrapping and sealing of the collar were found to be in a satisfactory condition.
