| INSPECTION DEPARTMENT |
| Main span North East. Crash barrier / Handrail. |
| DATE. 2015.01.21 |

MAIN SPAN NORTH (EAST)

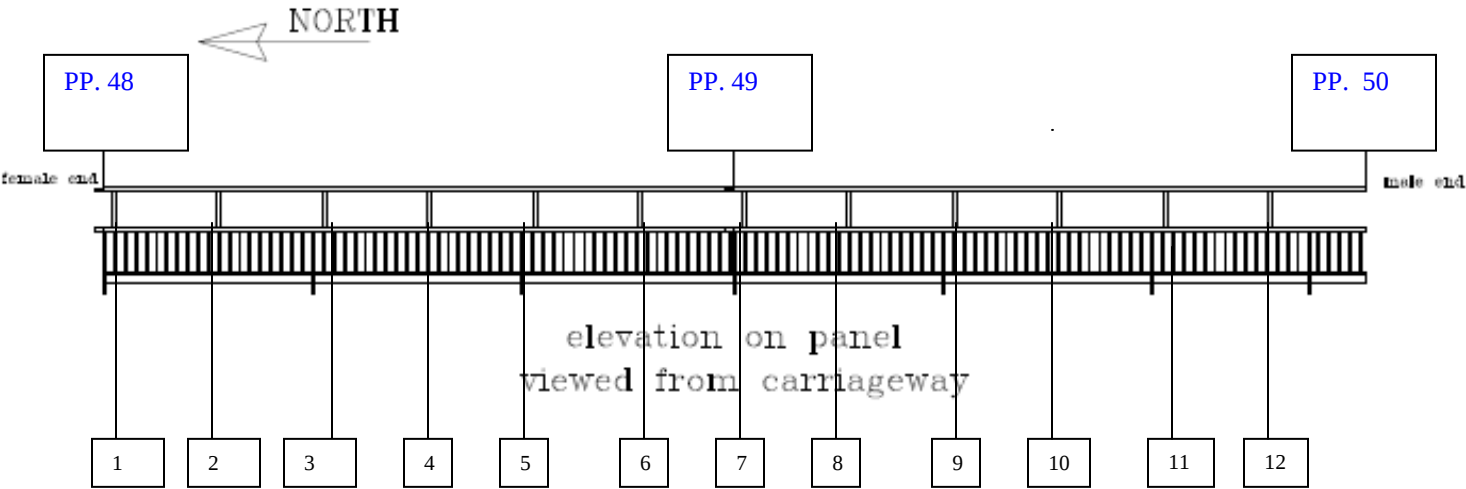
Top Rail. - New top rail joint detail – bolt pulled through at PP48 and plate washer for bolt required at PP50

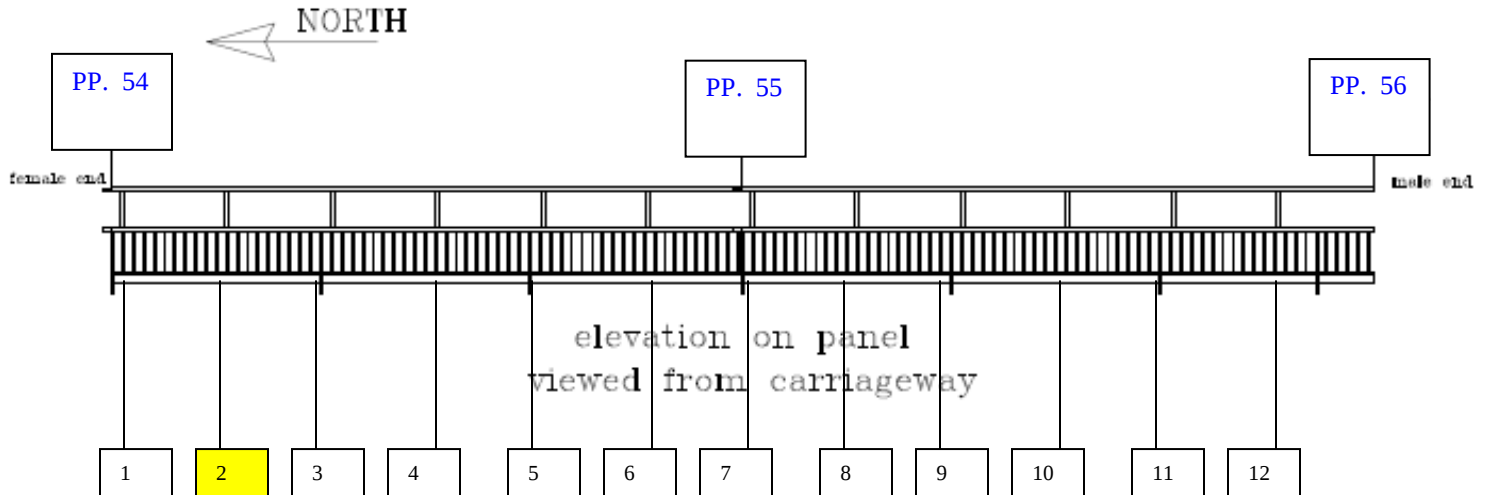
Top Rail. – Plate washer for bolt required at PP54

Post No2.- Bottom vertical weld cracked all the way round, previously plated, new plate required

Bottom Rail.- Crack on top surface, west and south faces at post 6

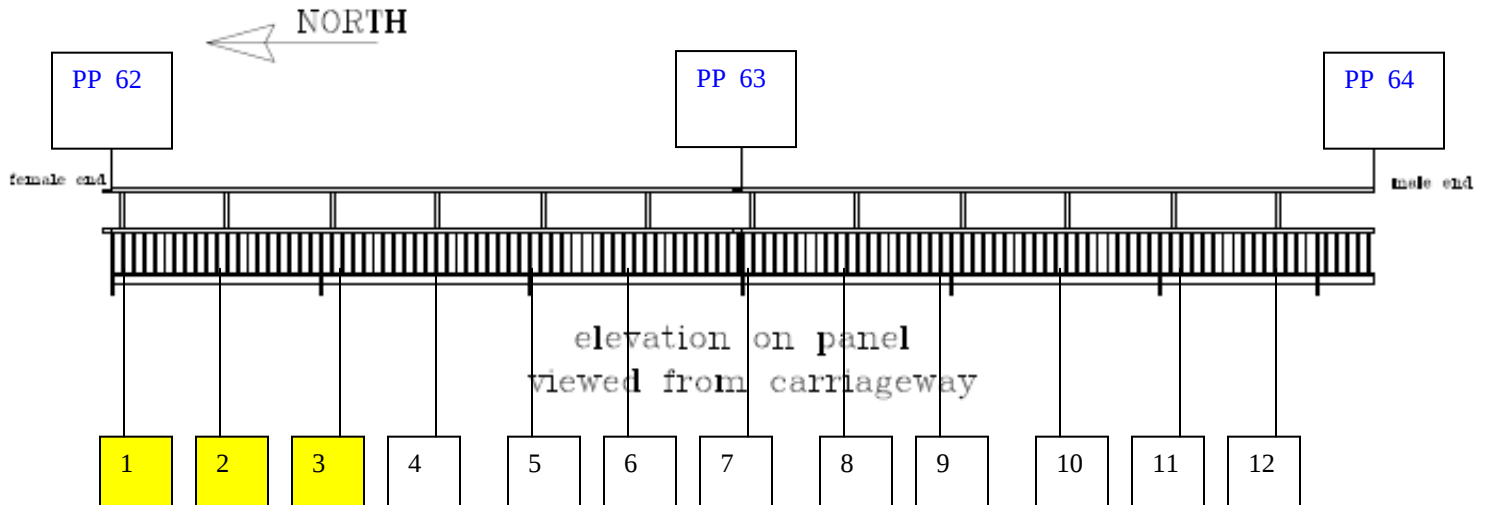
Top Rail. – New top joint detail – plate washer required for bolt at PP62  
Post No1.- Base weld broken all the way round – movement evident  
Post No2.- Base welds cracked on west and south faces  
Post No3.- Base weld cracked on east face  
Post No4.-  
Post No5.-  
Post No6.-  
Post No7.-  
Post No8.-  
Post No9.-  
Post No10.-  
Post No11.-  
Post No12.-  
Bottom Rail.-  
Grillage.-

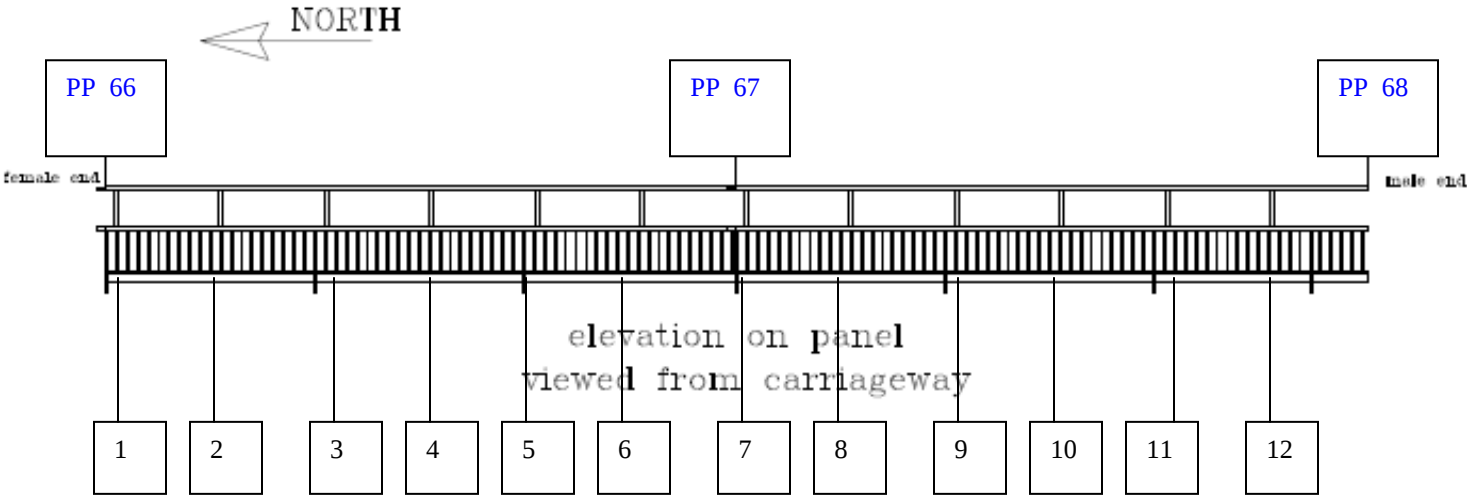
- Top Rail. – New top rail detail, plate washer required for bolt at PP66
- Post No1.-
- Post No2.-
- Post No3.-
- Post No4.-
- Post No5.-
- Post No6.-
- Post No7.-
- Post No8.-
- Post No9.-
- Post No10.-
- Post No11.-
- Post No12.-
- Bottom Rail.-
- Grillage.-

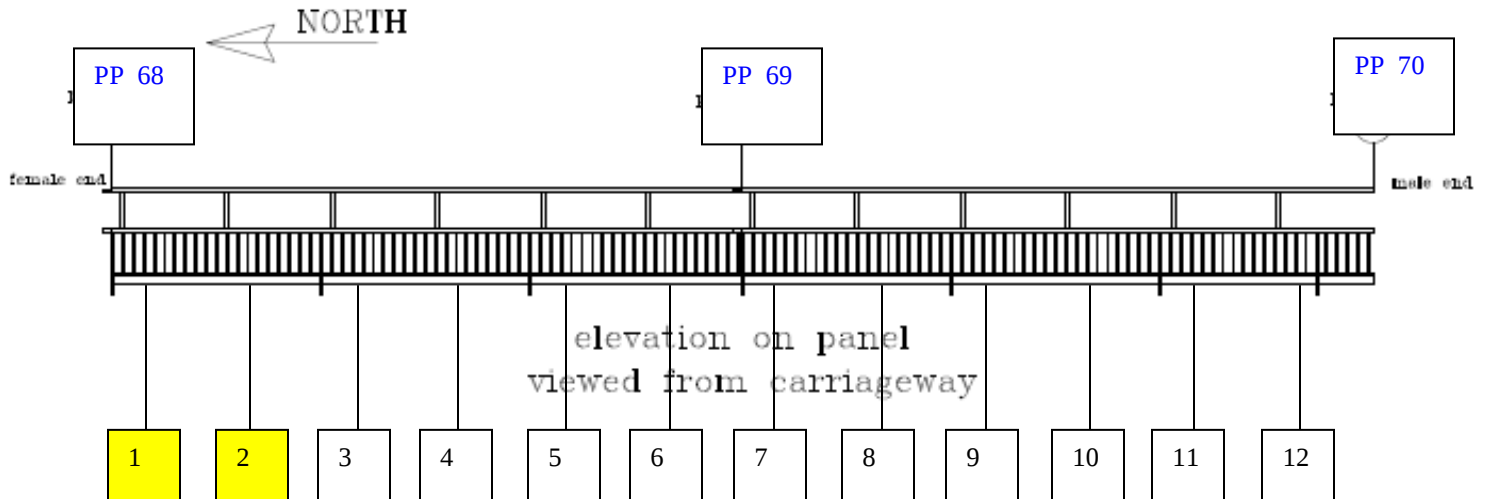
Top Rail. – New top rail detail bolt pulled through at PP68, plate washer required for bolt at PP70  
Post No1.- Base weld cracked on west face  
Post No2.- Base welds cracked on east and west faces  
Post No3.-  
Post No4.-  
Post No5.-  
Post No6.-  
Post No7.-  
Post No8.-  
Post No9.-  
Post No10.-  
Post No11.-  
Post No12.-  
Bottom Rail.-  
Grillage.-

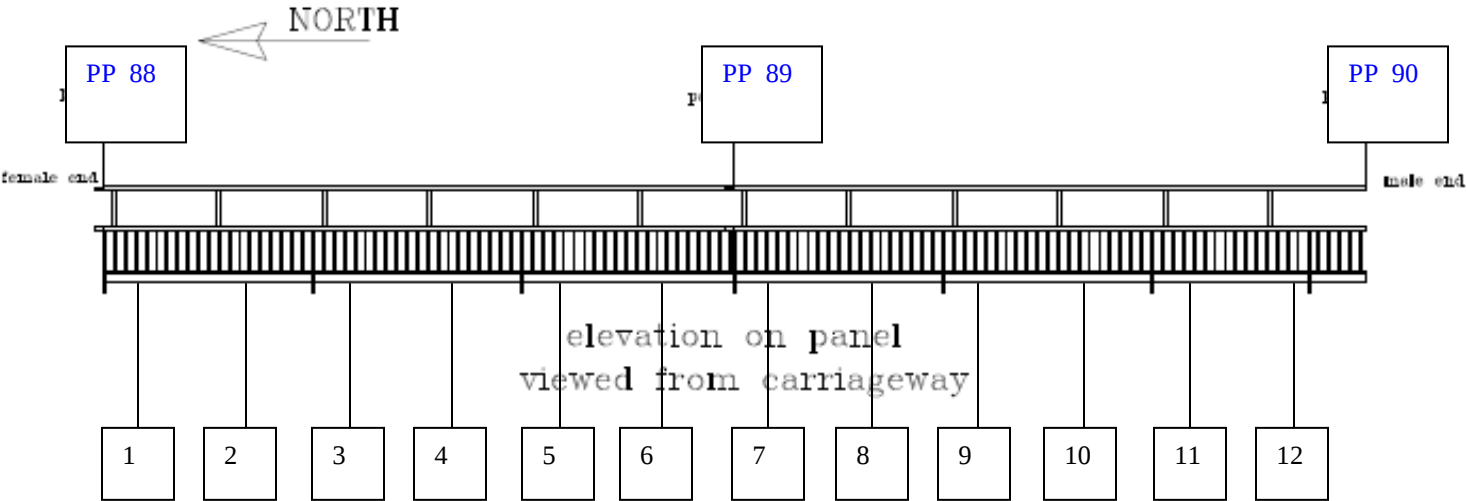
- Top Rail. -
- Post No1.-
- Post No2.-
- Post No3.-
- Post No4.-
- Post No5.-
- Post No6.-
- Post No7.-
- Post No8.-
- Post No9.-
- Post No10.-
- Post No11.-
- Post No12.-
- Bottom Rail.- Corroded all the way round base of post 2, plate required
- Grillage.-

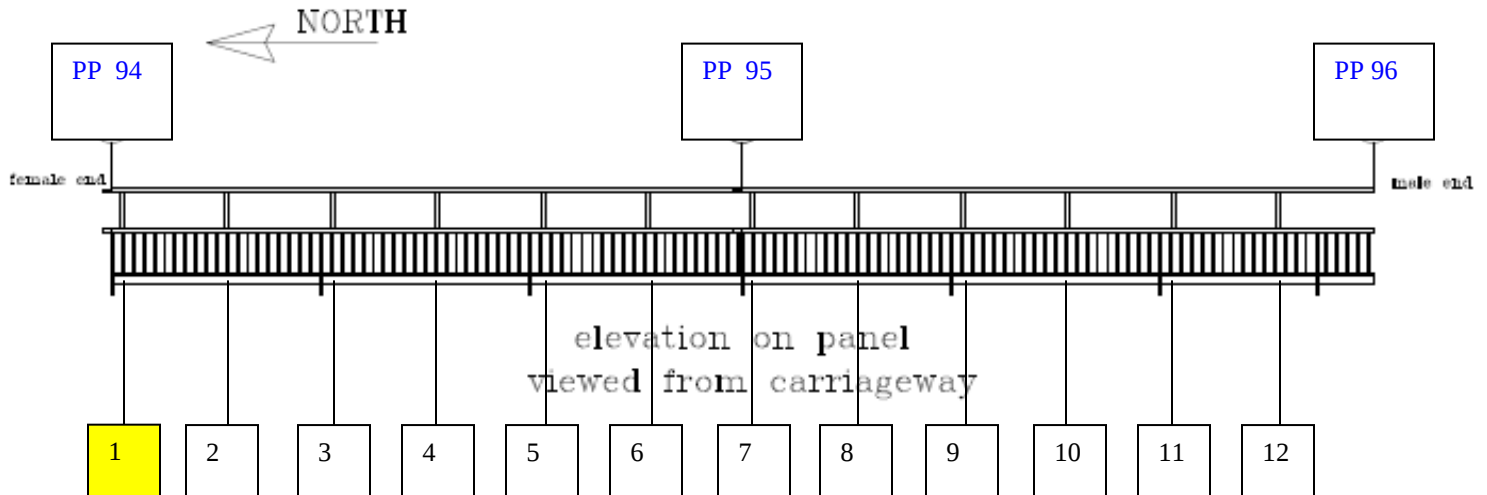
Top Rail. – Possible top rail weld connection cracked at post 1, top surface and west face - check  
Post No1.- Base welds cracked on west and south faces  
Post No2.-  
Post No3.-  
Post No4.-  
Post No5.-  
Post No6.-  
Post No7.-  
Post No8.-  
Post No9.-  
Post No10.-  
Post No11.-  
Post No12.-  
Bottom Rail.-  
Grillage.-

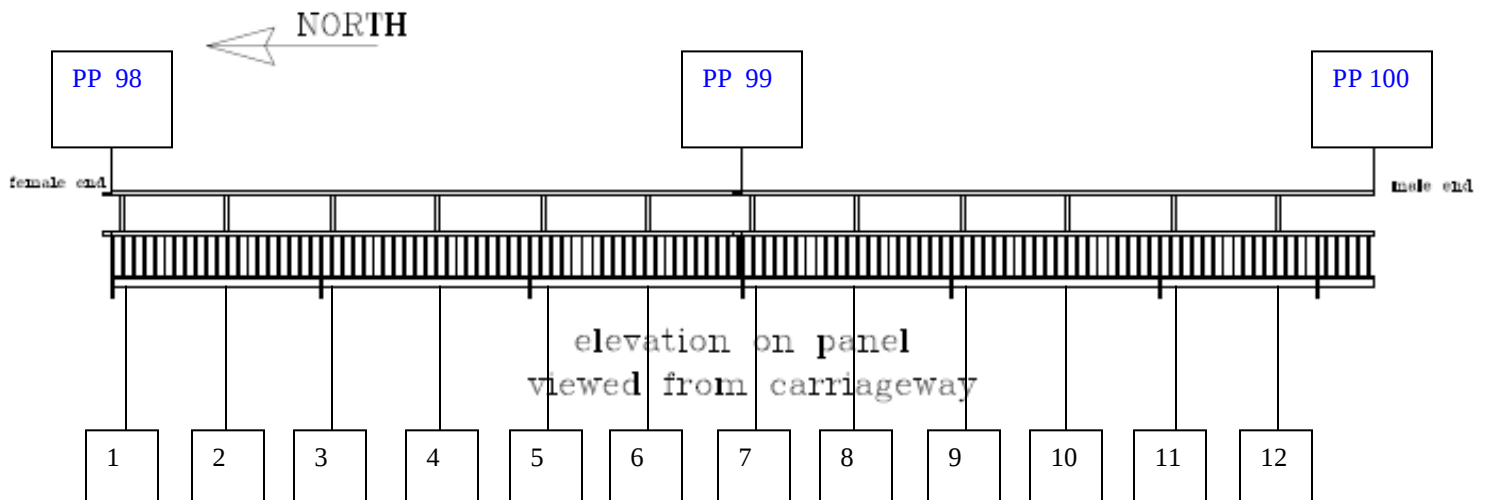
Top Rail. – New top rail detail 1 no. counter sunk screw missing at PP98

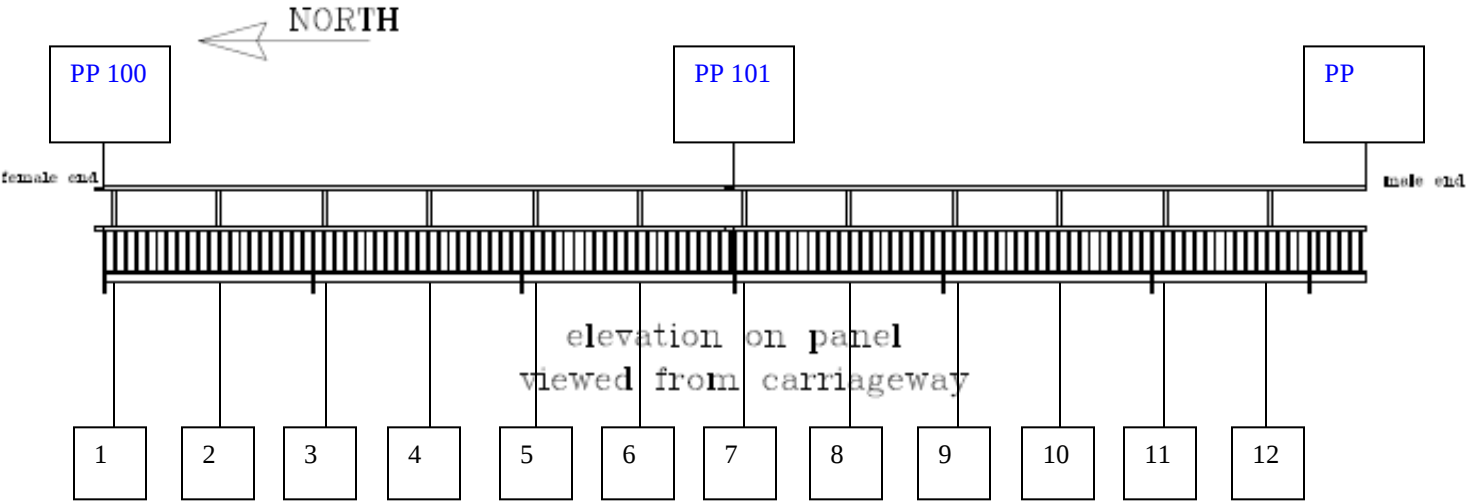
- Top Rail. – New top rail detail 1 no. counter sunk screw missing at PP100
- Post No1.-
- Post No2.-
- Post No3.-
- Post No4.-
- Post No5.-
- Post No6.-
- Post No7.-
- Post No8.-
- Post No9.-
- Post No10.-
- Post No11.-
- Post No12.-
- Bottom Rail.-
- Grillage.-
