**INSPECTION DEPARTMENT****Main Span South East. Crash
Barrier / Handrail.****DATE. 2015.01.21****MAIN SPAN SOUTH (EAST)**

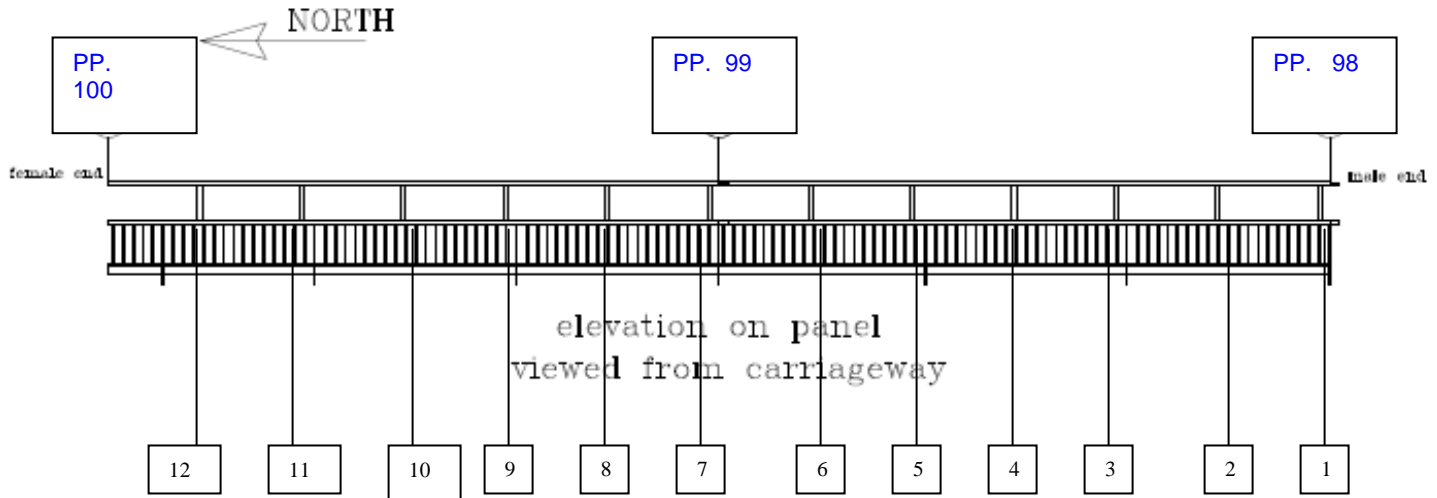
Top Rail. – New top rail detail at PP100 has 1 no. counter sunk screw missing and bolt missing

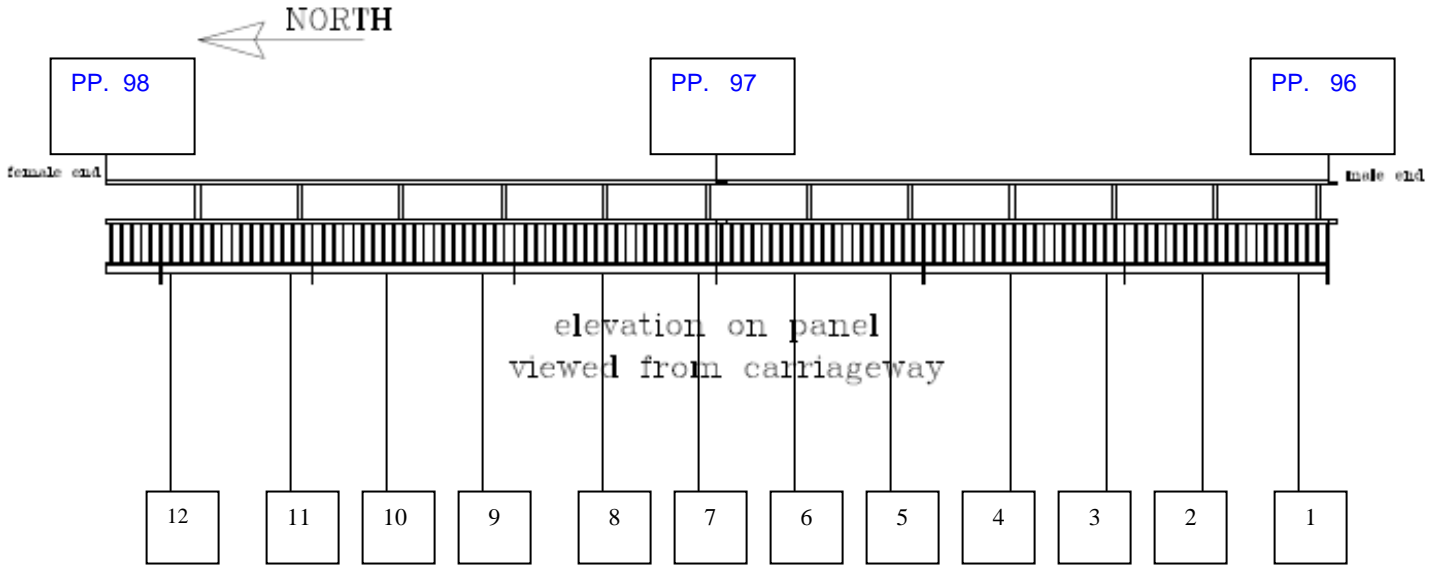
- Top Rail – New top rail detail at PP98 2 no. counter sunk screws missing
- Post No.1 –
- Post No.2 –
- Post No.3 –
- Post No.4 –
- Post No.5 –
- Post No.6 –
- Post No.7 –
- Post No.8 –
- Post No.9 –
- Post No.10 –
- Post No.11 –
- Post No.12 –
- Bottom Rail –
- Grillage –

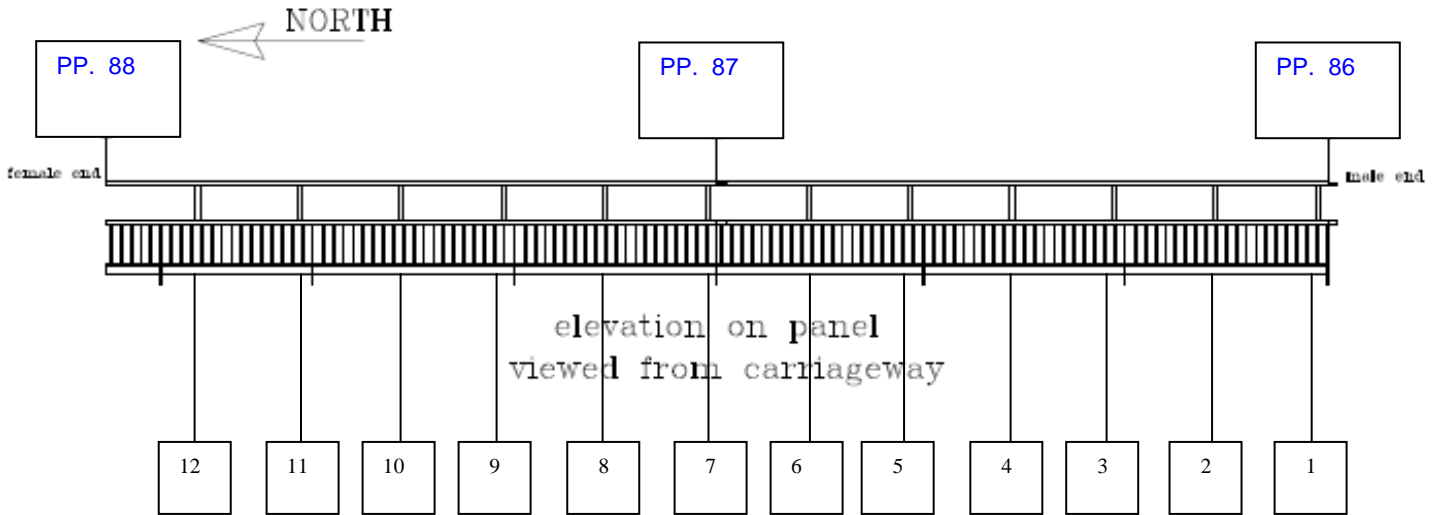
- Top Rail – Old detail expansion sleeve male end holed, west face at PP88
- Post No.1 –
- Post No.2 –
- Post No.3 –
- Post No.4 –
- Post No.5 –
- Post No.6 –
- Post No.7 –
- Post No.8 –
- Post No.9 –
- Post No.10 –
- Post No.11 –
- Post No.12 –
- Bottom Rail – Post 11 top section holed north face, cracked south face, plate required
- Post 12 top section holed north face and corroded all way round, plate required
- Grillage –

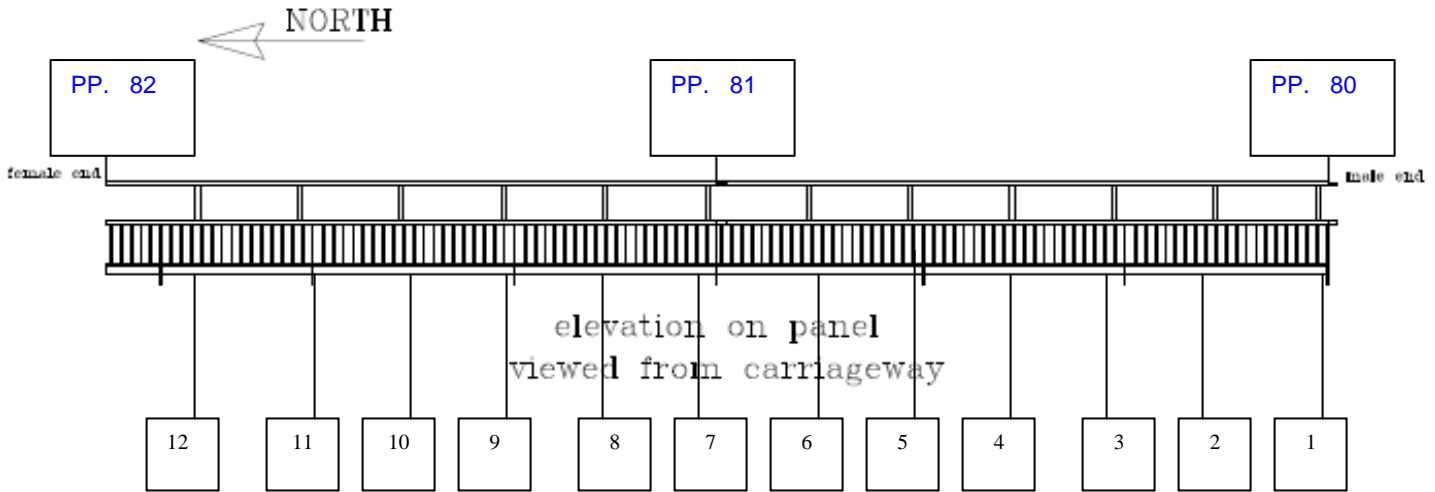
- Top Rail – Old detail expansion sleeve female end corroded on underside, west face at PP80
- Post No.1 –
- Post No.2 –
- Post No.3 –
- Post No.4 –
- Post No.5 –
- Post No.6 –
- Post No.7 –
- Post No.8 –
- Post No.9 –
- Post No.10 –
- Post No.11 –
- Post No.12 –
- Bottom Rail –
- Grillage –

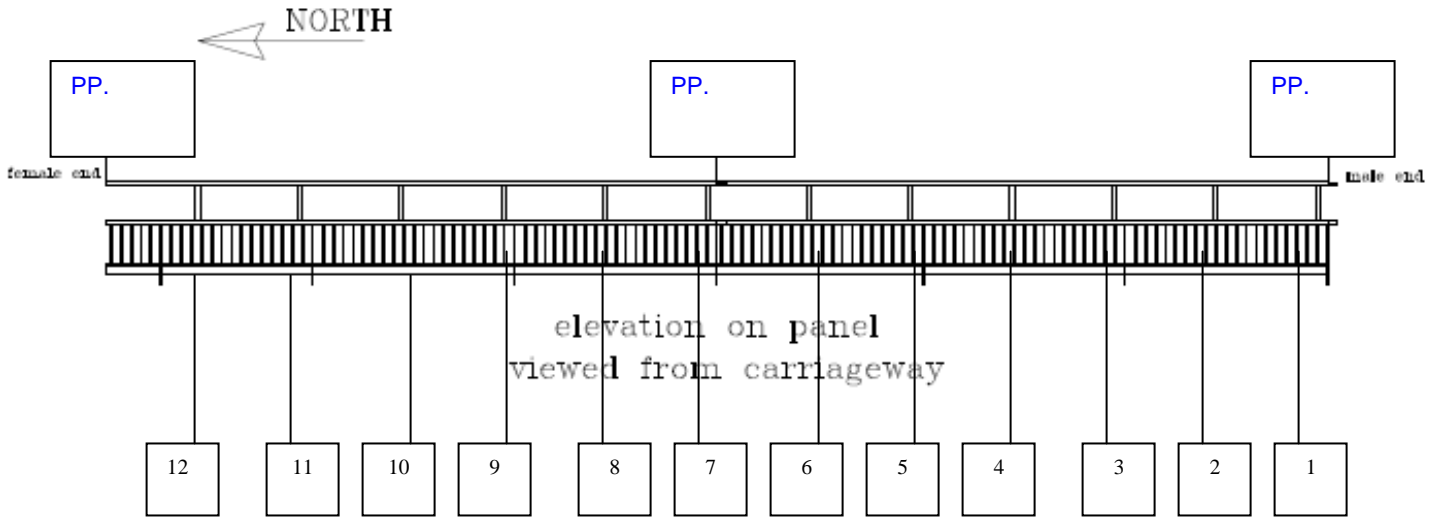
- Top Rail – Old detail female end holed on top section and west face at PP74
- Post No.1 –
- Post No.2 –
- Post No.3 –
- Post No.4 –
- Post No.5 –
- Post No.6 –
- Post No.7 –
- Post No.8 –
- Post No.9 –
- Post No.10 –
- Post No.11 –
- Post No.12 –
- Bottom Rail –
- Grillage –

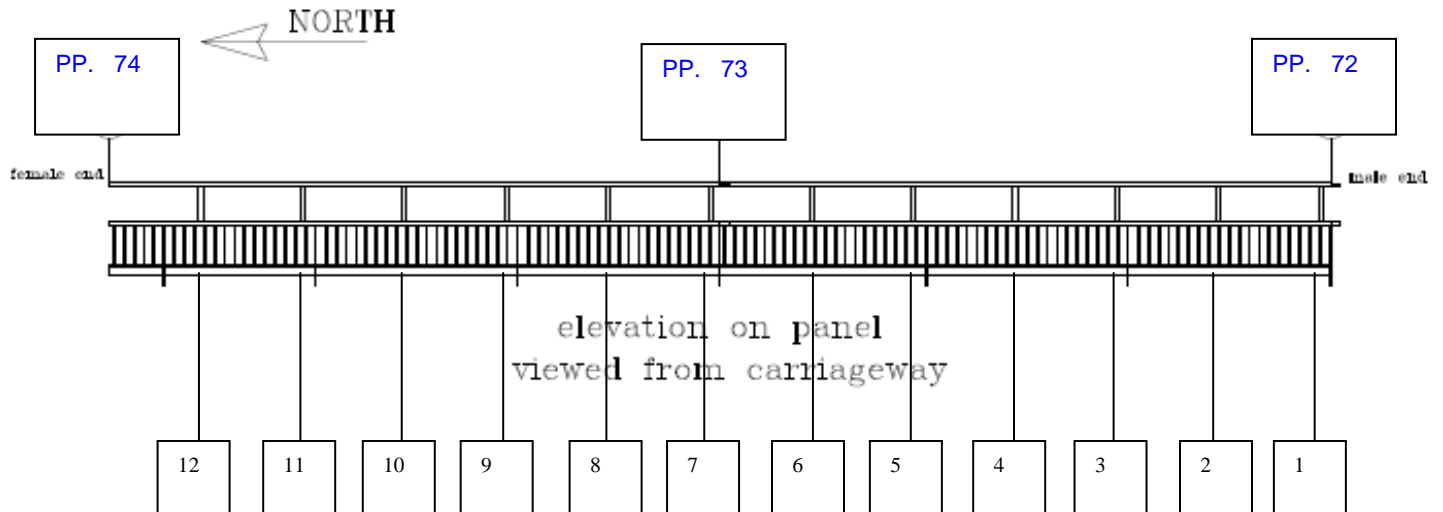
- Top Rail – Old detail expansion sleeve female end holed top section and west face at PP72
- Post No.1 –
- Post No.2 –
- Post No.3 –
- Post No.4 –
- Post No.5 –
- Post No.6 –
- Post No.7 –
- Post No.8 –
- Post No.9 –
- Post No.10 –
- Post No.11 –
- Post No.12 –
- Bottom Rail –
- Grillage –

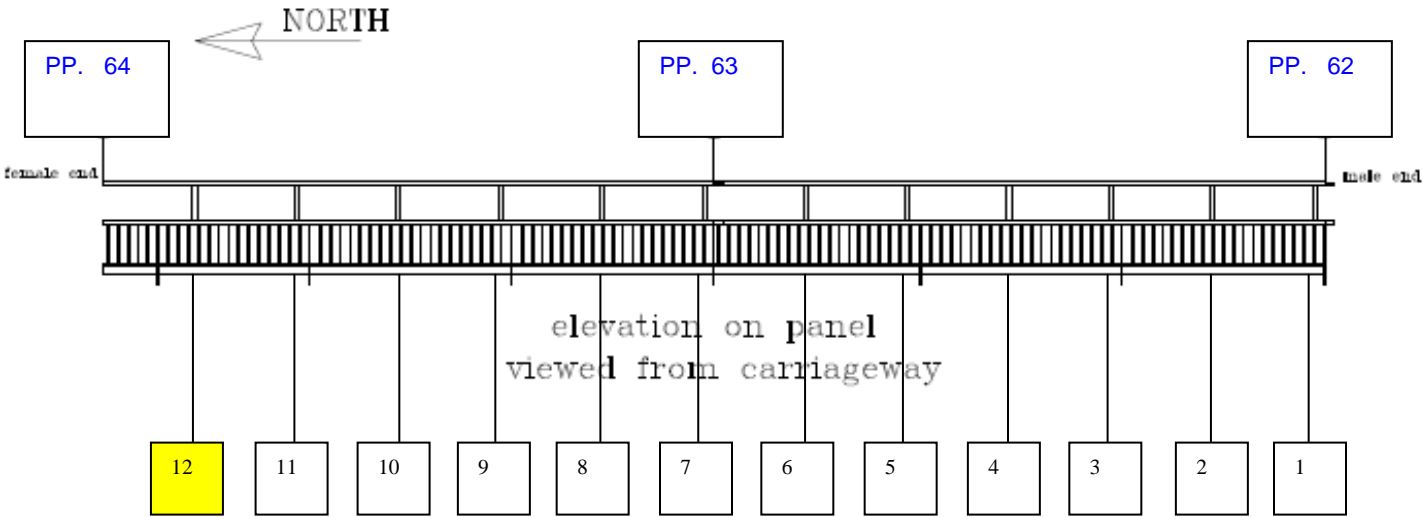
- Top Rail –
- Post No.1 –
- Post No.2 –
- Post No.3 –
- Post No.4 –
- Post No.5 –
- Post No.6 –
- Post No.7 –
- Post No.8 –
- Post No.9 –
- Post No.10 –
- Post No.11 –
- Post No.12 – Base weld cracked all the way round, plate required
- Bottom Rail –
- Grillage –

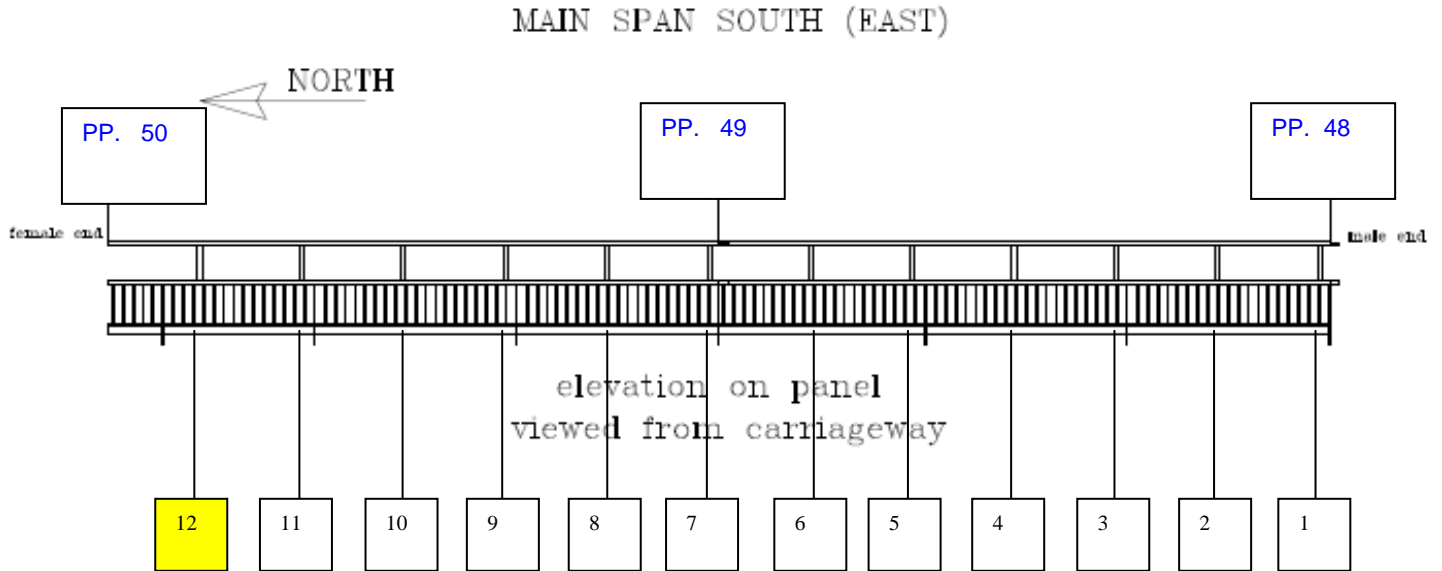
- Top Rail –
- Post No.1 –
- Post No.2 –
- Post No.3 –
- Post No.4 –
- Post No.5 –
- Post No.6 –
- Post No.7 –
- Post No.8 –
- Post No.9 –
- Post No.10 –
- Post No.11 –
- Post No.12 – Base weld cracked all the way round, possible plate required
- Bottom Rail –
- Grillage –
