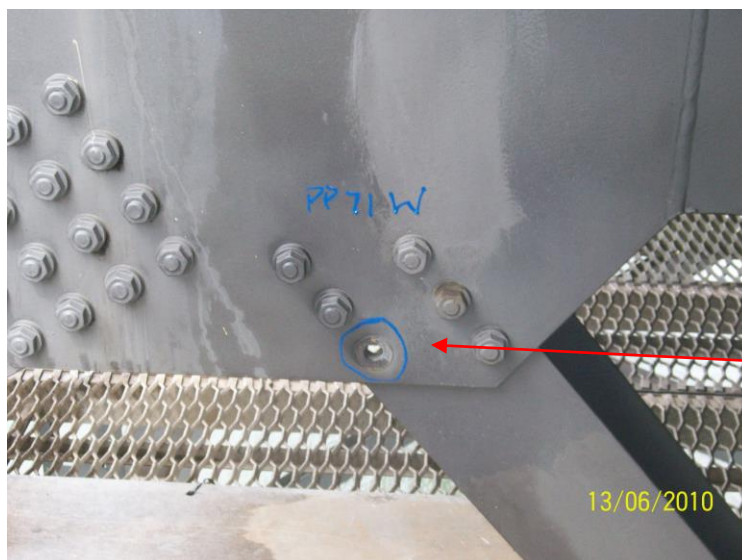
Missing bolt beam No 6 . on  
south face of cross girder  
PP71 (West. )

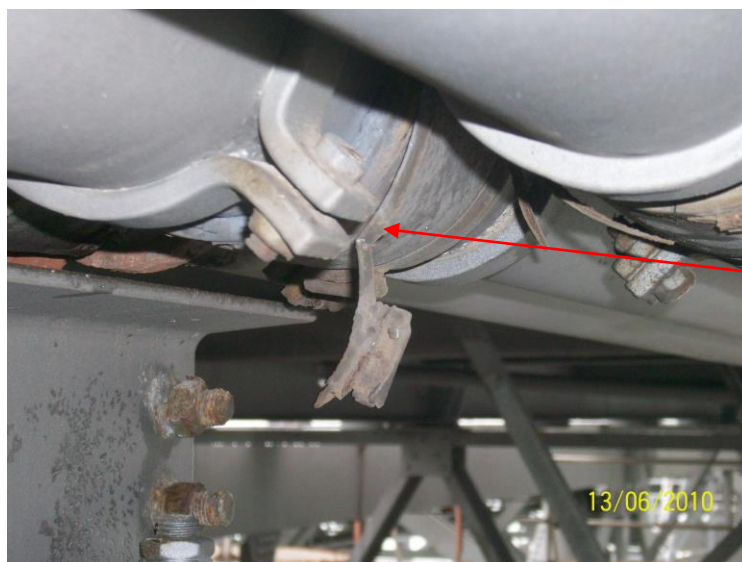
“ A line “ Tri-duct Expansion joint  
jubilee clips heavily corroded &  
broken , Require to be replaced on  
both E & W throughout Main-span  
PI. Area PP 68.5 to PP71.5.
