Main tower expansion joint plate removal.

Location: Main tower North west joint No 3. slow lane.

On Saturday 17th January 2009 the inspection to the Demag expansion joint MW3, continued after its extraction and initial inspection checks on nightshift 16th/17th January.

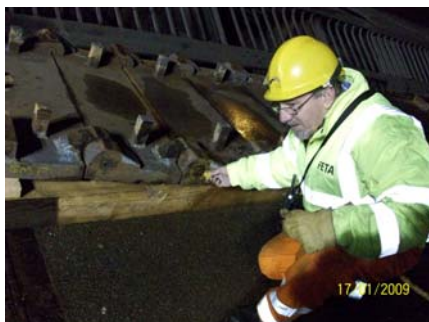
Any problems encountered during operational procedures .: On attempting to lift Rocker plate & shuttle plate as drawing no. BC. 06-63-01-17 rev 2. on MW 3, pin on shuttle plate No 3. East face was preventing the shuttle plate from lifting out. A visual inspection was carried out on the underside, and it was found to be protruding by approx 4 mm. Three attempted lifts failed to release the plates. Following consultation with maintenance manager, a decision was taken that to allow plate MW3 to have enough clearance to be lifted out, that we release the tongue plate spring (West) only on tongue plate no MW4. On completion of the removal of the spring the order was given to the crane driver to lift the plates.. This proved to be successful and the plates were removed. On inspection following removal of plate it was found that on MW 3, pin on shuttle plate no 3. had seized. Tongue plate spring to plate (MW4 west) was replaced with a new spring fitted before cleaning down of radius arm girder began.

Inspector: marking offending pin. Related to above comments.

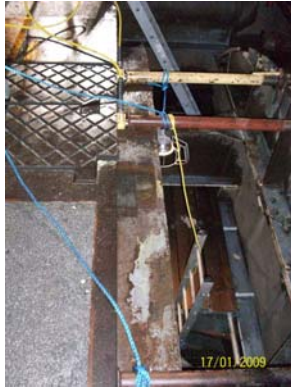
At approx 02.00 a.m. Adjustable props (accrows) were positioned between plates MW2 to MW4. hydraulic jacks were positioned on the face of plate MW2. pressure was applied .this operation was carried out to ensure that the re-positioning of plates MW3.would be made as easy as possible.

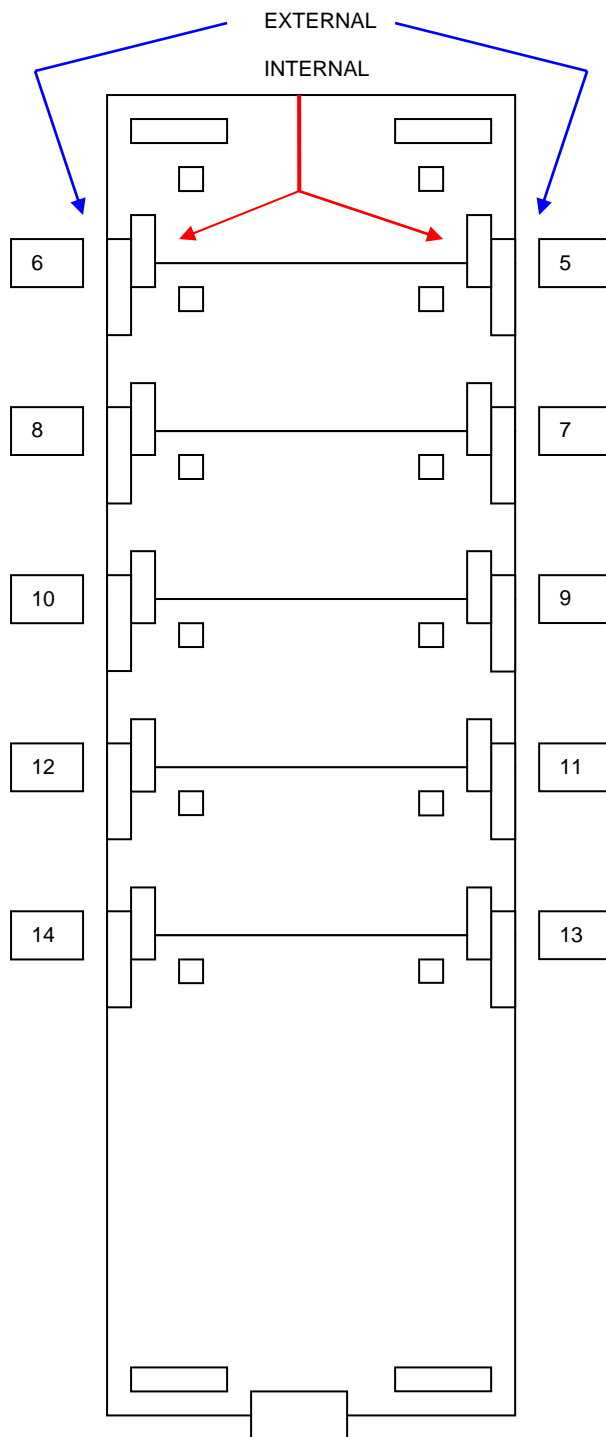
<u>PIN No.</u>	<u>EXTERNAL</u>	<u>INTERNAL</u>
<u>5</u>	39mm	39mm
<u>Bush thickness</u>		
Top	4mm	4mm
Bottom	4mm	4mm
North	4mm	4mm
South	4mm	4mm
<u>6</u>	39mm	39mm
<u>Bush thickness</u>		
Top	4mm	3mm
Bottom	4mm	3mm
North	4mm	3mm
South	4mm	3mm
<u>7</u>	39mm	39mm
<u>Bush thickness</u>		
Top	- mm	4mm
Bottom	3mm	4mm
North	3mm	4mm
South	3mm	4mm
<u>8</u>	39mm	39mm
<u>Bush thickness</u>		
Top	CORRODED	3mm
Bottom		3mm
North		3mm
South		3mm
<u>9</u>	39mm	39mm
<u>Bush thickness</u>		
Top	3mm	3mm
Bottom	4mm	3mm
North	3mm	1mm
South	2mm	3mm
<u>10</u>	39mm	39mm
<u>Bush thickness</u>		
Top	2mm	3.5mm
Bottom	2mm	2mm
North	2.5mm	1mm
South	1mm	2mm

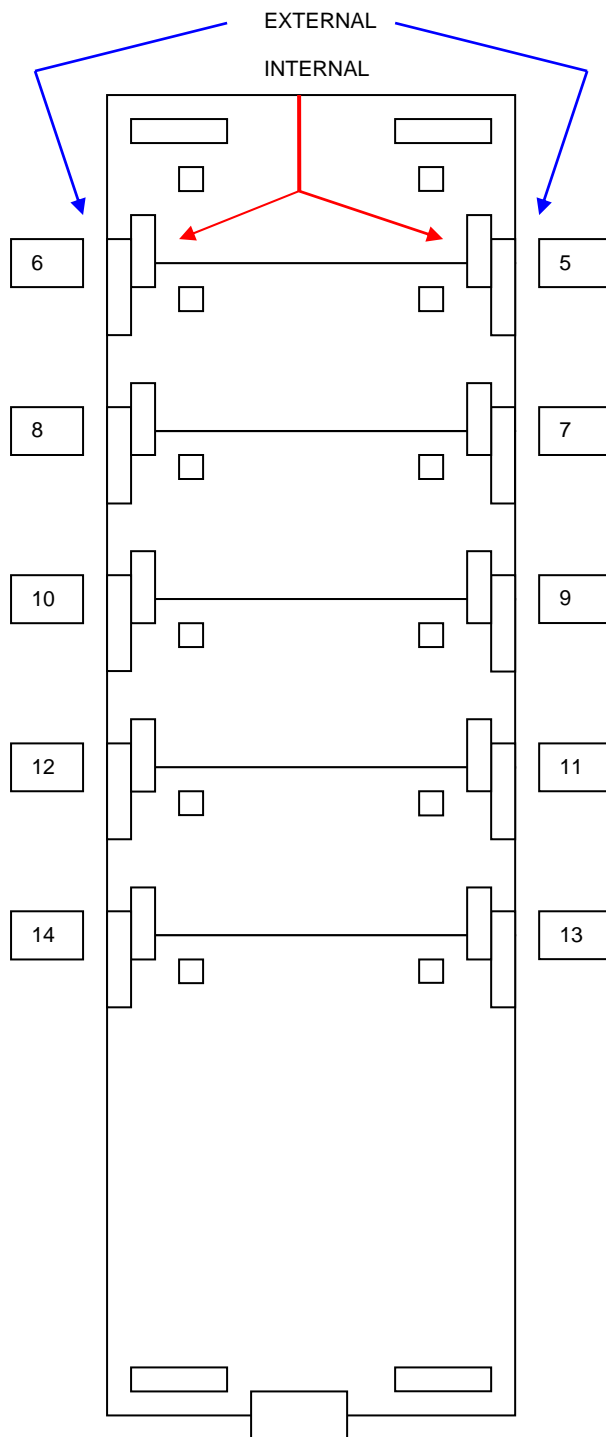
PIN No.	EXTERNAL	INTERNAL
<u>11</u>	39mm	39mm
<u>Bush thickness</u>		
Top	2mm	3mm
Bottom	4mm	3mm
North	4mm	0mm
South	0mm	3mm
<u>12</u>	39mm	39mm
<u>Bush thickness</u>		
Top	2mm	0mm
Bottom	0mm	2mm
North	0mm	0mm
South	0mm	2mm
<u>13</u>	39mm	39mm
<u>Bush thickness</u>		
Top	0 mm	1mm
Bottom	0mm	2mm
North	0mm	0mm
South	0mm	2mm
<u>14</u>	39mm	39mm
<u>Bush thickness</u>		
Top	0mm	2mm
Bottom	3mm	2mm
North	2mm	0mm
South	0mm	2mm

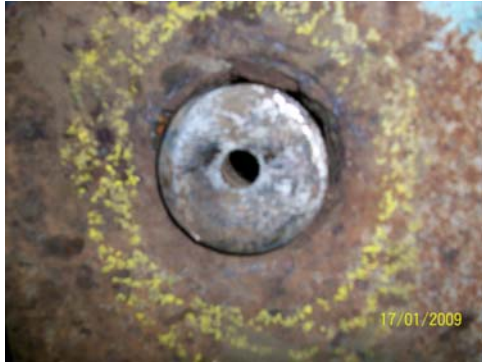
Position No. 8 External: Protruding pin, seized on inner lug. Pin ground down to ease reinstatement.

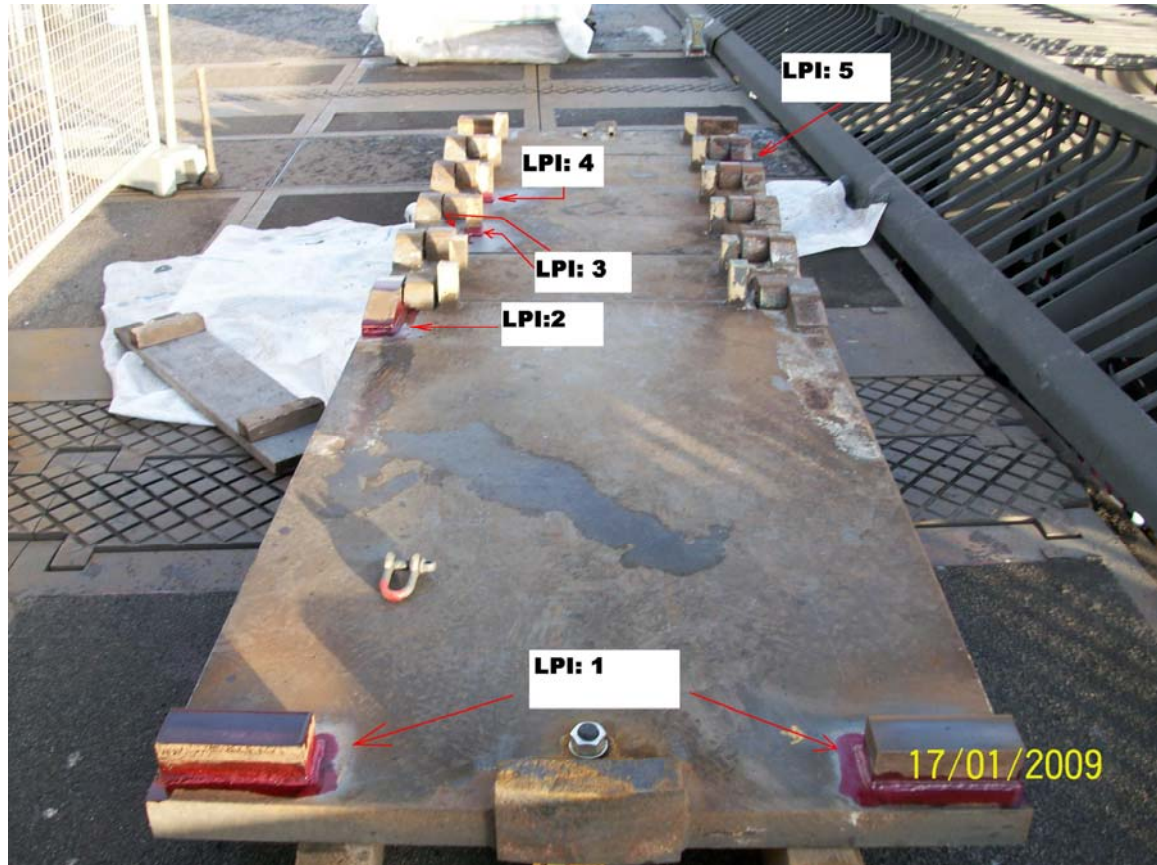
The liquid penetrant weld inspection consisted of five locations randomly chosen.
Below shows positions inspected, followed by individual inspection reports.

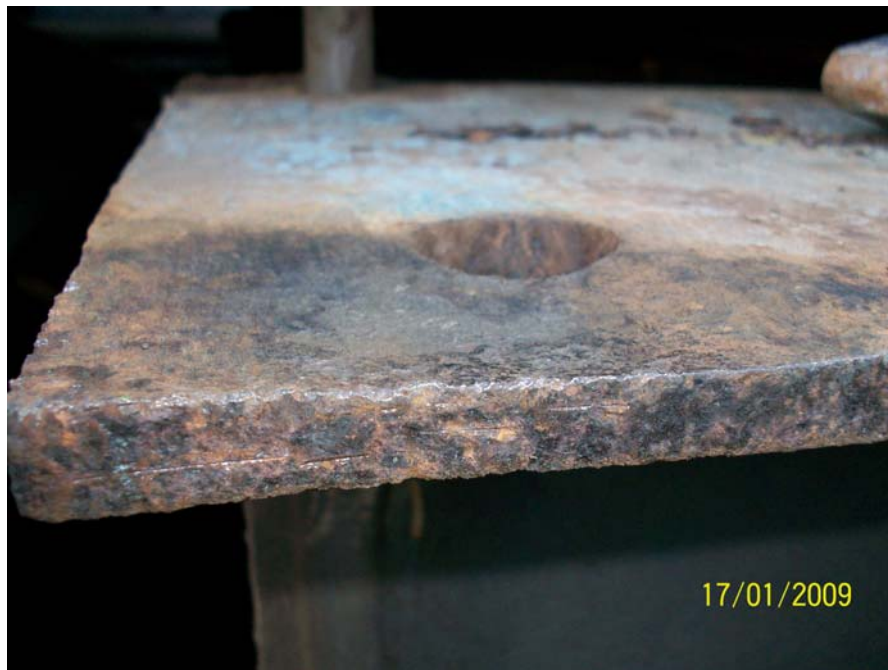
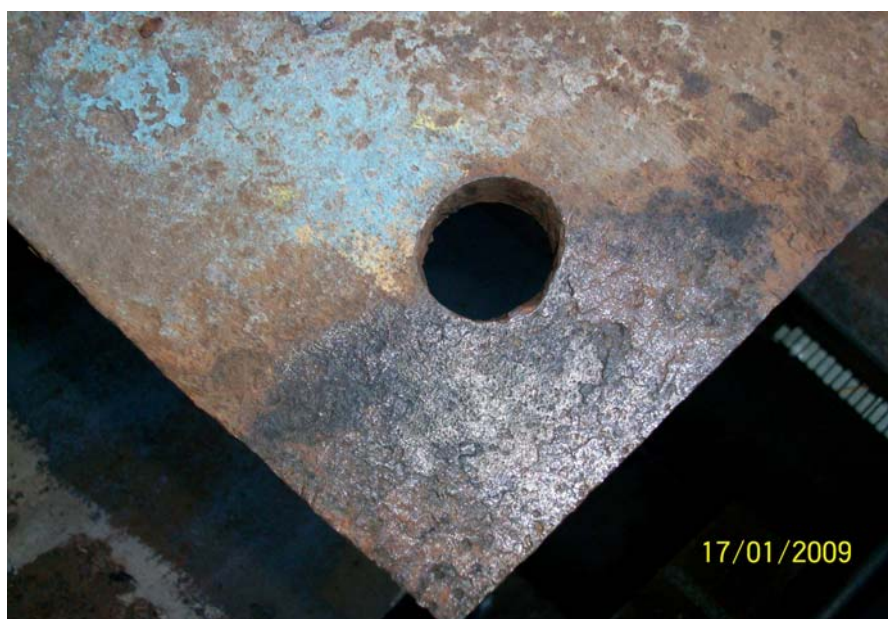
There was also an inspection of the west tongue plate bearing beam, which had a large amount of corrosion on its south east corner, the findings are as follows.

The flange of the beam has an approximate thickness of 18mm, when corrosion has been removed the edge thickness measures 12mm, with a depression of a thickness of 9mm.

The tongue plate pin hole is also elongated, this could be from time of installation or not. The hole measures 29mm Dia. and 36.5mm long.

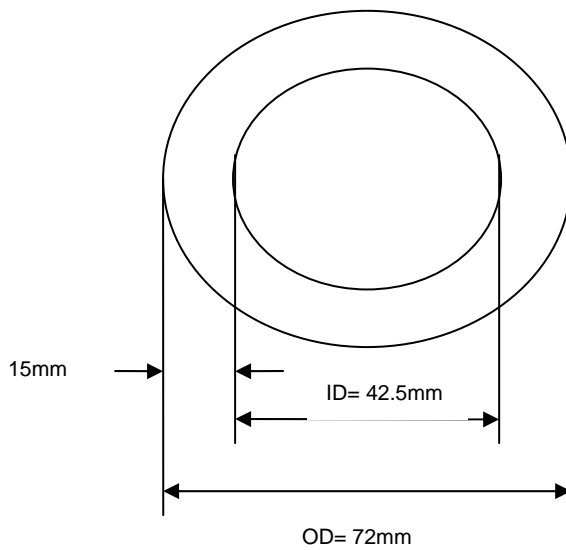
EXISTING SPRING

On reinstating the expansion joint, new springs were fitted to MW3 tongue plate and also to MW2 (east spring only) and also to MW4 (west spring only). On installation of the rocker plate it was discovered that the newly purchased rocker plate springs were the incorrect size. The original spring was re-used as it was in good enough condition.

MEAN DIA. = 57mm

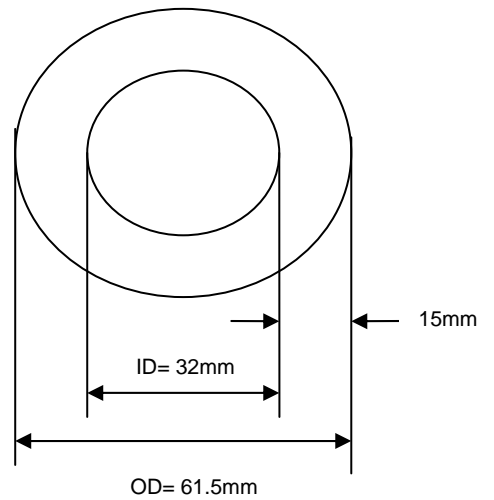
NEW SPRING

MEAN DIA. = 47mm

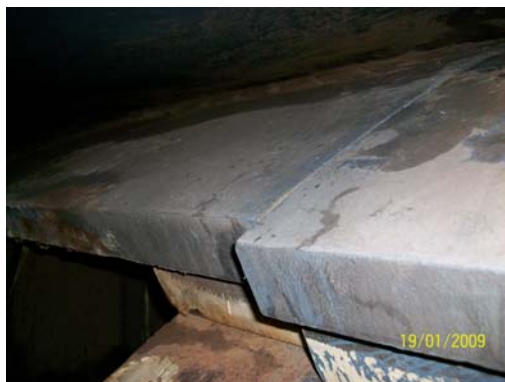
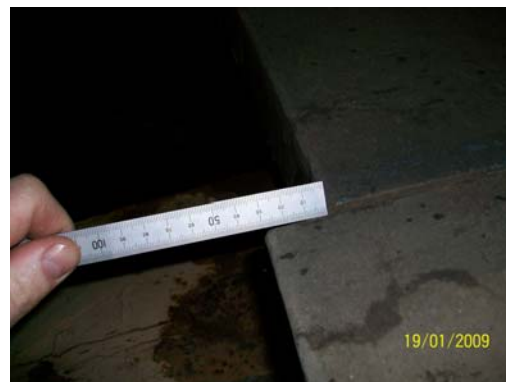
Slide plate No.5 has still not settled back into its original position, as photos show.

As a result gaps between rocker plate and slide plate1 are still sitting at approximately $30\text{mm} \pm 5\text{mm}$.
