INSPECTION DEPARTMENT
INSPECTION. North Anchorage Monthly Inspection
DATE. 2015.08.06

INSPECTION DEPARTMENT
South east anchor chamber. Crosshead block C6. & R2 INSPECTION.
DATE. 2015.08.06

INSPECTION DEPARTMENT
SOUTH ANCHORAGE FACE WEEKLY INSPECTION
DATE. 2015.08.06

INSPECTION DEPARTMENT
SOUTH WEST ANCHORAGE CHAMBER BLOCK R3
DATE. 2015.08.06

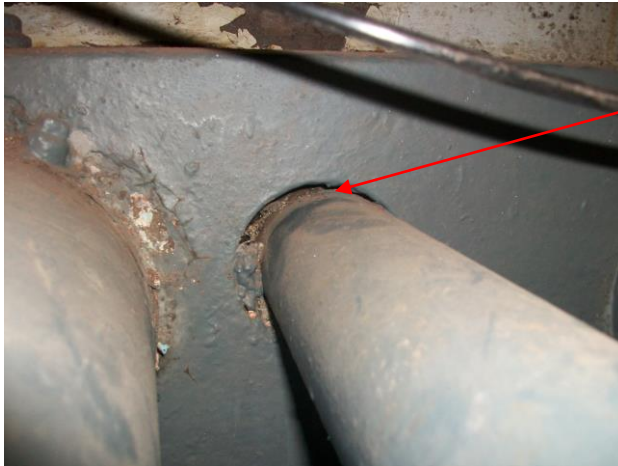
Crosshead block R 2.

East sleeve top , void evident at  
Top and east side of sleeve .

Voids evident on crosshead block R2. These were marked for indication of any movement or turning .
