INSPECTION DEPARTMENT
INSPECTION. North Anchorage Monthly Inspection
DATE. 2015.03.09

INSPECTION DEPARTMENT
South east anchor chamber. Crosshead block C6. & R2 INSPECTION.
DATE. 2015.05.11.

INSPECTION DEPARTMENT
SOUTH WEST ANCHORAGE CHAMBER BLOCK R3
DATE. 2015.03.09

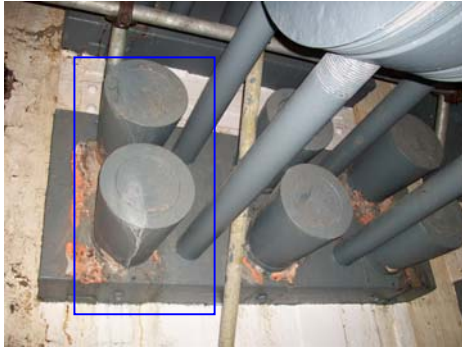
East side of crosshead block
from area between poured sockets.
Paint very brittle, cracking over whole
Block evident. loss of adhesion. (No
change from inspection date. (09.04.15.)

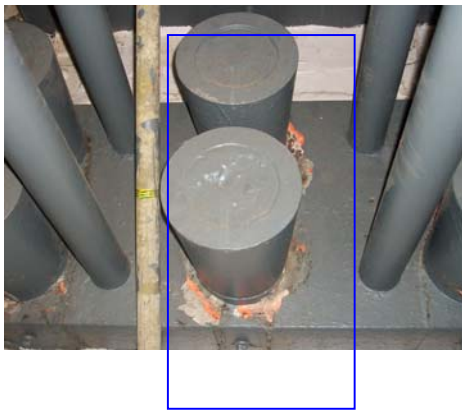
Centre of crosshead block C6. Paint
removed from west side of socket and from
directly below bottom socket.
(No change from inspection date.
(09.04.15.)

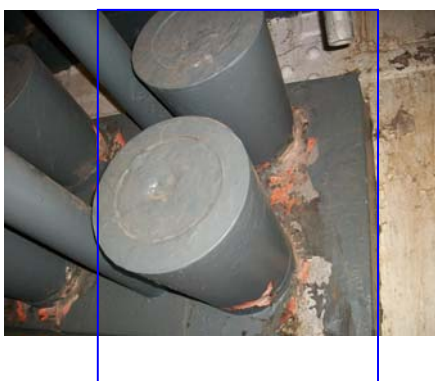
West side of crosshead block C6. Paint removed
from west side and directly below top socket and
on the west side of the bottom socket.
(No change from inspection date. (09.04.15.)

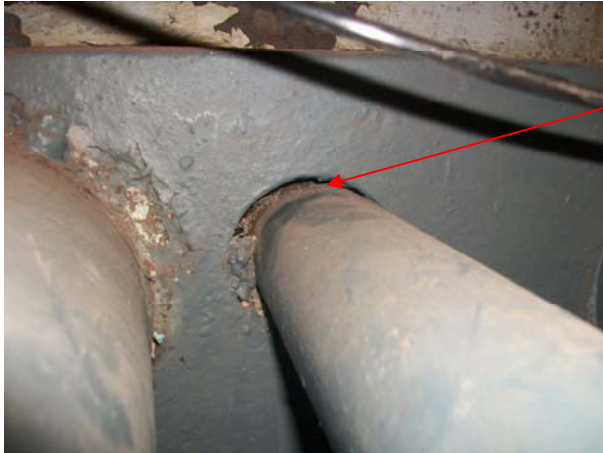
Crosshead block R 2.

East sleeve top , void evident at
Top and east side of sleeve .

Voids evident on crosshead block R2. These were marked for indication of any movement or turning .

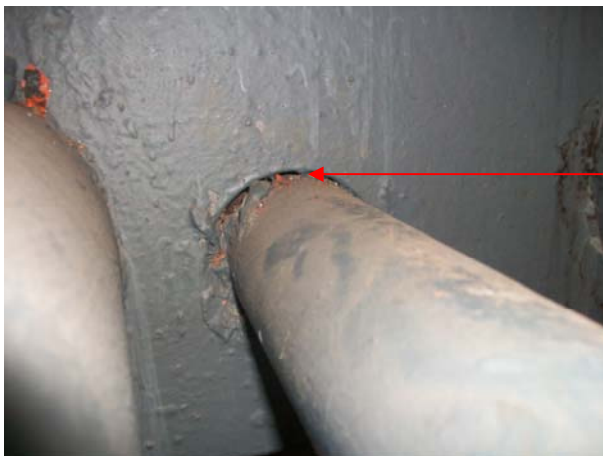
Crosshead block R 2.

East sleeve bottom , void evident at
Top and east side of sleeve .
