INSPECTION DEPARTMENT
INSPECTION. North Anchorage Monthly Inspection
DATE. 2015.04.09

INSPECTION DEPARTMENT
SOUTH ANCHORAGE FACE WEEKLY INSPECTION
DATE. 2015.04.09

INSPECTION DEPARTMENT
South east anchor chamber. Crosshead block C6. & R2 INSPECTION.
DATE. 2015.04.09

INSPECTION DEPARTMENT
SOUTH WEST ANCHORAGE CHAMBER BLOCK R3
DATE. 2015.04.09

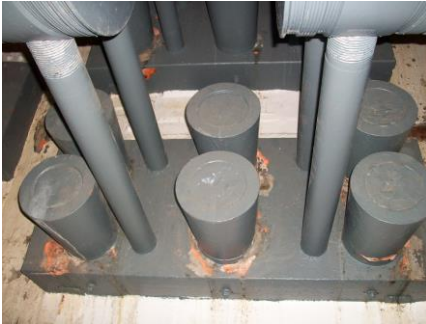
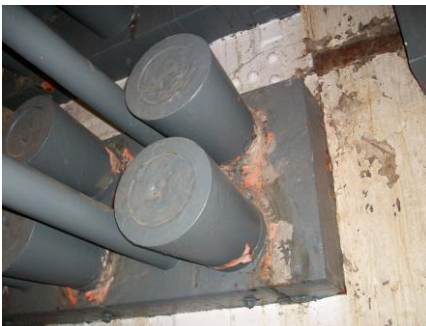
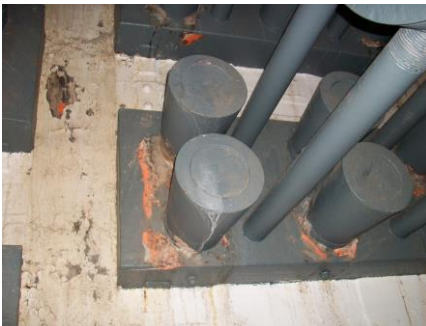
Comparison photographs recorded on Inspection date. (09.03.15.)

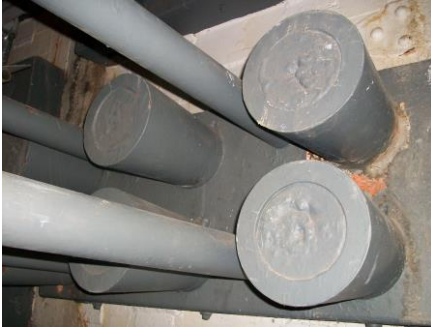
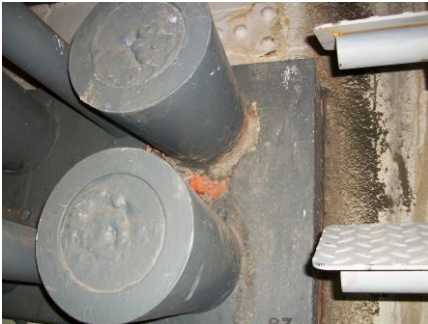
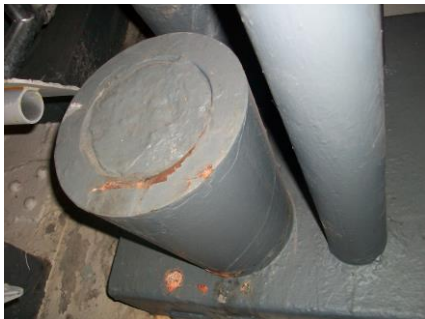
Comparison photographs recorded on Inspection date. (09.03.15.)
