INSPECTION DEPARTMENT
INSPECTION. North Anchorage Monthly Inspection
DATE. 2015.07.10

INSPECTION DEPARTMENT
SOUTH ANCHORAGE FACE WEEKLY INSPECTION
DATE. 2015.07.10

INSPECTION DEPARTMENT
South east anchor chamber. Crosshead block C6. & R2 INSPECTION.
DATE. 2015.07.10

INSPECTION DEPARTMENT
SOUTH WEST ANCHORAGE CHAMBER BLOCK R3
DATE. 2015.07.10

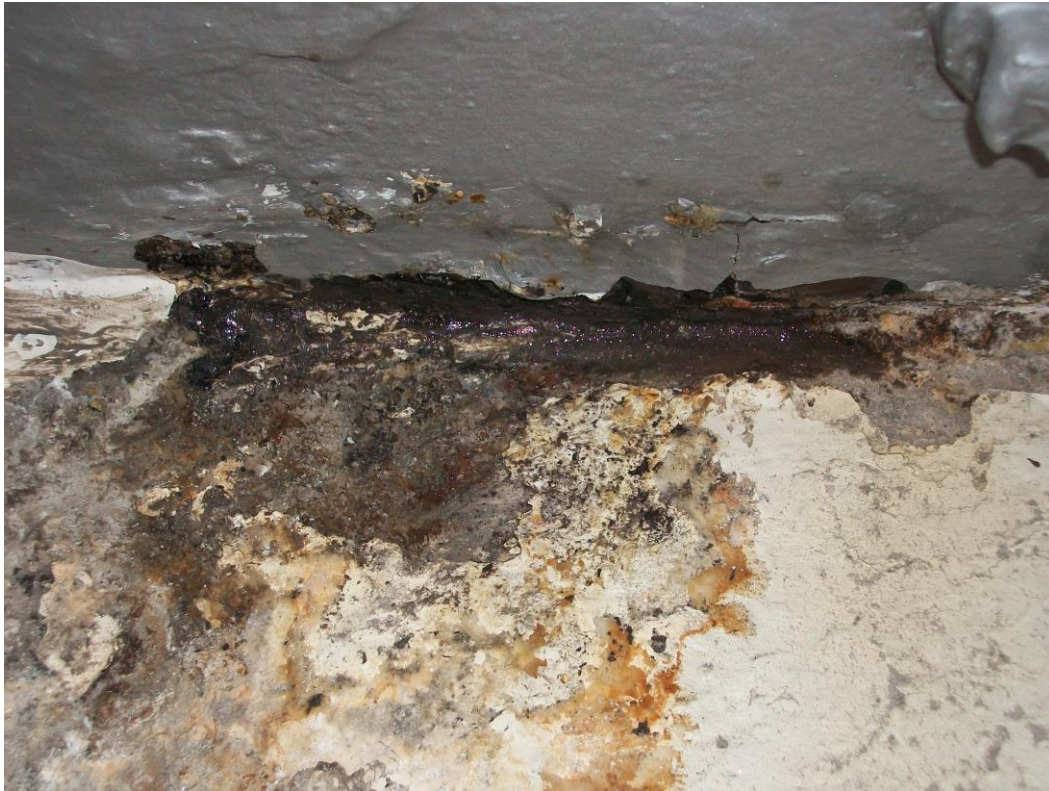
Small area of weeping over approx 200mm evident in centre where crosshead block meets anchorage face on **C6 . evidence of past staining but more prominent this weekly inspection. Localised.**

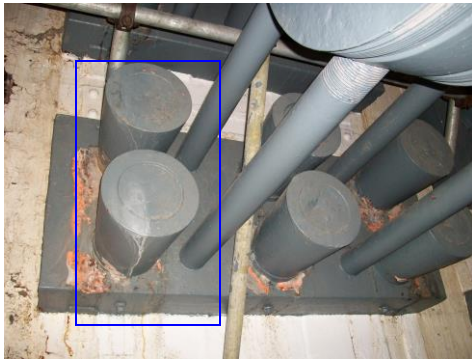
East side of crosshead block
from area between poured sockets.
Paint very brittle, cracking over whole
Block evident. loss of adhesion. (No
change from inspection date. (15.06.15.)

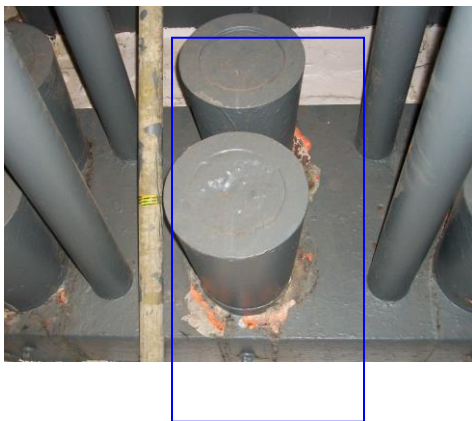
Centre of crosshead block C6. Paint
removed from west side of socket and from
directly below bottom socket.
(No change from inspection date.
. (15.06.15.)

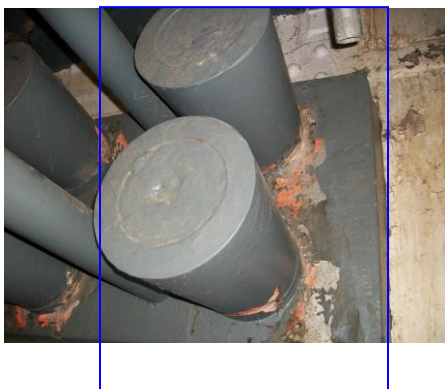
West side of crosshead block C6. Paint removed
from west side and directly below top socket and
on the west side of the bottom socket.
(No change from inspection date. . (15.06.15.)

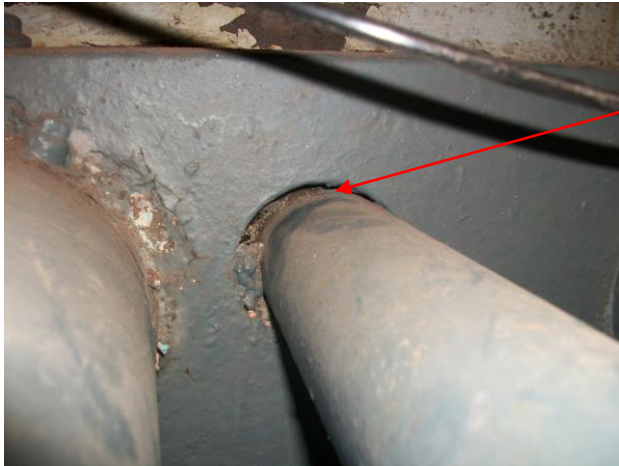
Crosshead block R 2.

East sleeve top , void evident at
Top and east side of sleeve .

Voids evident on crosshead block R2. These were marked for indication of any movement or turning .

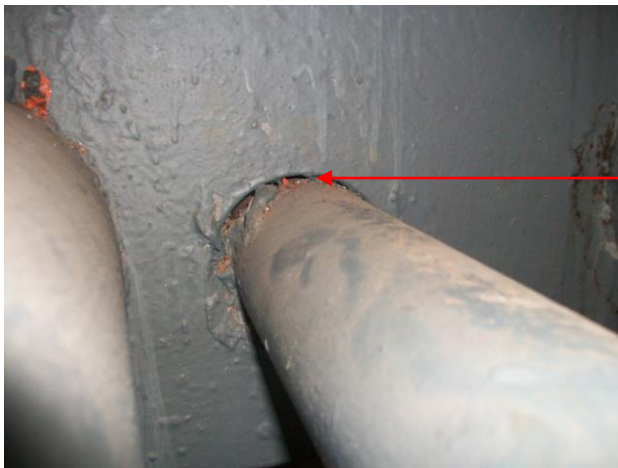
Crosshead block R 2.

East sleeve bottom , void evident at
Top and east side of sleeve .

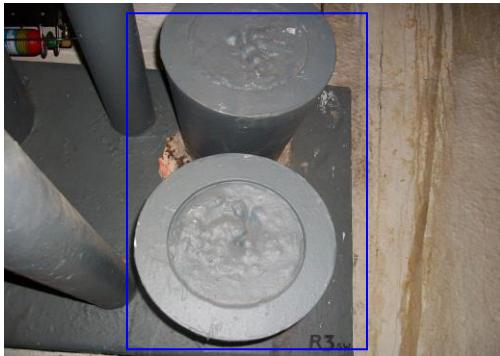
West side of crosshead block R3. paint removed from East & west side and directly below top socket .

(No change from inspection date. . (15.06.15.)

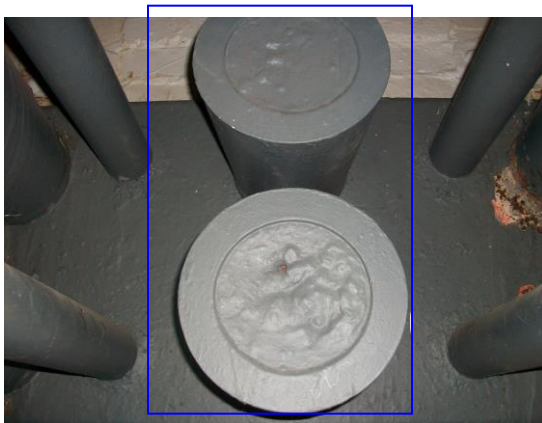
No paint missing from around top or bottom socket, no moisture evident.

(No change from inspection date. . (15.06.15.)

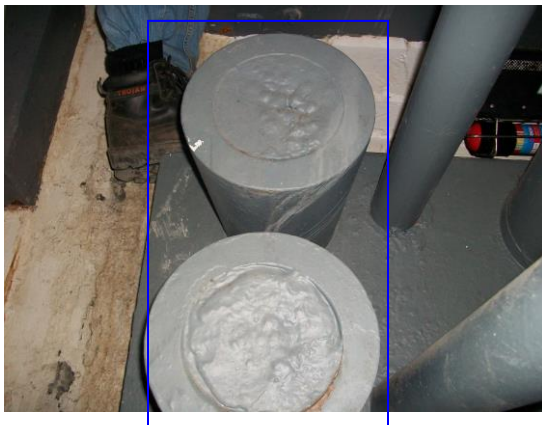
Sight area of zinc salts present on S/W corner of bottom socket. Area of paint breakdown evident.

Top socket satisfactory.

(No change from inspection date.
 . (15.06.15.)
