INSPECTION DEPARTMENT
INSPECTION. North Anchorage Monthly Inspection
DATE. 2015.09.11

INSPECTION DEPARTMENT
SOUTH ANCHORAGE FACE WEEKLY INSPECTION
DATE. 2015.09.11

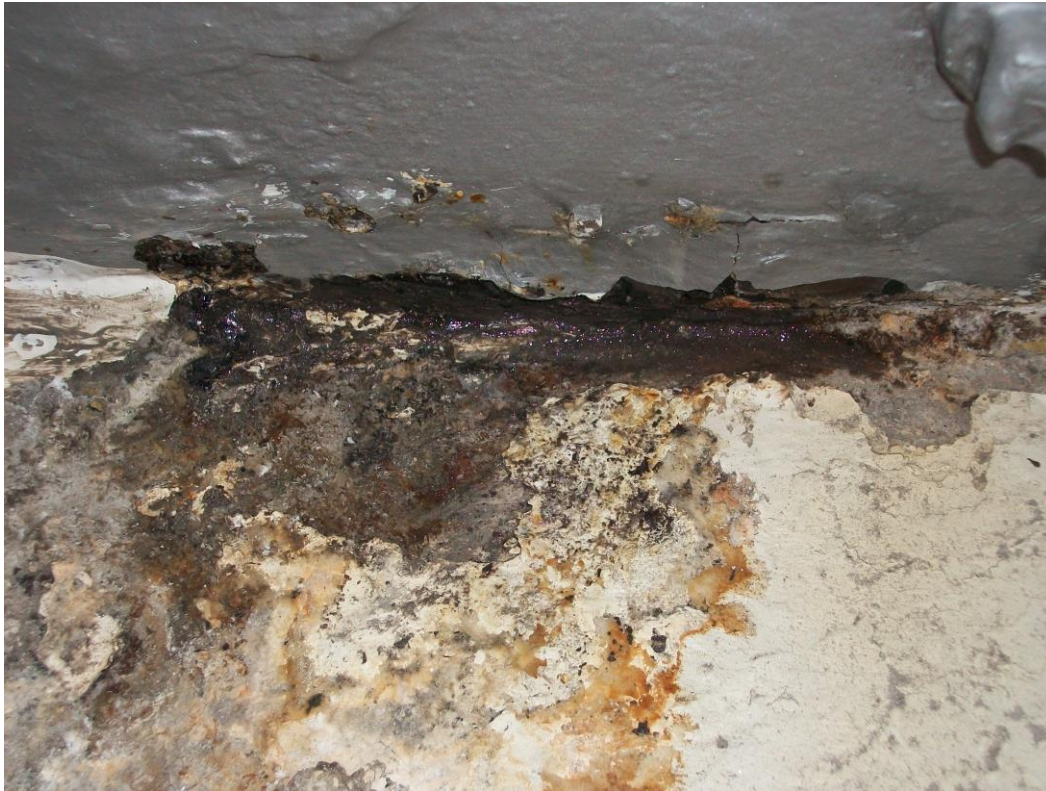
Small area of weeping over approx 200mm evident in centre where crosshead block meets anchorage face on **C6 . evidence of past staining but more prominent this weekly inspection. Localised.**

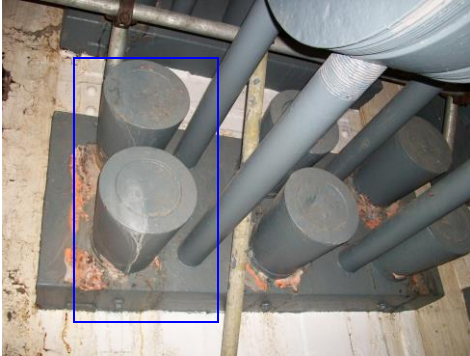
East side of crosshead block from area between poured sockets. Paint very brittle, cracking over whole Block evident. loss of adhesion. (No change from inspection date. (06.08.15)

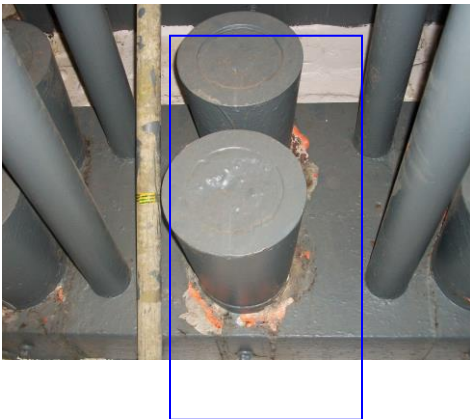
Centre of crosshead block C6. Paint removed from west side of socket and from directly below bottom socket. (No change from inspection date. (06.08.15.)

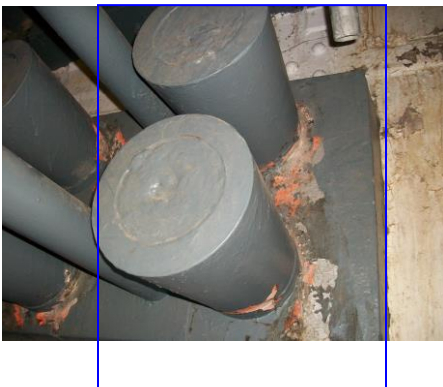
West side of crosshead block C6. Paint removed from west side and directly below top socket and on the west side of the bottom socket. (No change from inspection date. (06.08.15.)

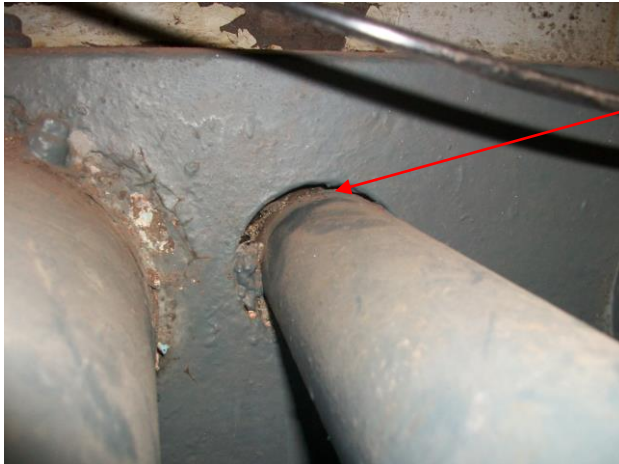
Crosshead block R 2.
East sleeve top , void evident at
Top and east side of sleeve .

Voids evident on crosshead block R2. These were marked for indication of any movement or turning .

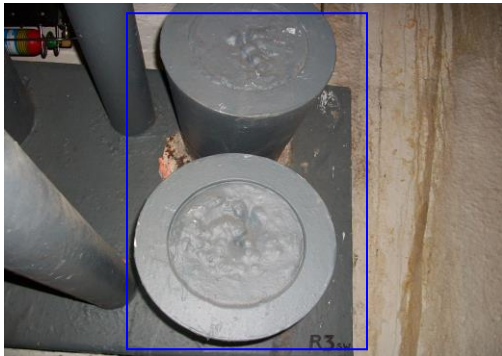
West side of crosshead block R3. paint removed from East & west side and directly below top socket .

(No change from inspection date. (06.08.15.)
