INSPECTION DEPARTMENT
INSPECTION. North Anchorage Monthly Inspection
DATE. 2015.01.12

INSPECTION DEPARTMENT
SOUTH ANCHORAGE FACE WEEKLY INSPECTION
DATE. 2015.01.12

INSPECTION DEPARTMENT
South east anchor chamber. Crosshead block C6. & R2 INSPECTION.
DATE. 2015.01.12

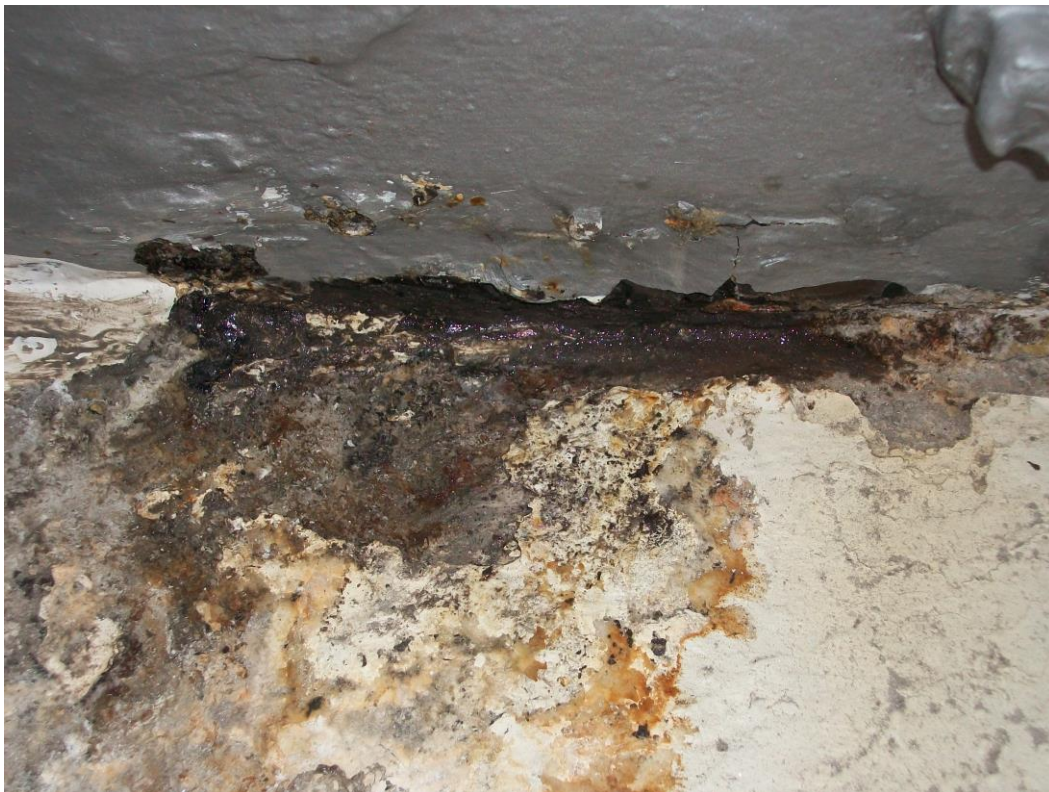
Small area of weeping over approx 200mm evident in centre where crosshead block meets anchorage face on **C6 . evidence of past staining but more prominent this weekly inspection. Localised.**

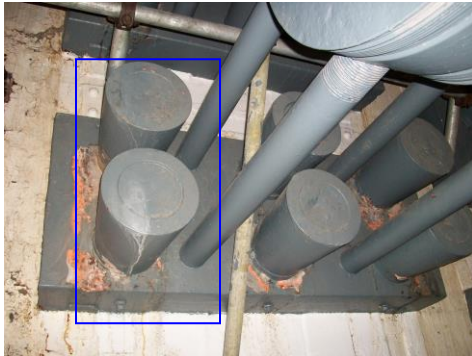
East side of crosshead block  
from area between poured sockets.  
Paint very brittle, cracking over whole  
Block evident. loss of adhesion. ( No  
change from inspection date. (03.12.14.)

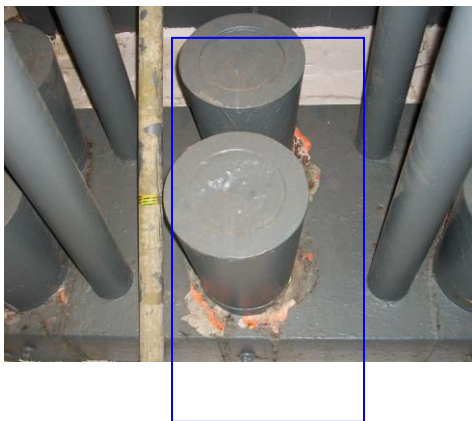
Centre of crosshead block C6. Paint  
removed from west side of socket and from  
directly below bottom socket.  
(No change from inspection date.  
(03.12.14.)

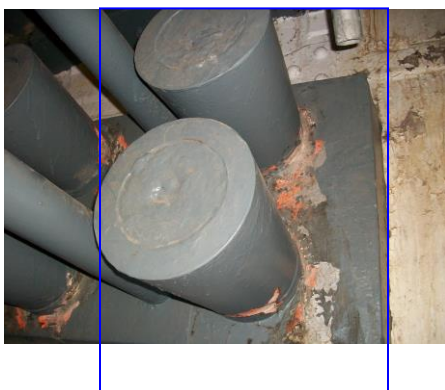
West side of crosshead block C6. Paint removed  
from west side and directly below top socket and  
on the west side of the bottom socket.  
( No change from inspection date. (03.12.14.)

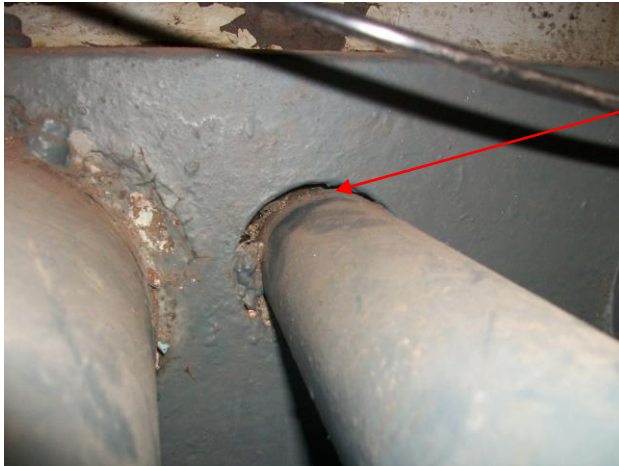
Crosshead block R 2.

East sleeve top , void evident at  
Top and east side of sleeve .

Voids evident on crosshead block R2. These were marked for indication of any movement or turning .

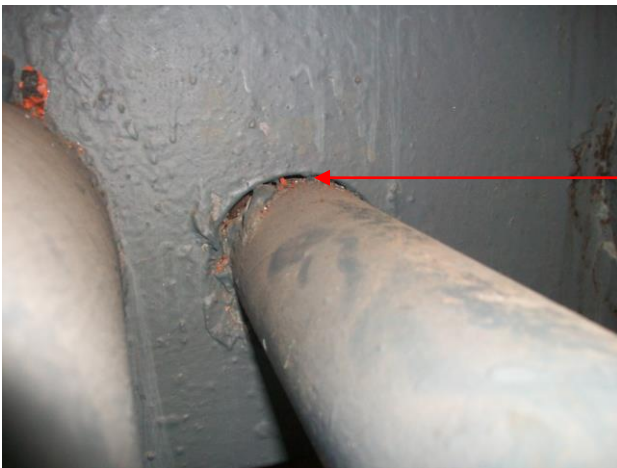
Crosshead block R 2.

East sleeve bottom , void evident at  
Top and east side of sleeve .

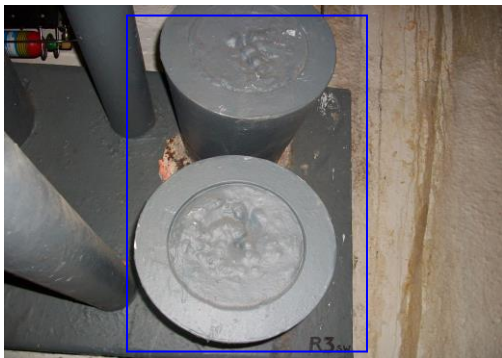
West side of crosshead block R3. paint removed from East & west side and directly below top socket .

( No change from inspection date. (03.12.14.)

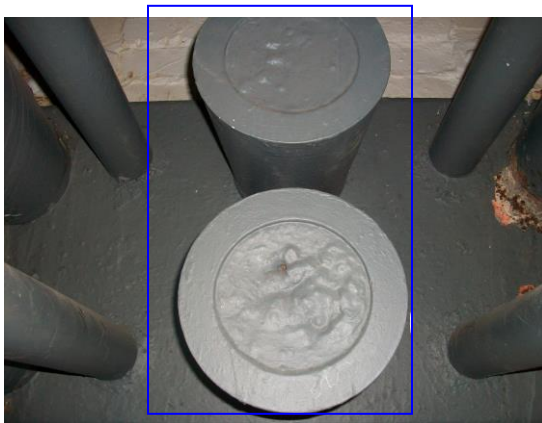
No paint missing from around top or bottom socket, no moisture evident.

(No change from inspection date. (03.12.14.)

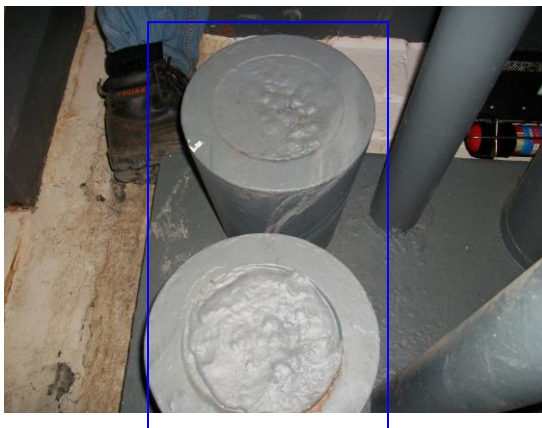
Sight area of zinc salts present on S/W corner of bottom socket. Area of paint breakdown evident.

Top socket satisfactory.

(No change from inspection date.  
(03.12.14.)
