INSPECTION DEPARTMENT
INSPECTION. North Anchorage Monthly Inspection
DATE. 2015.02.12

INSPECTION DEPARTMENT
South east anchor chamber. Crosshead block C6. & R2 INSPECTION.
DATE. 2015.02.12

INSPECTION DEPARTMENT
SOUTH WEST ANCHORAGE CHAMBER BLOCK R3
DATE. 2015.02.12

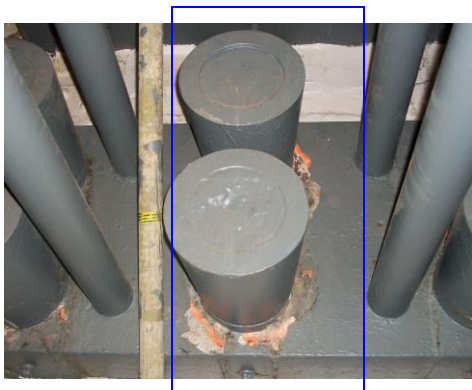
Centre of crosshead block C6. Paint
removed from west side of socket and from
directly below bottom socket.
(No change from inspection date.
(12.01.15.)

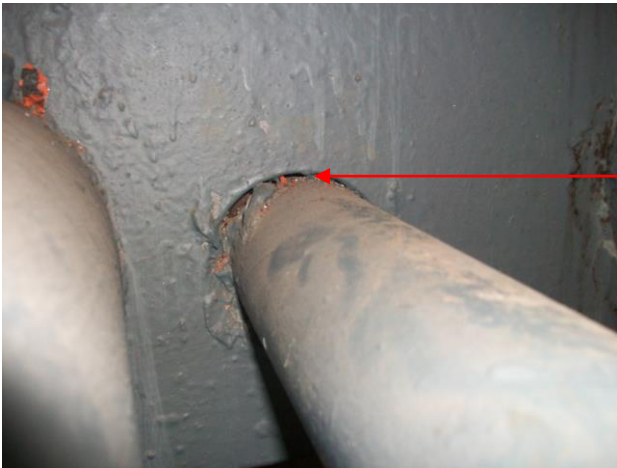
Crosshead block R 2.

East sleeve bottom , void evident at
Top and east side of sleeve .

Voids evident on crosshead block R2. These were marked for indication of any movement or turning .

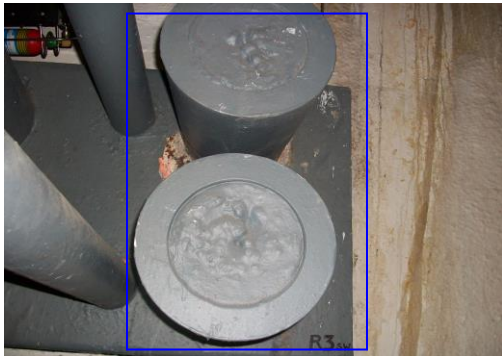
West side of crosshead block R3. paint removed from East & west side and directly below top socket .

(No change from inspection date. (12.01.15.)
