INSPECTION DEPARTMENT
INSPECTION. North Anchorage Monthly Inspection
DATE. 2015.06.15.

INSPECTION DEPARTMENT
SOUTH ANCHORAGE FACE WEEKLY INSPECTION
DATE. 2015.06.15.

INSPECTION DEPARTMENT
South east anchor chamber. Crosshead block C6. & R2 INSPECTION.
DATE. 2015.06.15..

INSPECTION DEPARTMENT
SOUTH WEST ANCHORAGE CHAMBER BLOCK R3
DATE. 2015.06.15.

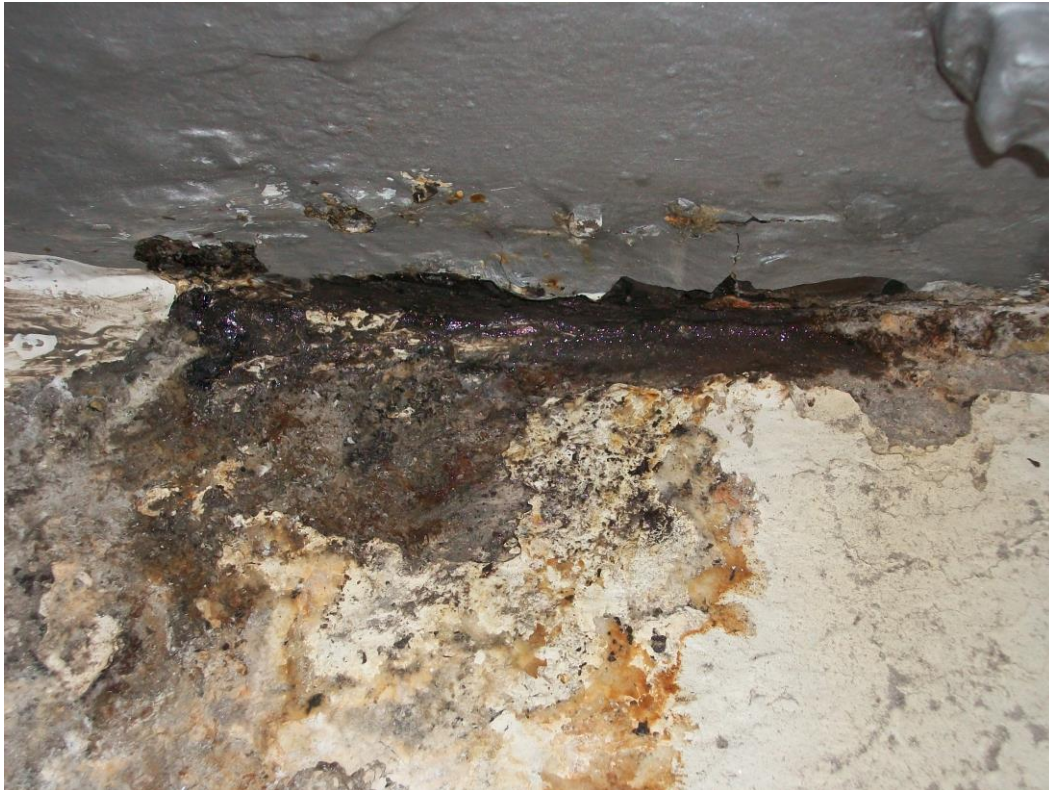
Small area of weeping over approx 200mm evident in centre where crosshead block meets anchorage face on **C6 . evidence of past staining but more prominent this weekly inspection. Localised.**

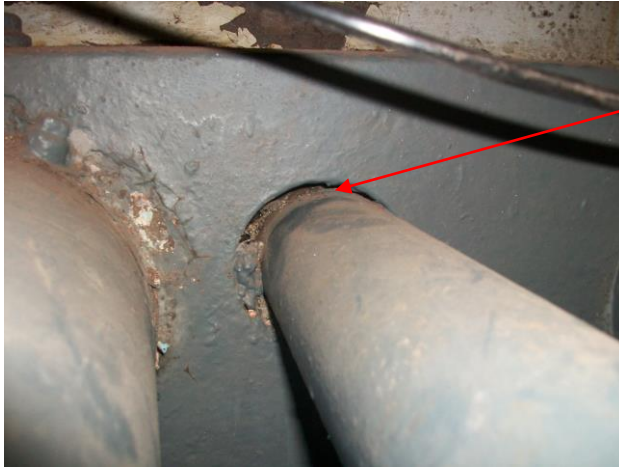
Crosshead block R 2.

East sleeve top , void evident at
Top and east side of sleeve .

Voids evident on crosshead block R2. These were marked for indication of any movement or turning .

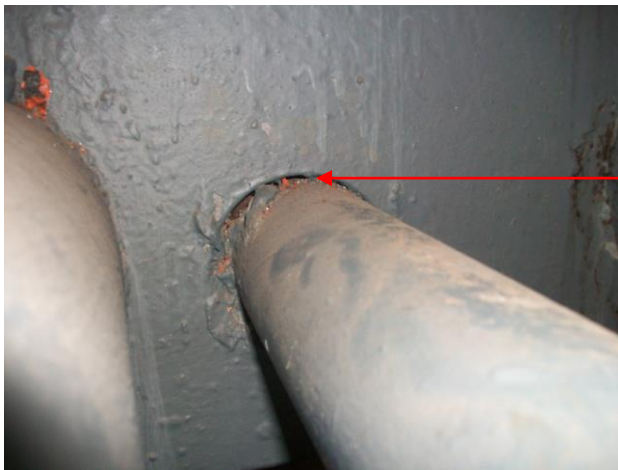
Crosshead block R 2.

East sleeve bottom , void evident at
Top and east side of sleeve .
