INSPECTION DEPARTMENT
INSPECTION. North Anchorage Monthly Inspection
DATE. 2015.12.30..

INSPECTION DEPARTMENT
SOUTH ANCHORAGE FACE WEEKLY INSPECTION
DATE. 2015.12.30.

INSPECTION DEPARTMENT
SOUTH WEST ANCHORAGE CHAMBER BLOCK R3
DATE. 2015.12.30..

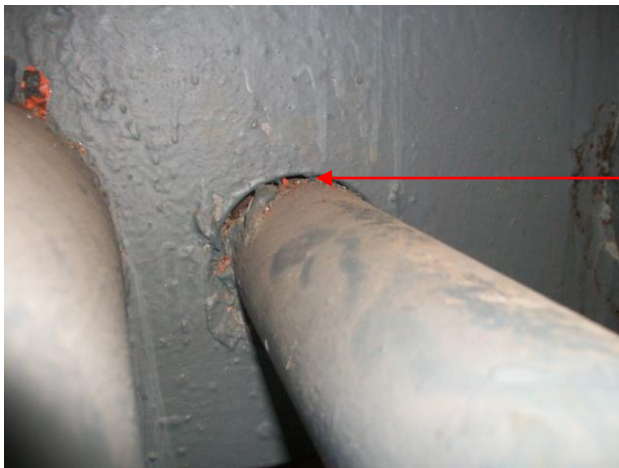
Crosshead block R 2.

East sleeve bottom , void evident at
Top and east side of sleeve .

Voids evident on crosshead block R2. These were marked for indication of any movement or turning .

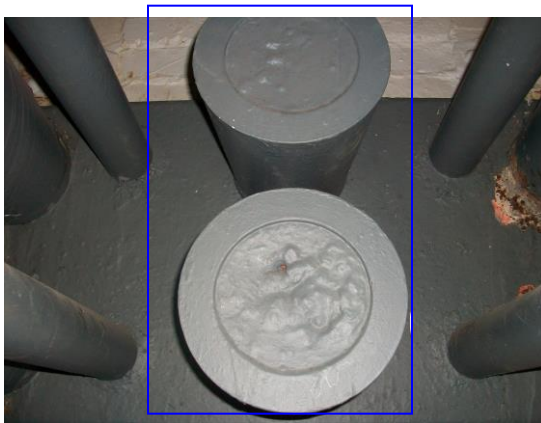
No paint missing from around top or bottom socket, no moisture evident.

(No change from inspection date. (12.11.2015.)

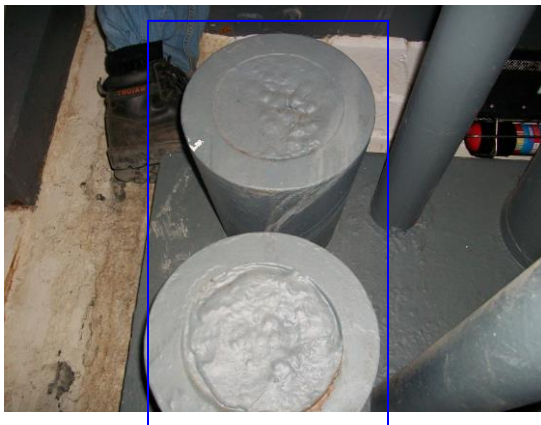
Sight area of zinc salts present on S/W corner of bottom socket. Area of paint breakdown evident.

Top socket satisfactory.

(No change from inspection date.
. (12.11.2015.)
