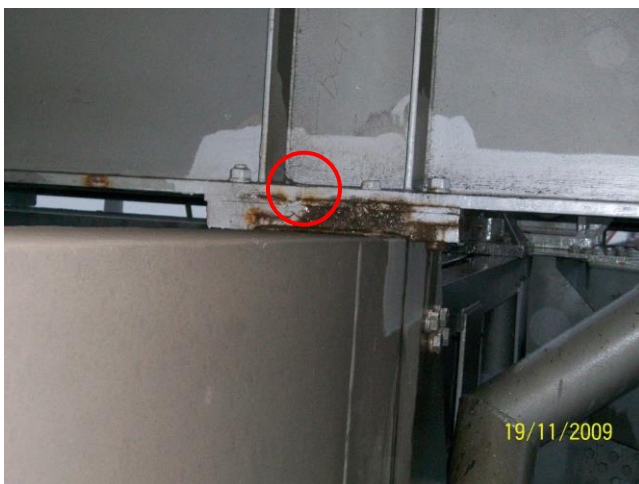
P.P.54 N.E.

No.1 STRINGER BEARING PLATE
HAS ONE BOLT SHEARED OR
MISSING.

ACCESS REQUIRED.

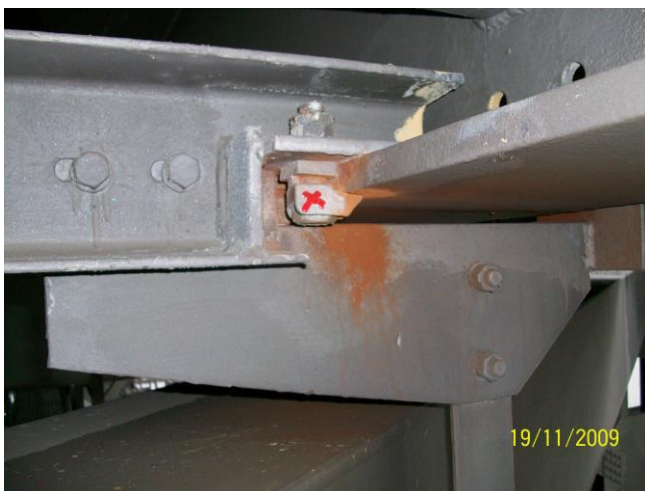
P.P.70 N.E.

2nd WALKWAY SUPPORT SOUTH
HAS WEAR BETWEEN STRINGER &
LINDAPTORS, BOTH NORTH &
SOUTH SIDES OF SUPPORT.
NEW LINDAPTORS REQUIRED.

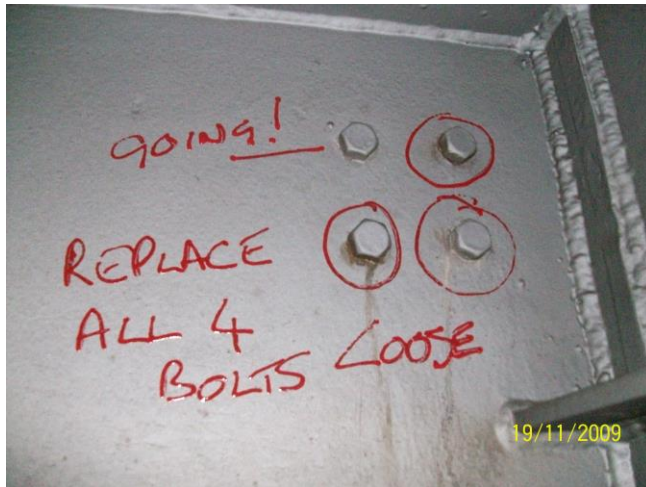
P.P.94 N.E.

GULLY POT LOCATED ON
STRINGER No.1 HAS 4 BOLTS
LOOSE AND THE FOURTH
BEGINNING TO GO.

REPLACE ALL 4 BOLTS.

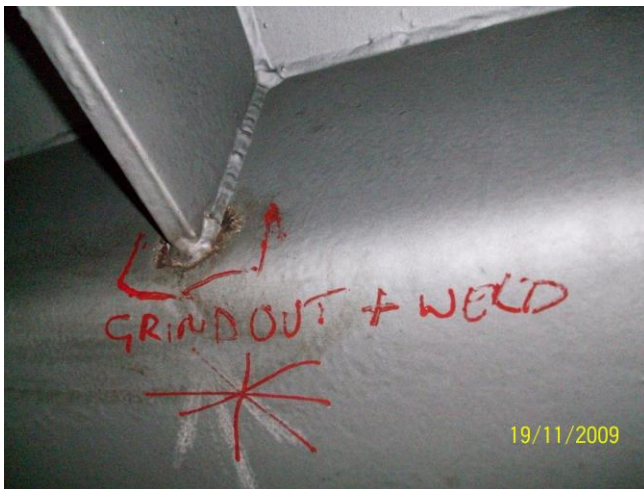
P.P.94 N.E.

STIFFENER PLATE FROM STRINGER
No.1 TO TROUGH No.1 HAS
CRACKED WELD.

GRIND OUT AND RE-WELD
REQUIRED.
