INSPECTION DEPARTMENT
DEFECTIVE AREA ON CONCRETE SOFFIT. C/BEAMS 58-59 N/E VIADUCT.
DATE. 06/04/10

Following a meeting with ESM. C.Tracey. which was attended by bridge inspectors, a request was made to carry out a special inspection of an area of discoloured concrete located on the carriageway deck soffit between crossbeams 59-60 on the north east viaduct.

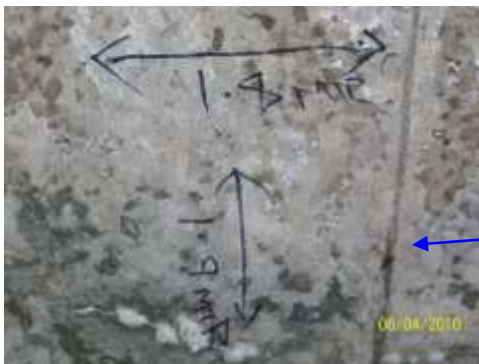
The area on the deck soffit was inspected visually, approximate measurements were taken. Heavy veinular cracking was evident with signs of salts (formed stalagtites and surface powder were clearly evident over two transverse cracks approx 600 mm apart). No longitudinal cracking evident at time of inspection. Area dimensions as per photographs.

Approximate area
dimensions of
discoloured area on
deck soffit .

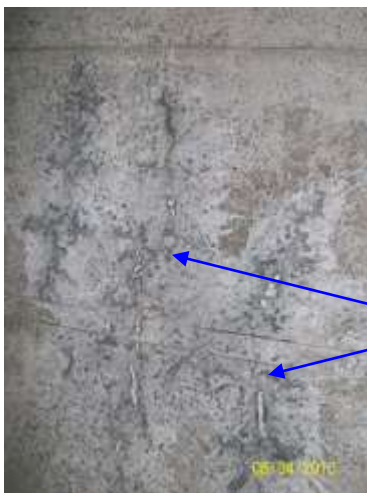
Two transverse cracks evident at
affected area. Salts being
discharged to deck soffit area.

Stalagtites beginning to form.

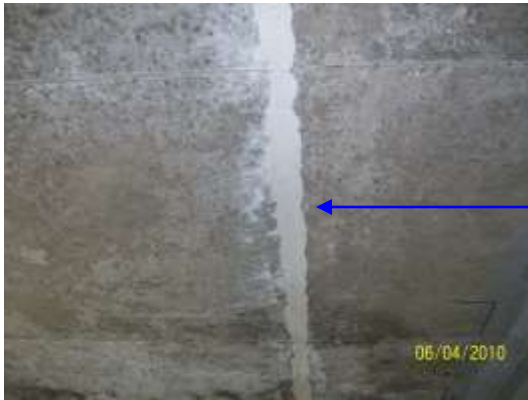
Transverse epoxy mortar repair
carried out pre- 1990

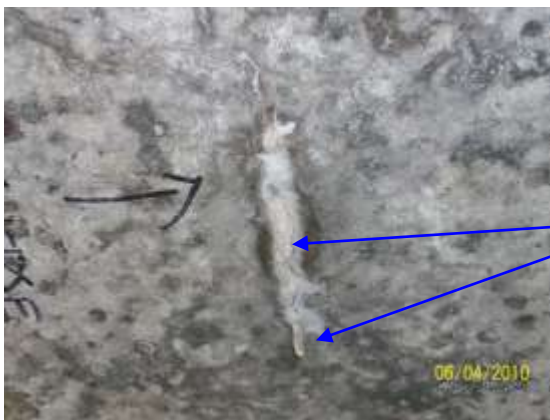
Salts being discharged
from transverse cracks.

Stalagmites evident.

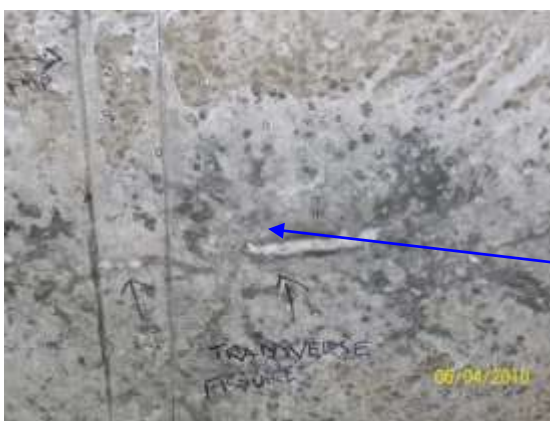
Another view of Transverse
crack with Salts being
discharged.
