An independent inspection was carried out on the west side barrier of the north approach, on Sunday 8th February 2009.

The state of corrosion was investigated at this time.

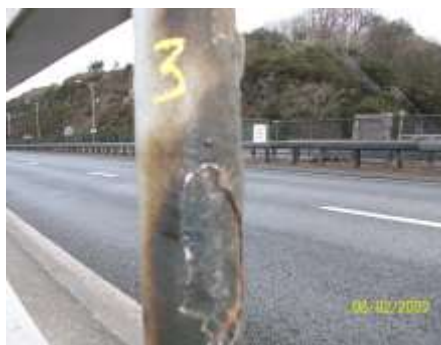
Example of corrosion.

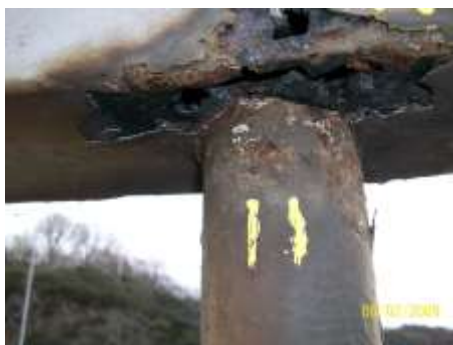
The only weld that was found to be defective or lacking was at the top of the post at position 11. All other welds are visibly satisfactory. Top rail is also holed position 11.

Position 11 (upper post + rail).

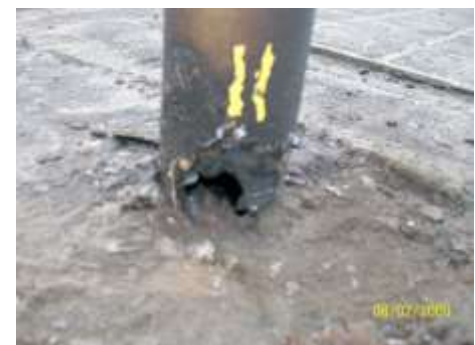
Position 11 (lower post).

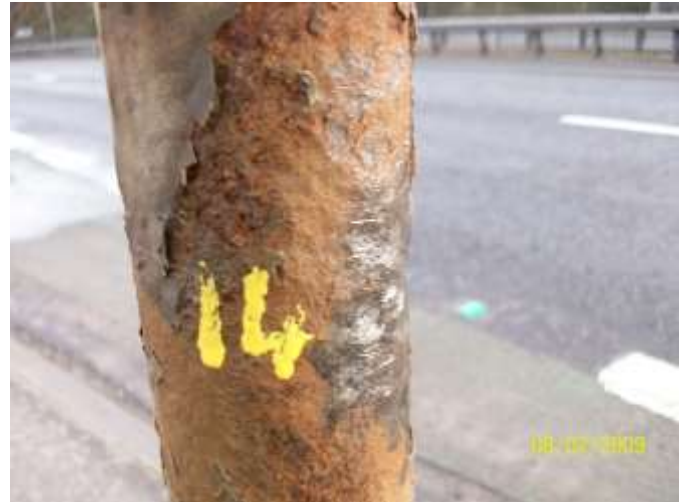
Although not all posts are holed, they are all subject to heavy corrosion and wall thinning, which will result in a hole in time. Posts 17, 18 and 19 are in the best condition, but rails show signs of impact damage.

Position 14 (wall thinning).

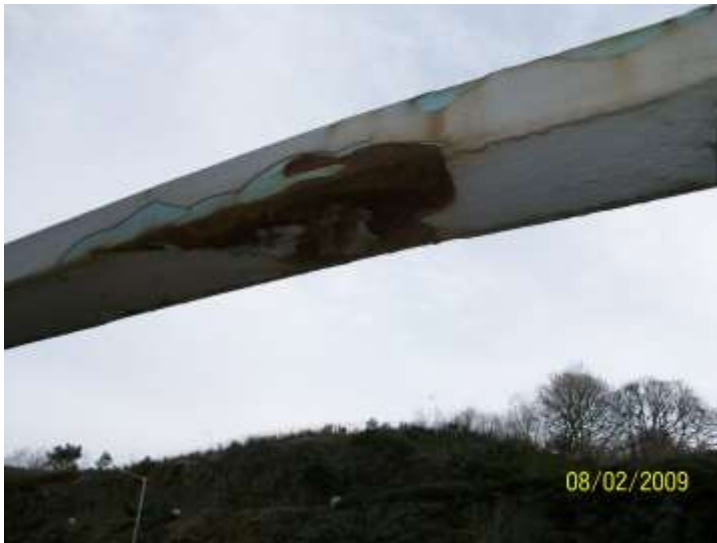
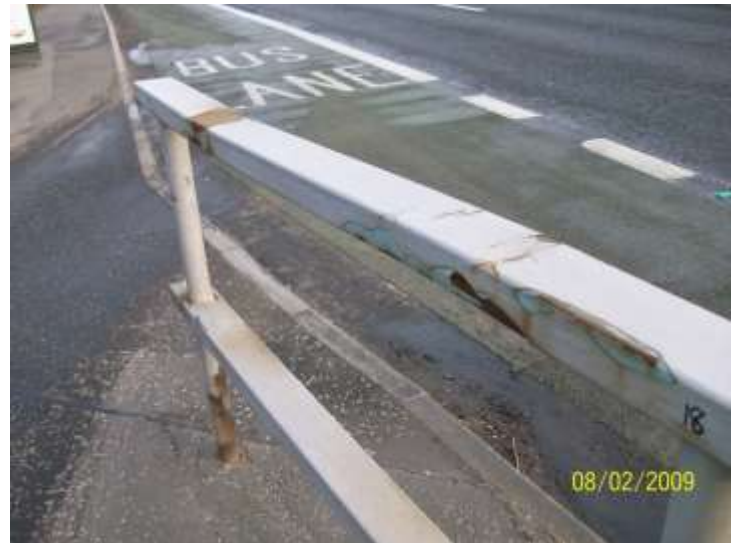
Top rail impact damage between positions 18 and 19.
