On the evening of Thursday the 26<sup>th</sup> of November. I was asked to attend / observe photograph & record all information in relation to the exposure of the foundation base-plates at one specified location on the North crash barrier/handrail on the East cycle track. Information as follows. :

**Barrier location. 16 on crash /barrier / handrail.**

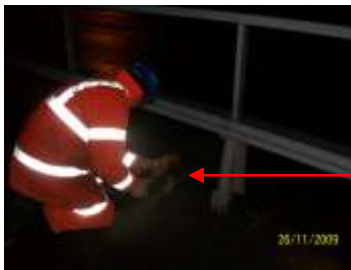
**Work procedure. : 1. -**

Area specified by consultants flint & neill ( south side of base only ) representative marked & cut out using “9 “ inch angle grinder & stone cutting blade.

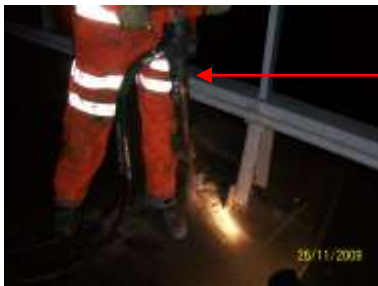
**Work procedure . 2. :**

Area breakout of concrete using generator powered hydraulic road breaker.on south side only of crash barrier base.

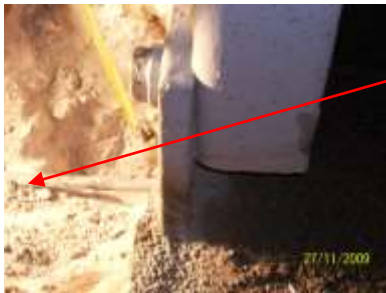
**Work procedure. 3. :**

Photograph showing location of longitudinal 16 mm round rebar approx 100mm below low point of cycle track surfacing. On south side of plate.

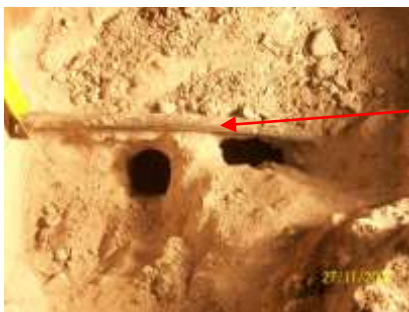
Work procedure. 4.

Photograph showing location of longitudinal 16 mm round rebar approx 200mm below low point of cycle track surfacing. Also visible 2 in No. holes created by impact of jackhammer. This was breakthrough of viaduct soffit.

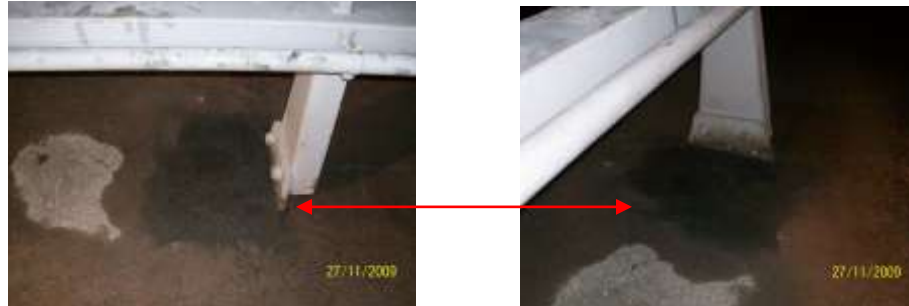
Work procedure. 6. :

Photographs showing completion of surface repairs following completion of investigation / survey by consultants Flint & neill.
