INSPECTION DEPARTMENT
North east main tower (cycle track) expansion joint Outer balustrade cover plate.
DATE. 08/04/13

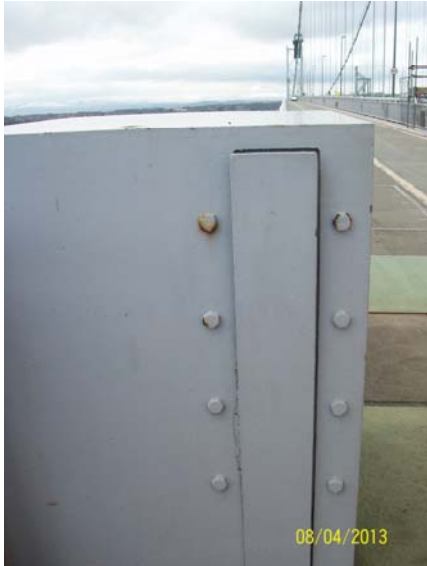
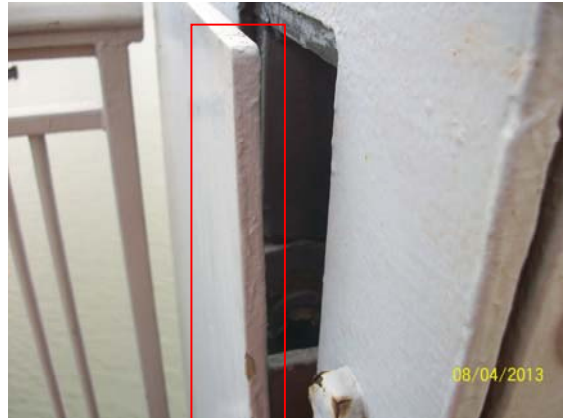
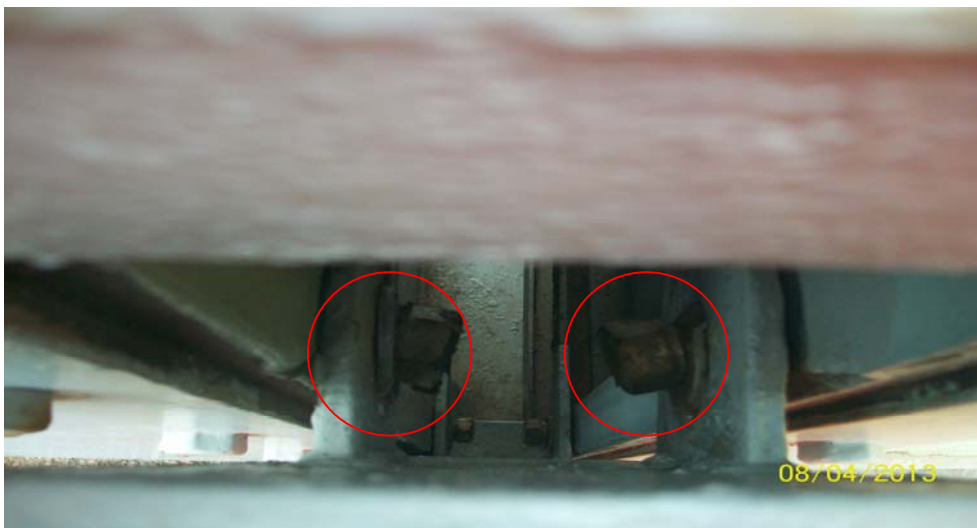
At the North east main tower on the main-span side, the outer balustrade cover plate hatch located on the north face has moved out. This plate appears to be some form of inspection hatch connected to four sliding plates (2 top & bottom) and have retaining bolts which are located in the slots. On inspection it appears that the top 2 bolts are badly distorted and that the inspection plate is misshapen vertically over its length. This maybe purely coincidental, but this has never been noticed until the removal of the D.O.C. access stairs at this location.
