**INSPECTION DEPARTMENT**

North east viaduct handrail.(
between outrigger handrail
nos 74 to 78.

DATE. 05.12.13.

Requested inspection findings of damage to North east viaduct handrail .

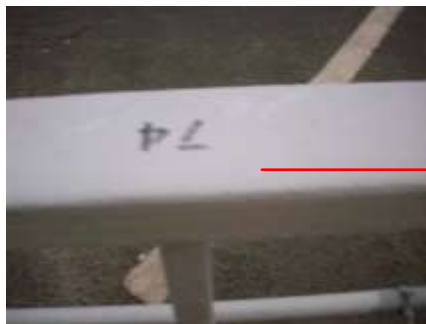
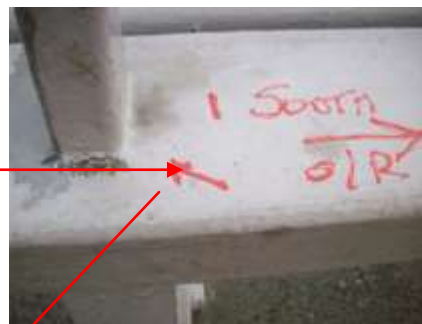
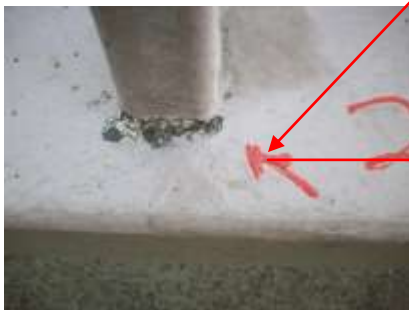
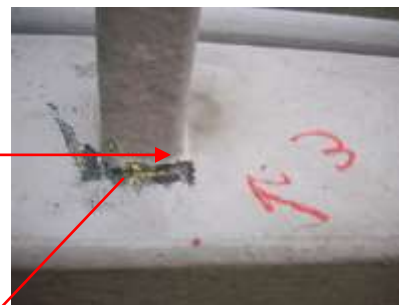
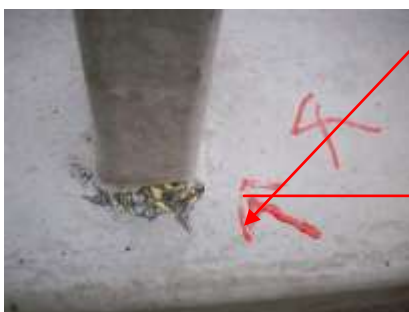
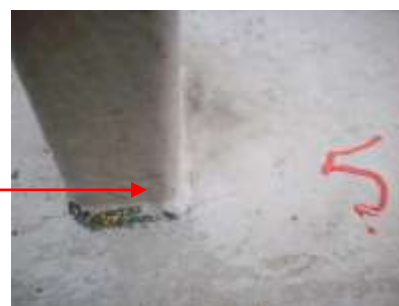
Damage incurred by vehicle. A total of 8 in No handrail vertical base welds appear to have been cracked through repeated impact of stationary vehicle. Location of damaged vertical welds are from handrail outrigger No 74 to 78. All photographs relate to carriageway side. Possible inspection and repairs to be carried out as required to cycle track (east) welds as required. No apparent distortion or misalignment of top handrail evident at time of inspection.

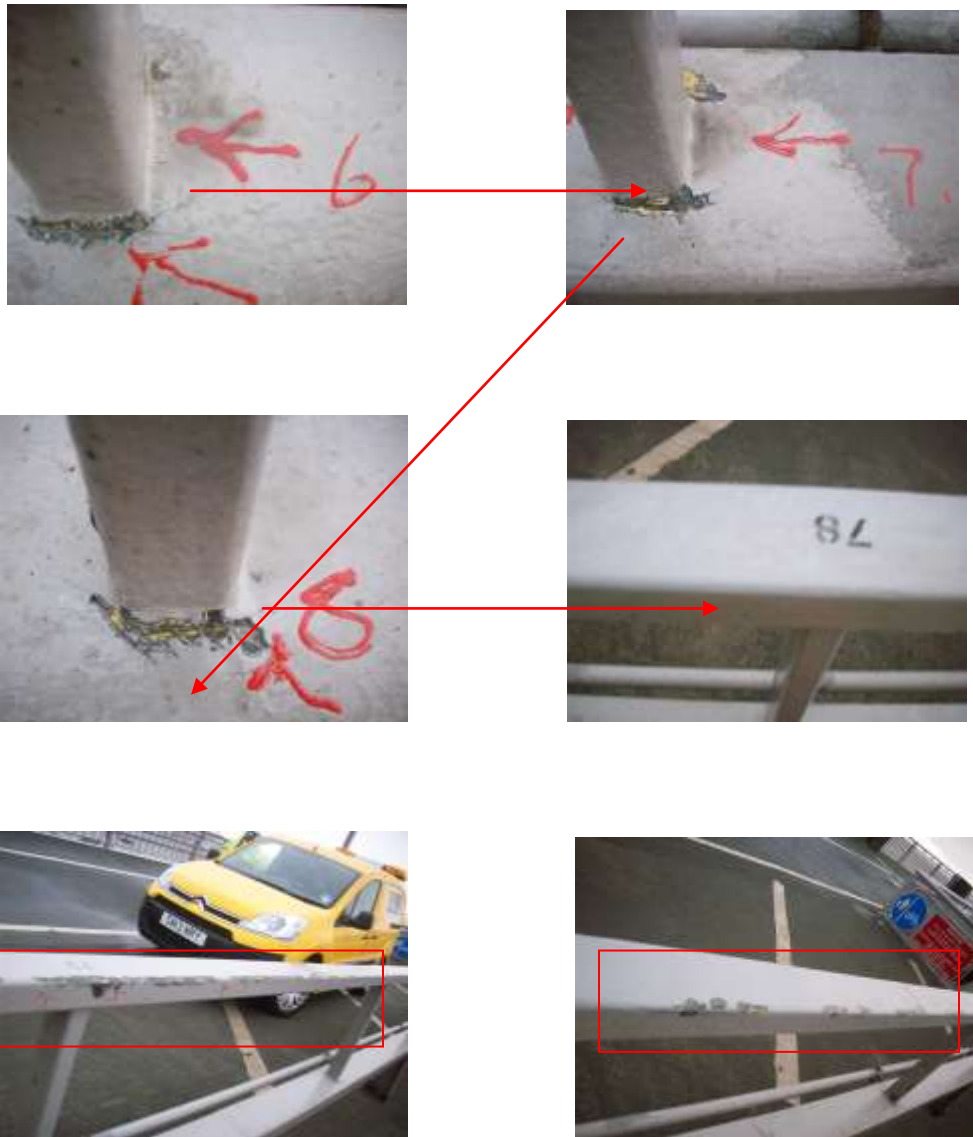
Photographs showing areas of top rail paint damage.
