INSPECTION DEPARTMENT
North side span. (West) Deck stiffener located on short panel side.
DATE. 2013. 02. 20.

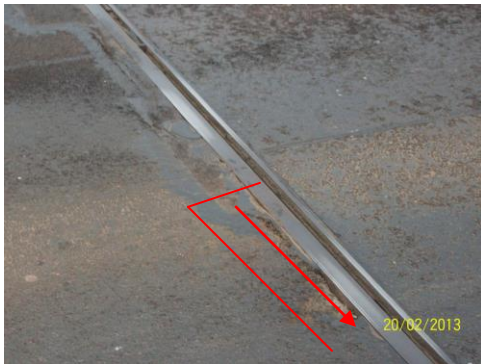
Whilst accessing the main cable to carry out the Backstay inspection, bridge inspectors observed excessive noise coming from the north side of the deck stiffener located on the short panel at PP00 N/W. Closer inspection revealed excessive movement in the surface plate over an area of approx 1.5 mtrs from the inner kerb- line. **An emergency temporary repair was requested to be carried out as soon as possible. This repair was completed by engineers.**

Excessive movement recorded on deck stiffener located on the North side of short deck panel Lane No 1. (Emergency temporary repair carried out by engineers 20. 02. 13).

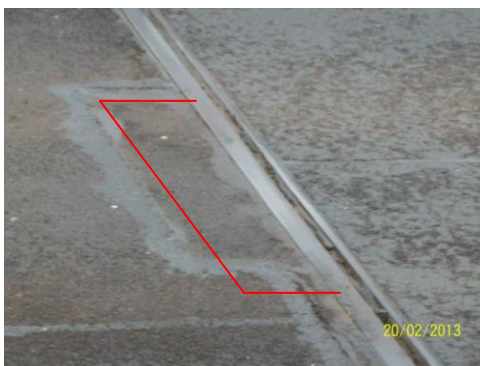
On assessment it was also recorded that there was also noise evident from a stiffener holding tang area which was previously investigated / repaired this would suggest that the probability is that further investigative works may be required. This location is approx 1.5 mtrs from the centre grillage into Lane No 2.

Photograph shows area where stiffener holding tang replacement was carried out. Noise/banging now evident. Probability is that further investigation / repair / replacement is required.
