INSPECTION DEPARTMENT
North side tower (top) inspection of all elements accessible.
DATE. .

As requested a visual / principal was conducted of all accessible elements on the North side tower top both East and West , following are photographic and written information with regards to current status related to

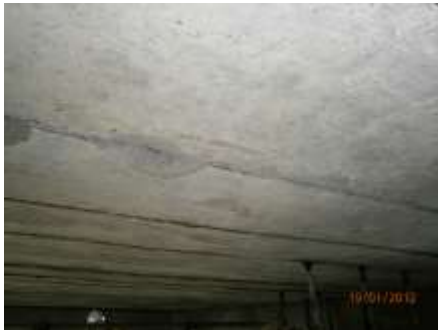
West

All Cycle track support beam slabs remain in very good condition both East & West. There are no signs of any longitudinal or transverse cracking or concrete spalling on any of the soffits of the beams. No evidence of any reinforcement movement, beam deflection or beam distortion at time of inspection.

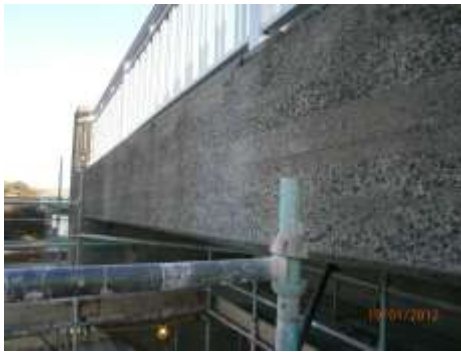
West. Outer face

Concrete outer cycle track side tower well support beam . : The cycle track outer support beam . Externally this concrete is in very good condition, there are no visible signs of any longitudinal or transverse cracking , reinforcement exposure or concrete spalling on any of the soffits or external faces of the beams. No evidence of any reinforcement movement, beam deflection or beam distortion at time of inspection.

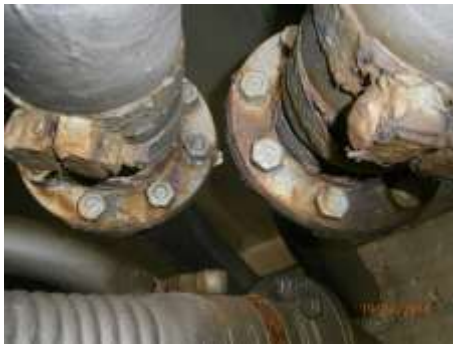
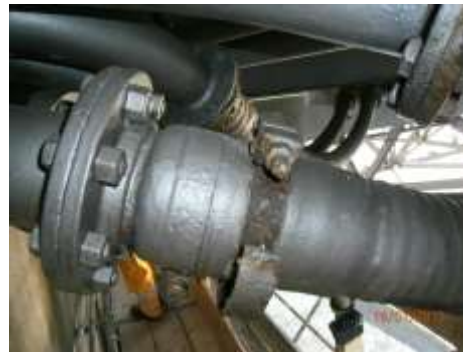
Flexi duct support brackets , ducts & fixings. :

Side- tower to Side-span flexi – ducts. : All flexi- ducts both East and West side remain in a satisfactory condition. Paint breakdown and Heavy corrosion evident around some flange mating faces bolts and nuts. There are some clamp arrangement fittings which are missing but this does not affect their function all ducts remain fitted and secure . The condition of these clamps have been highlighted in Past side-span inspection reports . All flexi- ducts remain in a satisfactory condition , with no deterioration evident. all support hangers remain intact, secure but heavy corrosion is evident.

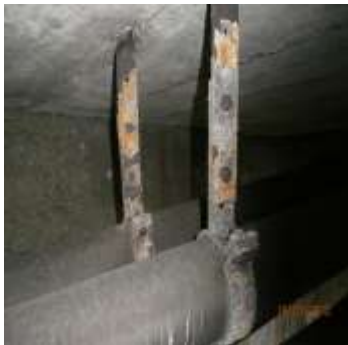
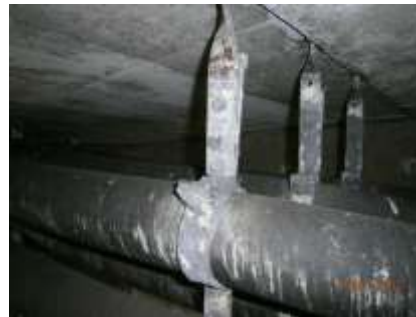
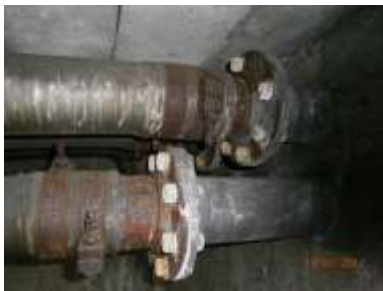
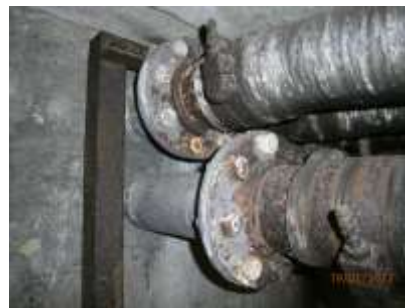
Viaduct box girder to side tower flexi- ducts and hangers. : All flexi- ducts both East and West side remain in a satisfactory condition, paint breakdown and medium to heavy corrosion is evident around all flange mating faces , clamp arrangement fittings bolts and nuts. The condition of these clamps have been highlighted in Past viaduct external inspection reports . All flexi- ducts remain in a satisfactory condition , with no deterioration evident. all galvanised support hangers which are fitted into the joints of the cycle track concrete support beams remain secure and intact . All support hangers have medium to heavy corrosion evident.

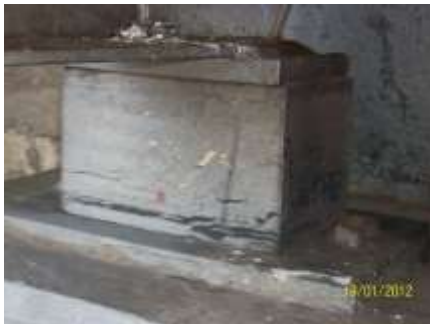
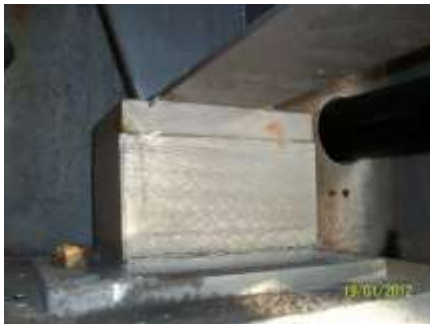
Side- span Stringer elastomeric support bearing pads. : All side- span stringer to side-tower ledge elastomeric support pads both East and West remain in good condition , All fixings remain in a satisfactory condition. Evidence of slight cracking on painted face surfaces slight corrosion evident on fixing bolt heads evident at time of inspection.

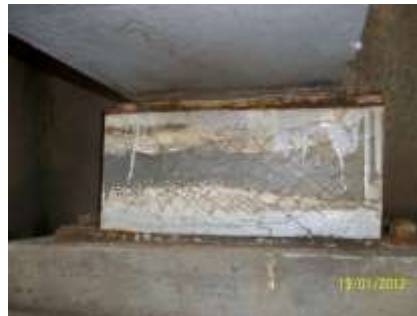
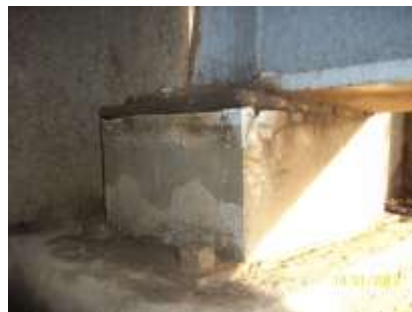
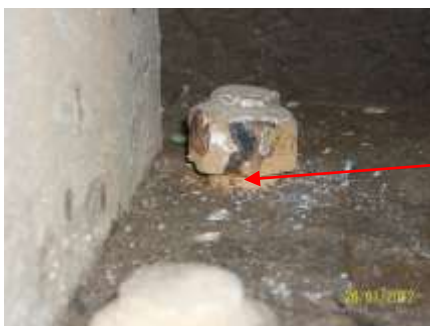
East

Stringer No 4 East. Picture showing gap between plate face & underside of nut on North bolt. (East side)

Spanner set on bolt . No movement evident.

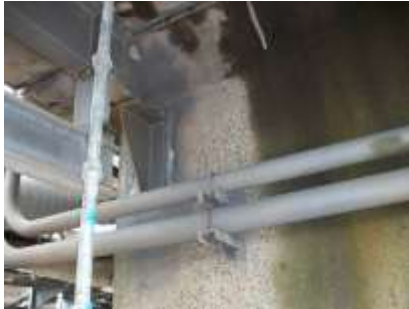
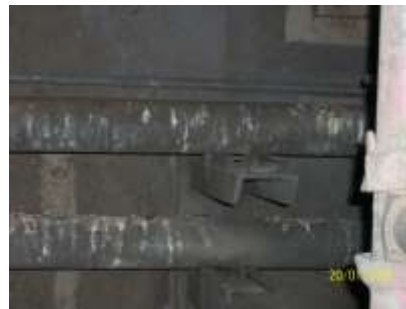
Pipe-work , support brackets & fixings.: All ring-main pipe-work on the viaduct to side tower well and inner balustrade , both East and West sides their connection flanges, support brackets, u- hangers & fixings remain in a satisfactory condition. All ring-main crossover pipe-work from side tower north face to side span inner balustrade sides of the side tower remains in a satisfactory condition.

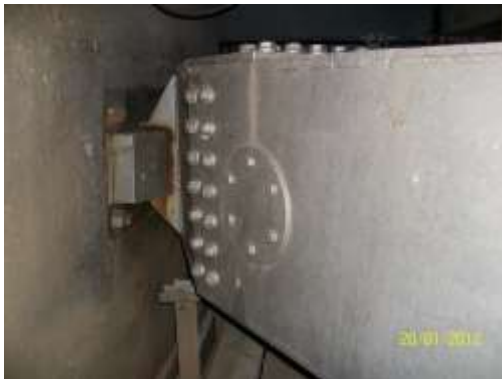
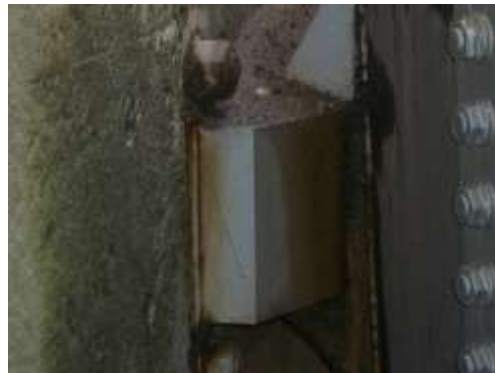
Top lateral connection to side tower , side – span side. Remains in a satisfactory condition, Slight staining evident on face and nuts. No movement .
Discolouration/staining slight corrosion , this is due to location, Constant exposure to water and road detritus being distributed on to it from both carriageway fast lanes.
Concrete surrounding plate in a satisfactory condition. All lateral bolts in location and secure , slight corrosion to nuts evident.

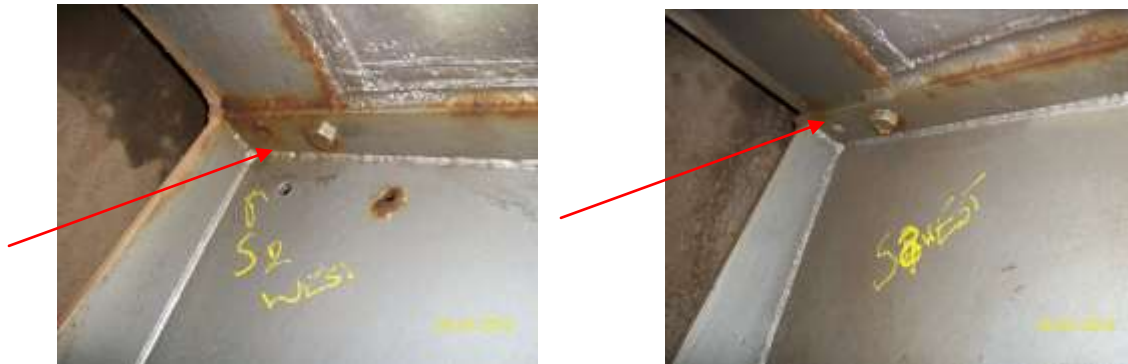
Stringer top flange to concrete deck soffit bolts

Pictures show missing bolts located on the stringer top flange to concrete deck on stringers No 2 & 3 on the west side. (It should be noted that that information related to these bolts were recorded on the maint data base under structure number 7276 on inspection date 27/10/98 by Bridge inspector G.Hamilton.)

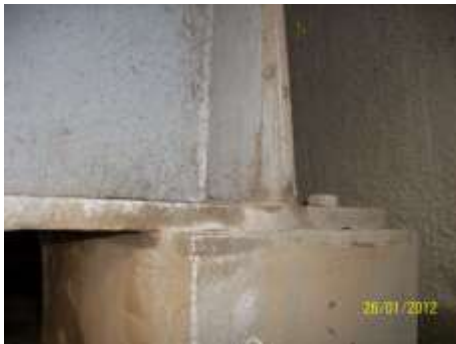
Stringer bottom flange to bearing mounting plate.

Picture shows missing bolt located on the stringer bottom flange to bearing mounting plate on stringer No 1 on the East side. (It should be noted that information related to this bolt were recorded on the maint data base under structure number 7275 on inspection date 27/10/98 by Bridge inspector G.Hamilton.)

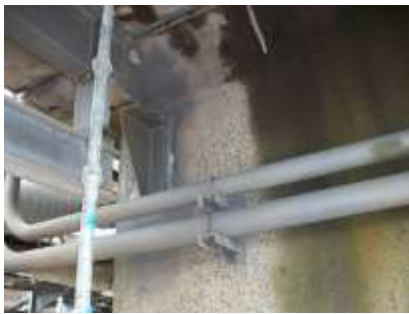
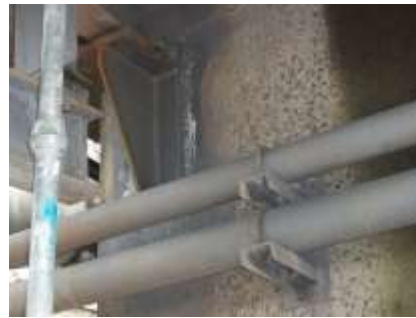
Viaduct runway beams to side tower support brackets. (North face) . : Viaduct runway beam support brackets located on the north face all remain in a satisfactory condition, slight staining / discolouration evident at mating faces of runway beam to support bracket. Location fixings intact, secure and in a satisfactory condition. . No movement at tower face evident.

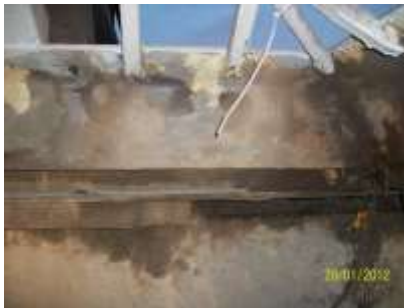
West.

Plate located under concrete on South face of side tower side span side , both East and west sides directly below grillage which runs through from PP.00. carriageway expansion joint on the North side span. Plate movement evident. Infill support material missing below plate in some areas., noise evident. There are also defects on the top plate at PP 00 N/E related to top plate deflection/ deterioration. This work is recorded on the Maint data base under structure No 7281 .

These defects discussed by Bridge inspector/ Maintenance inspector and work will be carried out to repair as required.

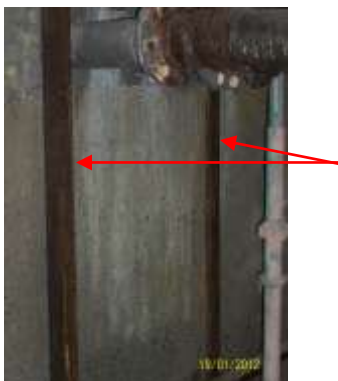
East.

On the North side of the South face of the side tower (East side) there is a frame (which is heavily corroded and serving no purpose) attached by “U” brackets to ducts . (Requires to be removed.

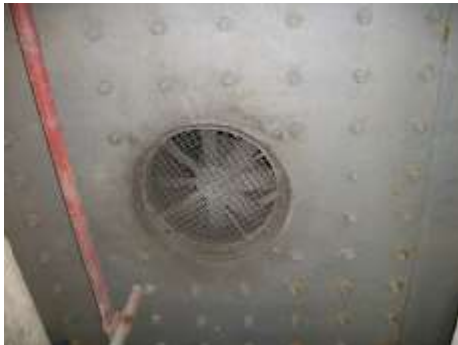
Viaduct box girder air extraction fan and splice plates. Both extractor fan units and splice plates located on the soffit of the box girder both East & West side remain in a satisfactory condition. All splice bolts & nuts remain intact and secure and in good condition..
